UPPER TRUCKEE MARSH SEWER FACILITIES ADAPTIVE MANAGEMENT PLAN

2015 ANNUAL REPORT

South Tahoe Public Utility District

Northwest Hydraulic Consultants Inc.

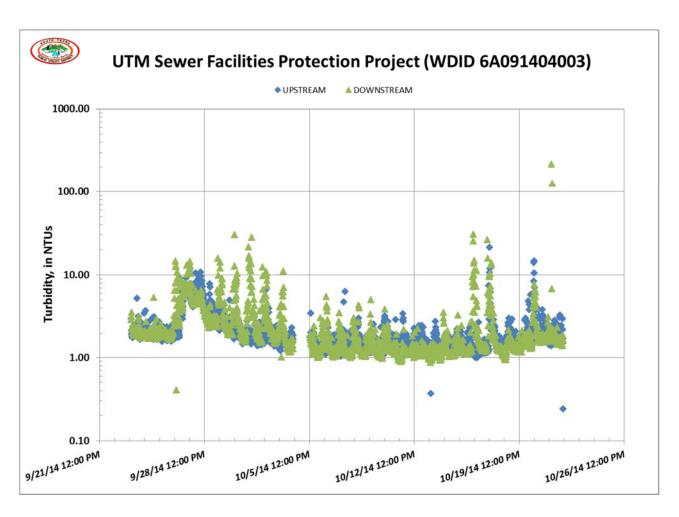
Figure 3-1 shows the data from the recording turbidimeters upstream and immediately downstream of the Bellevue work area.

Figure 3-1. Turbidity upstream and downstream of Bellevue Avenue work area during Year 1 construction period

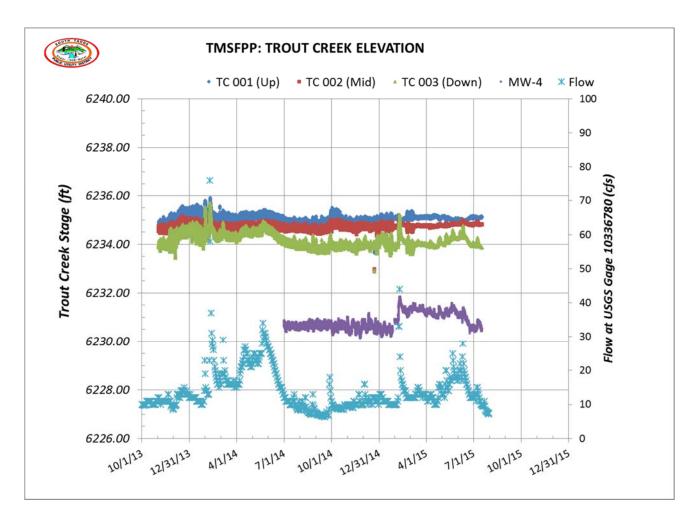
The pressure transducers shown in Figure 2-6 continued to operate following Year 1 construction. Figure 4-2 shows the water level record between October 2014 and July 2015. The water levels are intended to supplement observations on easement inundation and pilot channel performance in conjunction with survey data. The data indicate that water levels at the middle and upper stations on Trout Creek have remained relatively constant since the baseline period. The lower station is below the channel avulsion area and stages vary more with flow than for the other two stations. The data indicate that at low flows there is about a foot of drop between the middle and lower station, which is a higher gradient than the Trout Creek slope in the reach. The higher gradient represents potential for pilot channel development, but as noted above, little development was observed in the period following Year 1 construction.

Groundwater levels remained relatively constant with a slight increase during the spring that may correlate to precipitation. In the data collected to date, groundwater levels are not well correlated to stream stage and are below the stream levels, indicating potential for loss of flow from the stream to groundwater in the local area.

Figure 4-2. Water levels through end of July 2015

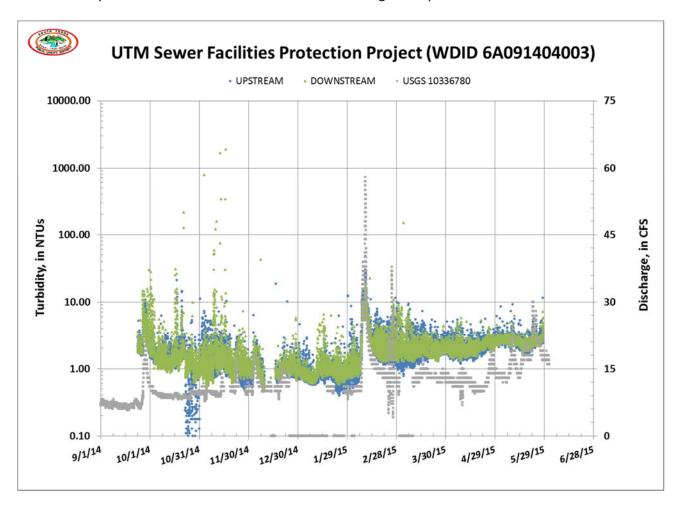
Figure 4-3 shows the turbidity measurements upstream and downstream of the work area near Bellevue Avenue for the period during and after Year 1 construction through May 2015. Trout Creek flows at USGS 10336780 are also shown in the plot. Although there are outlying data points indicating short duration elevated turbidity levels both upstream and downstream of the work area, the data generally show turbidity levels to be similar at the two stations and to generally be less than about 5 NTUs.

Figure 4-3. Turbidity upstream and downstream of work area near Bellevue Avenue through June 2015

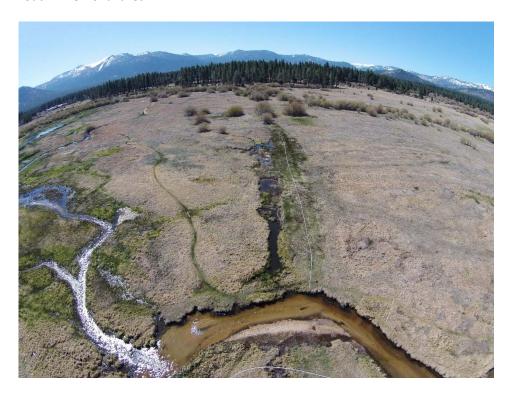
Figure 4-7. Aerial view of road fill removal area looking south, 17 Apr 2015 (road fill removal in right center of frame, pilot channel outlet in left foreground)

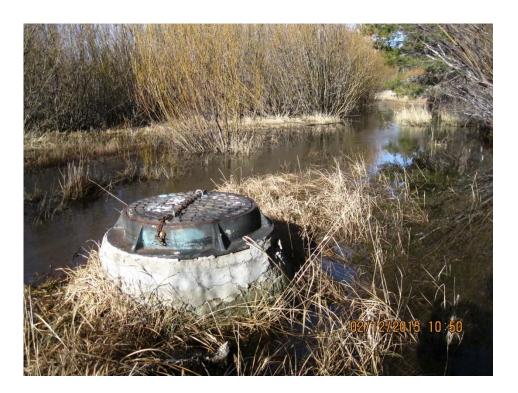
Shortly after construction, beaver activity was observed upstream of the Bellevue Avenue work area in portions of the stream where beavers had not previously been present. A main dam is currently located on Trout Creek just downstream of the location of the secondary channel in the center of the meadow, and several auxiliary dams are in place to block return or distributary channels. The result is widespread flooding of the meadow at very low flows in the area upstream of Bellevue Avenue. This flooding has created new challenges for the District associated with flooding in the easement and persistent water around manholes.

Figure 4-9. STPUD Manhole BV22, inundation due to beaver activity, 12 Feb 2015

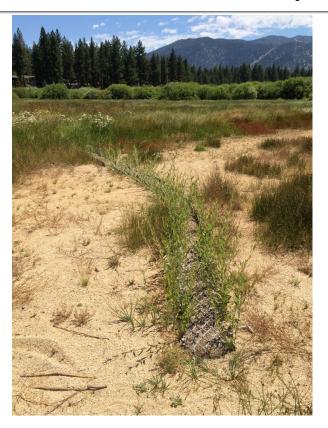
Willow stake counts were made for the willow sausal and the willow fences. Survival was 13% for the willow sausal and 40% for the willow fence, not meeting the performance standard of 80% survival. The vegetation monitoring report attributes the low success to improper materials and planting methods, but notes that the survival rate is sufficient for the features to serve their intended function if the material continues to grow.

Photo 3. Willow brush fence

The new hummock should be installed as soon as possible to maximize growth for this year. Additional willows are not necessary are the present time.

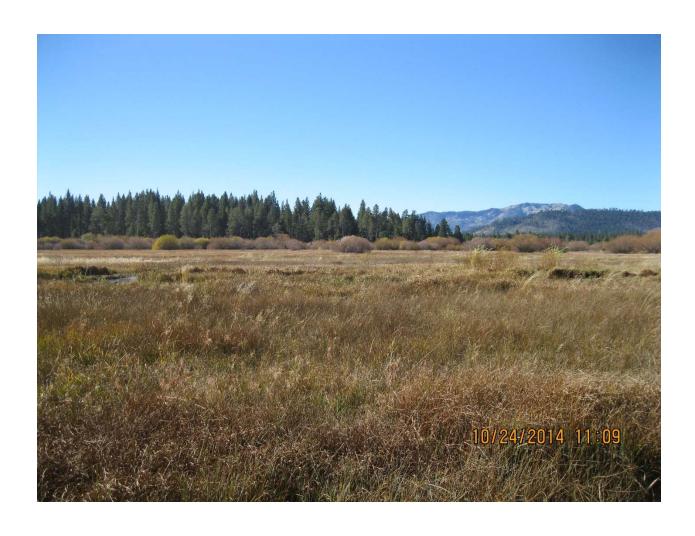
PP#1_10 24 2014.JPG: Photo Point #1, View looking SW across right overbank; LBO-5 at Trout Creek, center left.

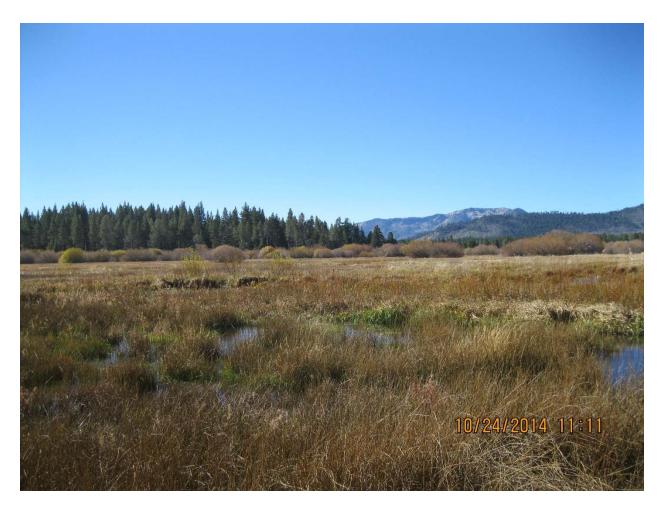
PP#2_10 24 2014.JPG: Photo Point #2, View looking SW across right overbank.

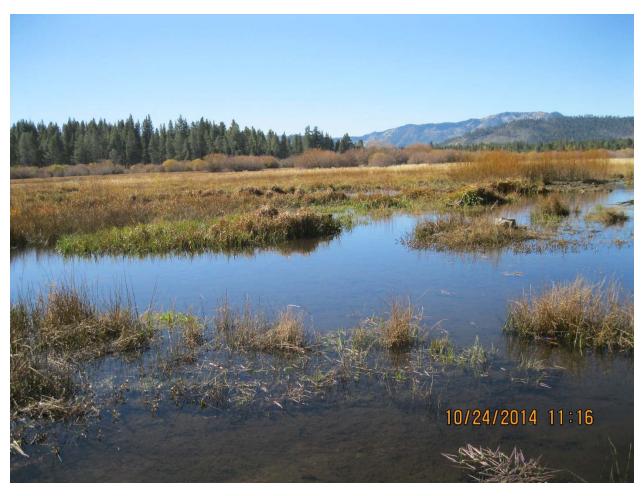
PP#3_10 24 2014.JPG: Photo Point #3, View looking SW across right overbank in avulsion area; LBO-1 at middle far right of view.

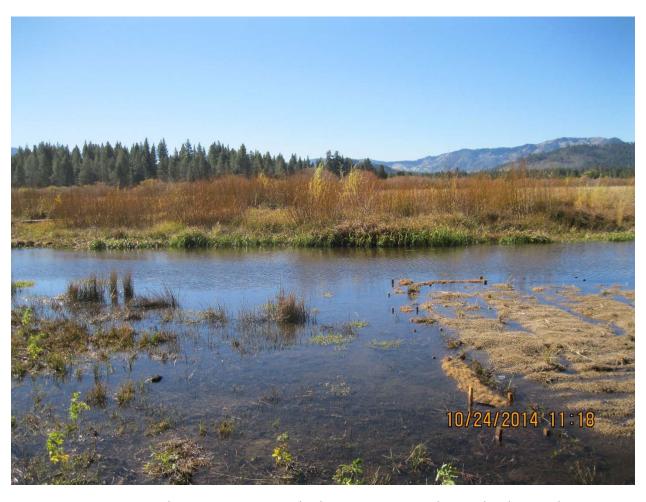
PP#4_10 24 2014.JPG: Photo Point #4, View looking SW across right overbank in avulsion area; FH-3 at lower right of view.

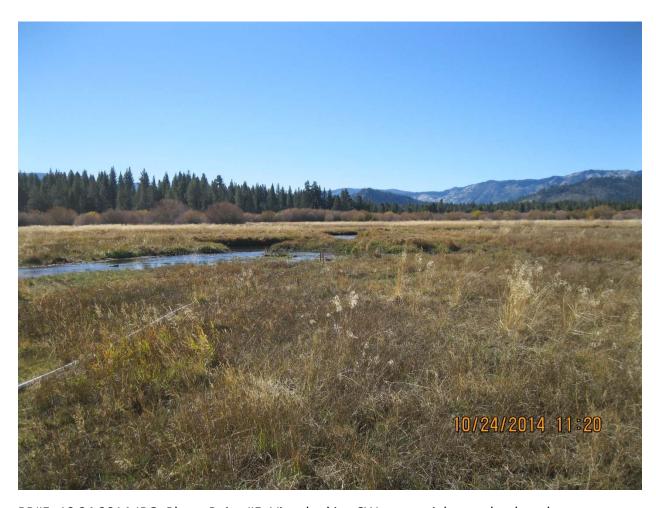
PP#5_10 24 2014.JPG: Photo Point #5, View looking SW across right overbank at downstream end of avulsion area.

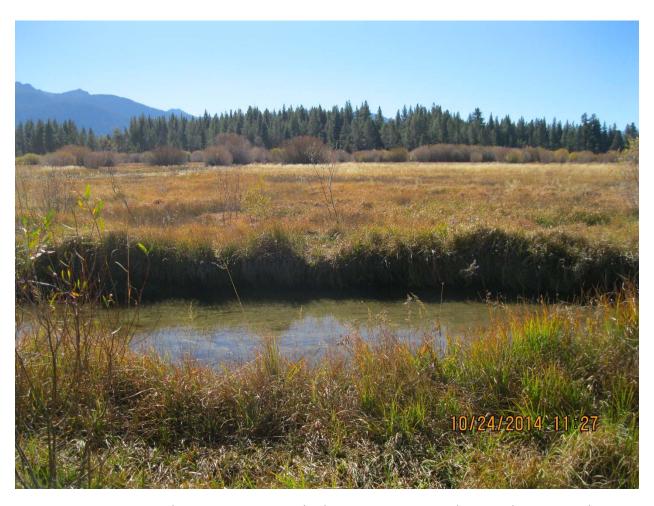
PP#6_10 24 2014.JPG: Photo Point #6, View looking SW across marsh toward Trout Creek, near downstream end of project area near Bellevue Avenue.
