# South Tahoe Public Utility District

## TAHOE VALLEY SOUTH SUBBASIN (6-005.01) ANNUAL REPORT Water Year 2022

*6 April 2023*

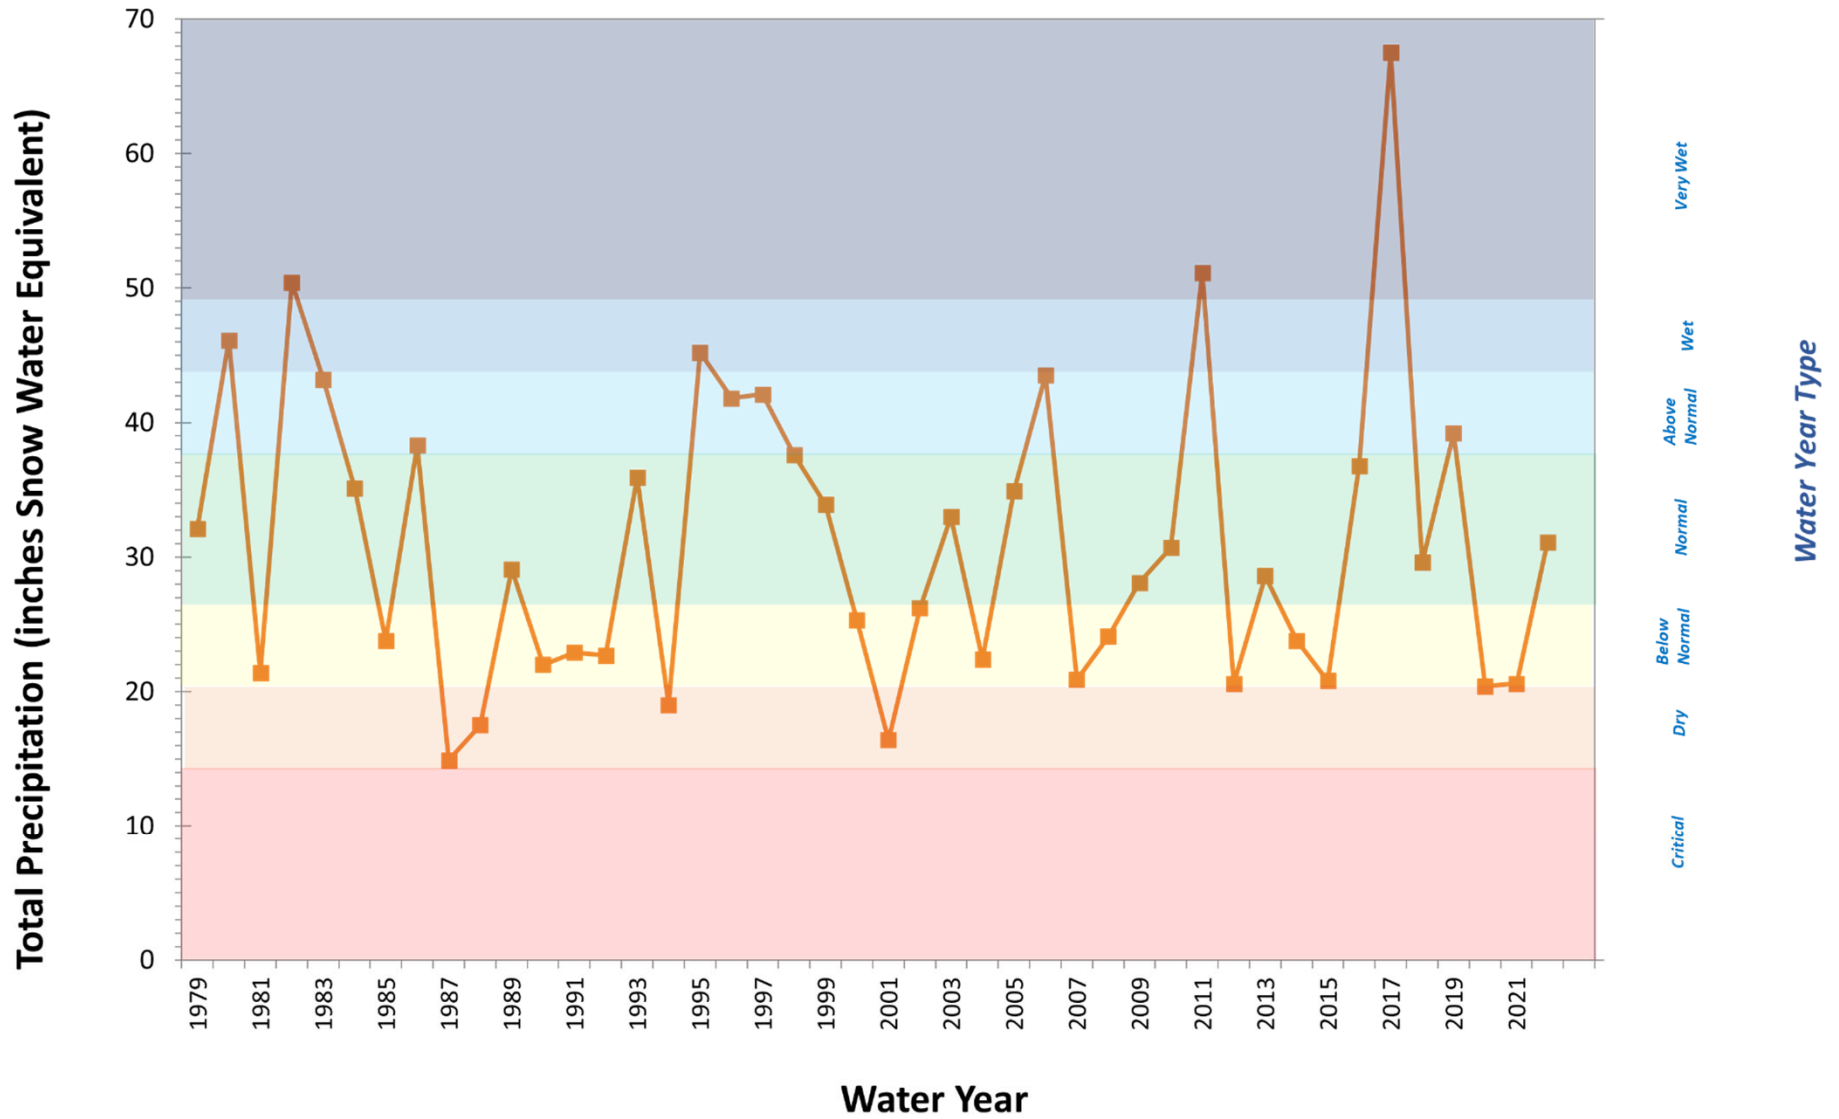
Snotel 508: Hagans Meadow, CA

Water Year 2022 had normal precipitation

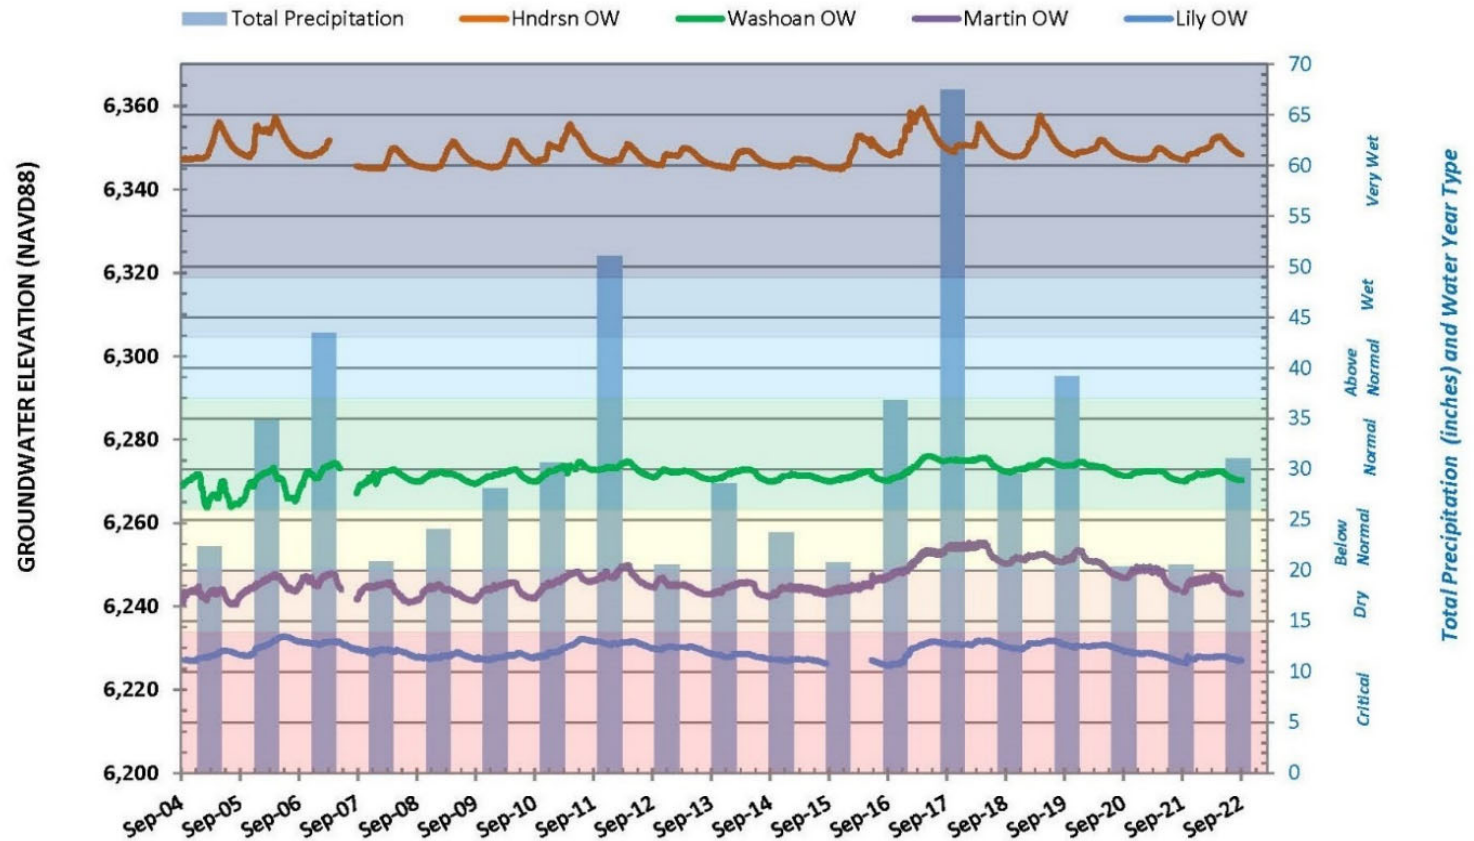
Measured water levels are generally stable over a range of hydrologic conditions

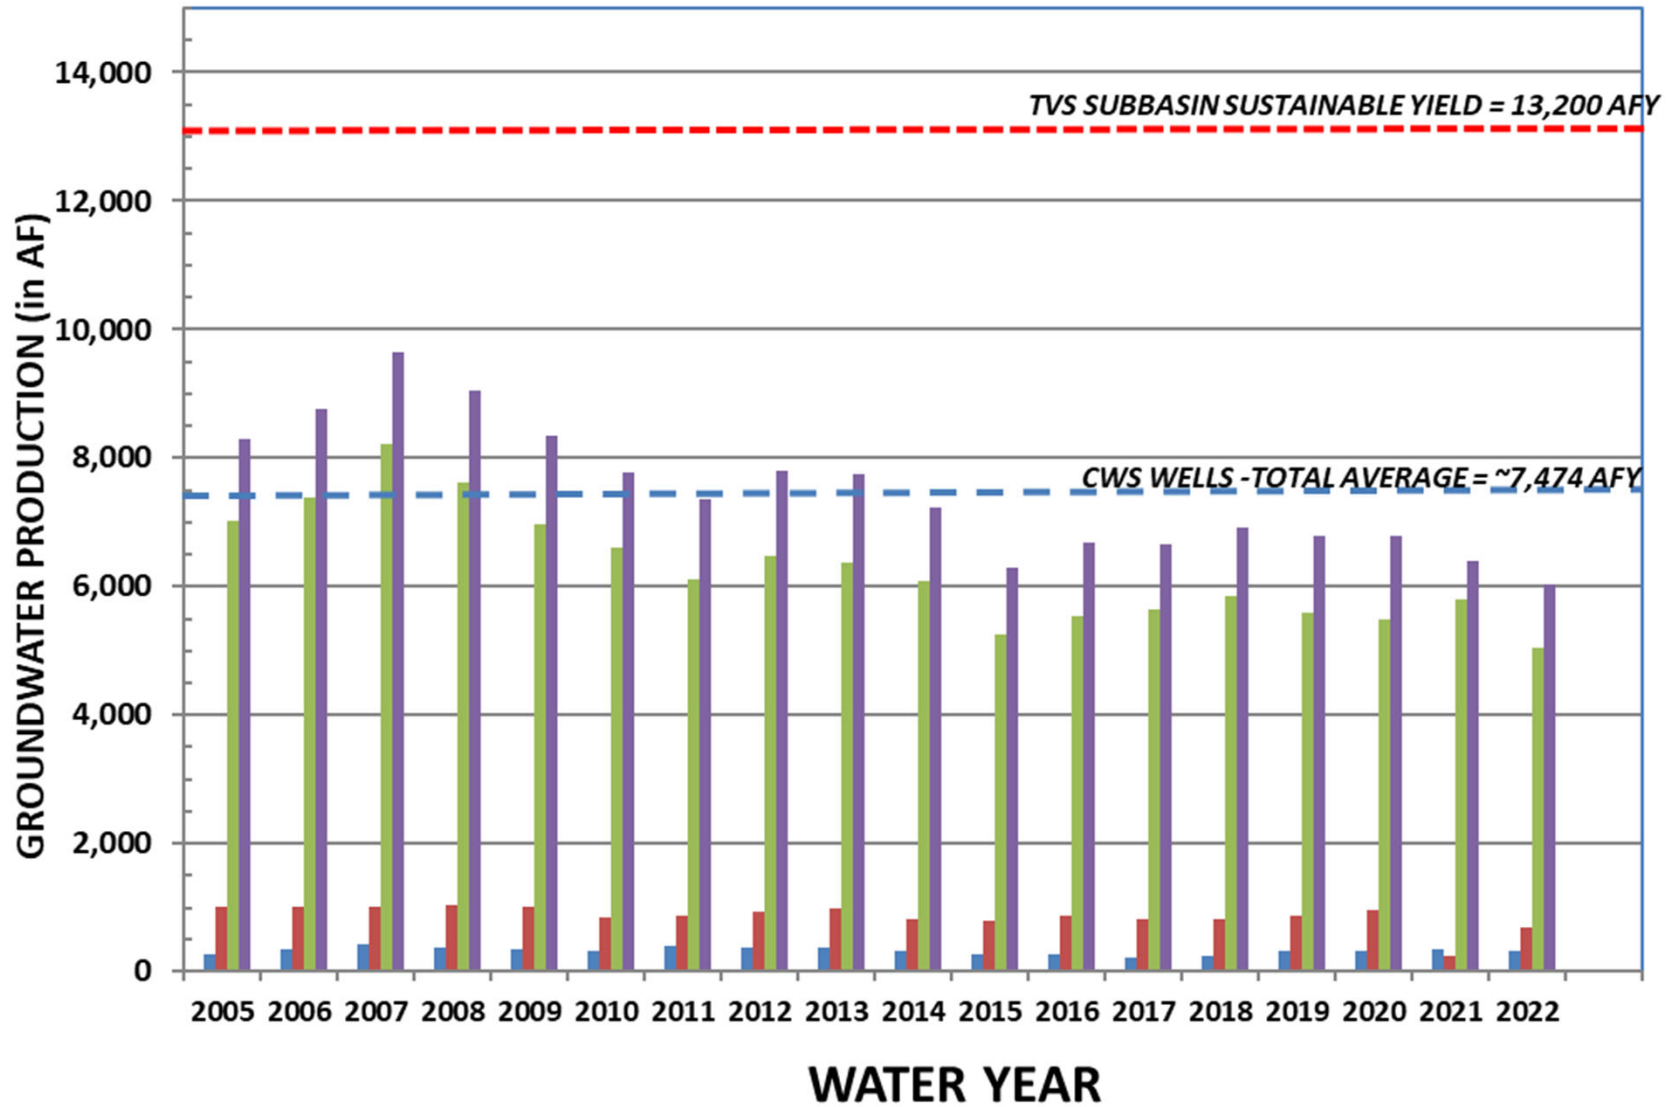
# TVS Subbasin Community Water System Pumpage

■ LPA ■ LBWC ■ TKWC ■ STPUD ■ CWS WELLS - TOTAL

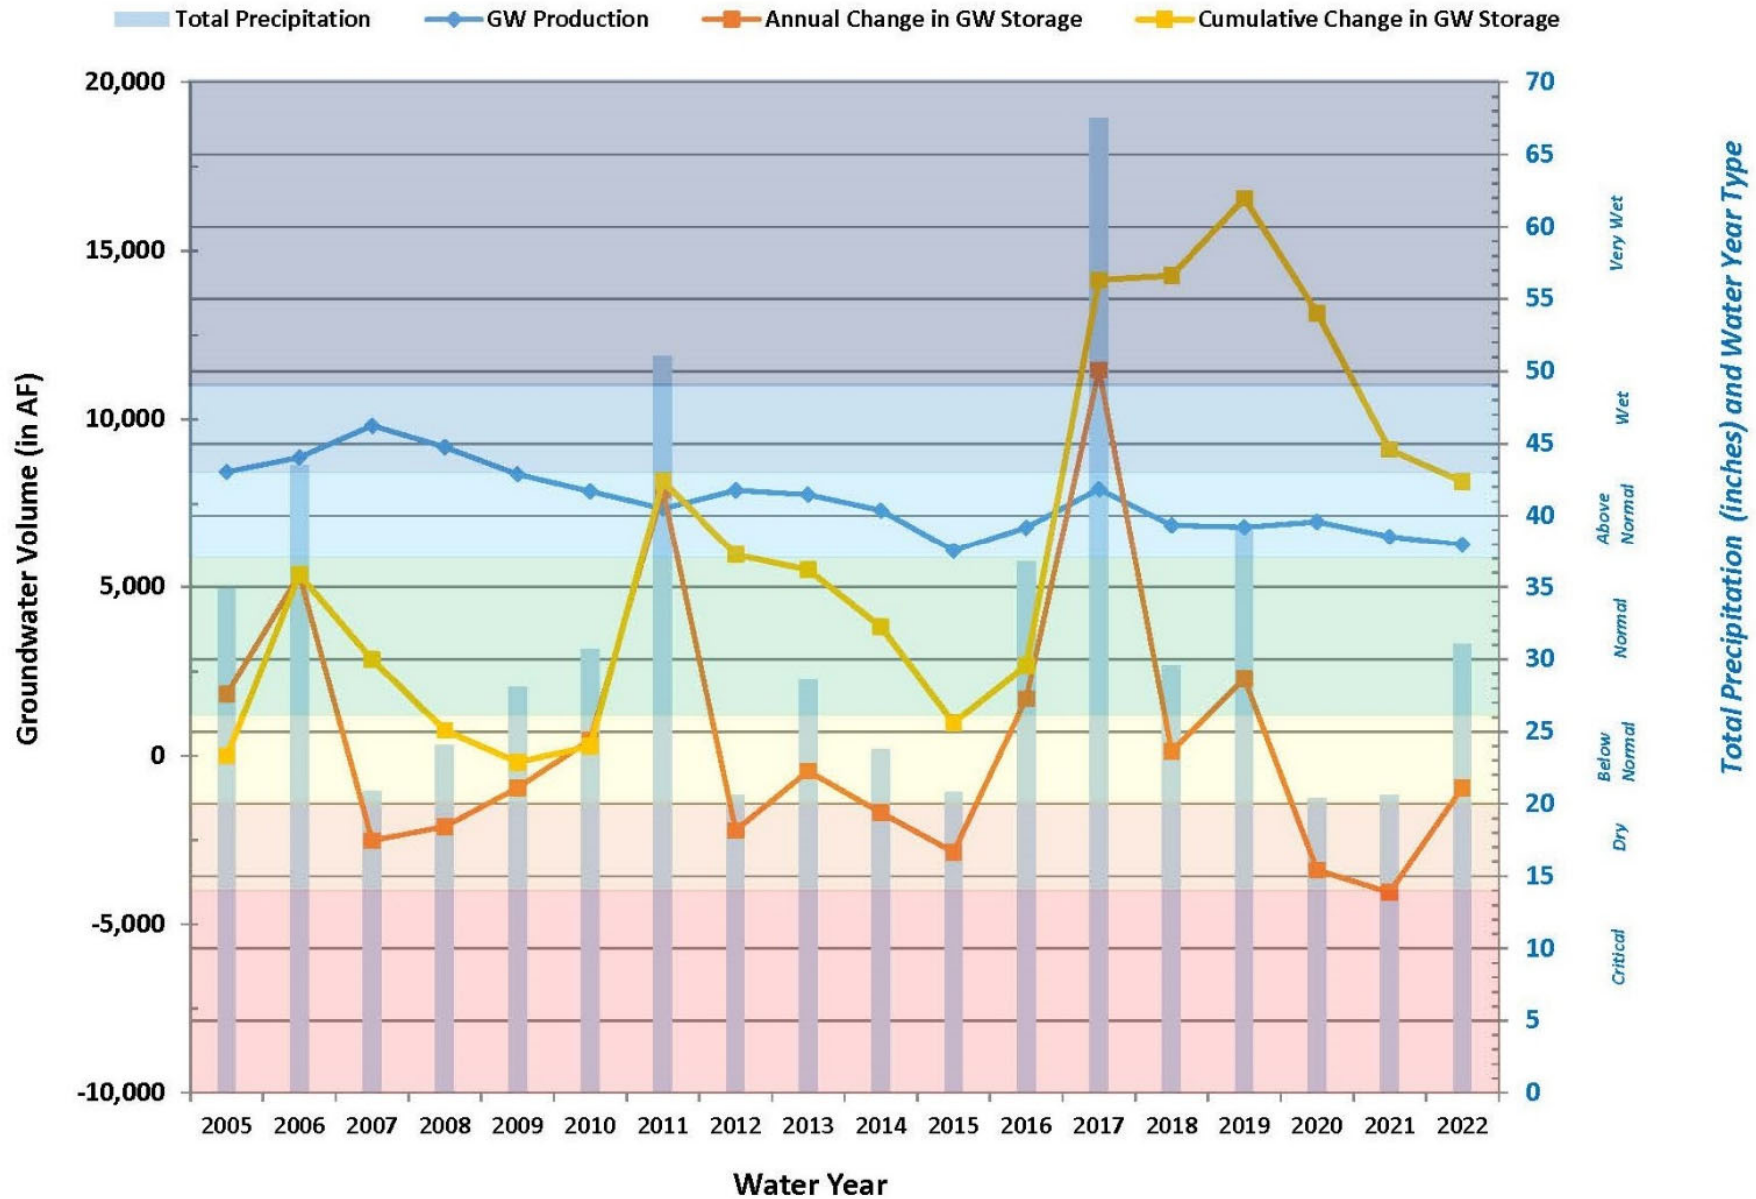
### TVS SUBBASIN GROUNDWATER USE and STORAGE

Modeled GW Storage has increased with normal precipitation because of increased recharge

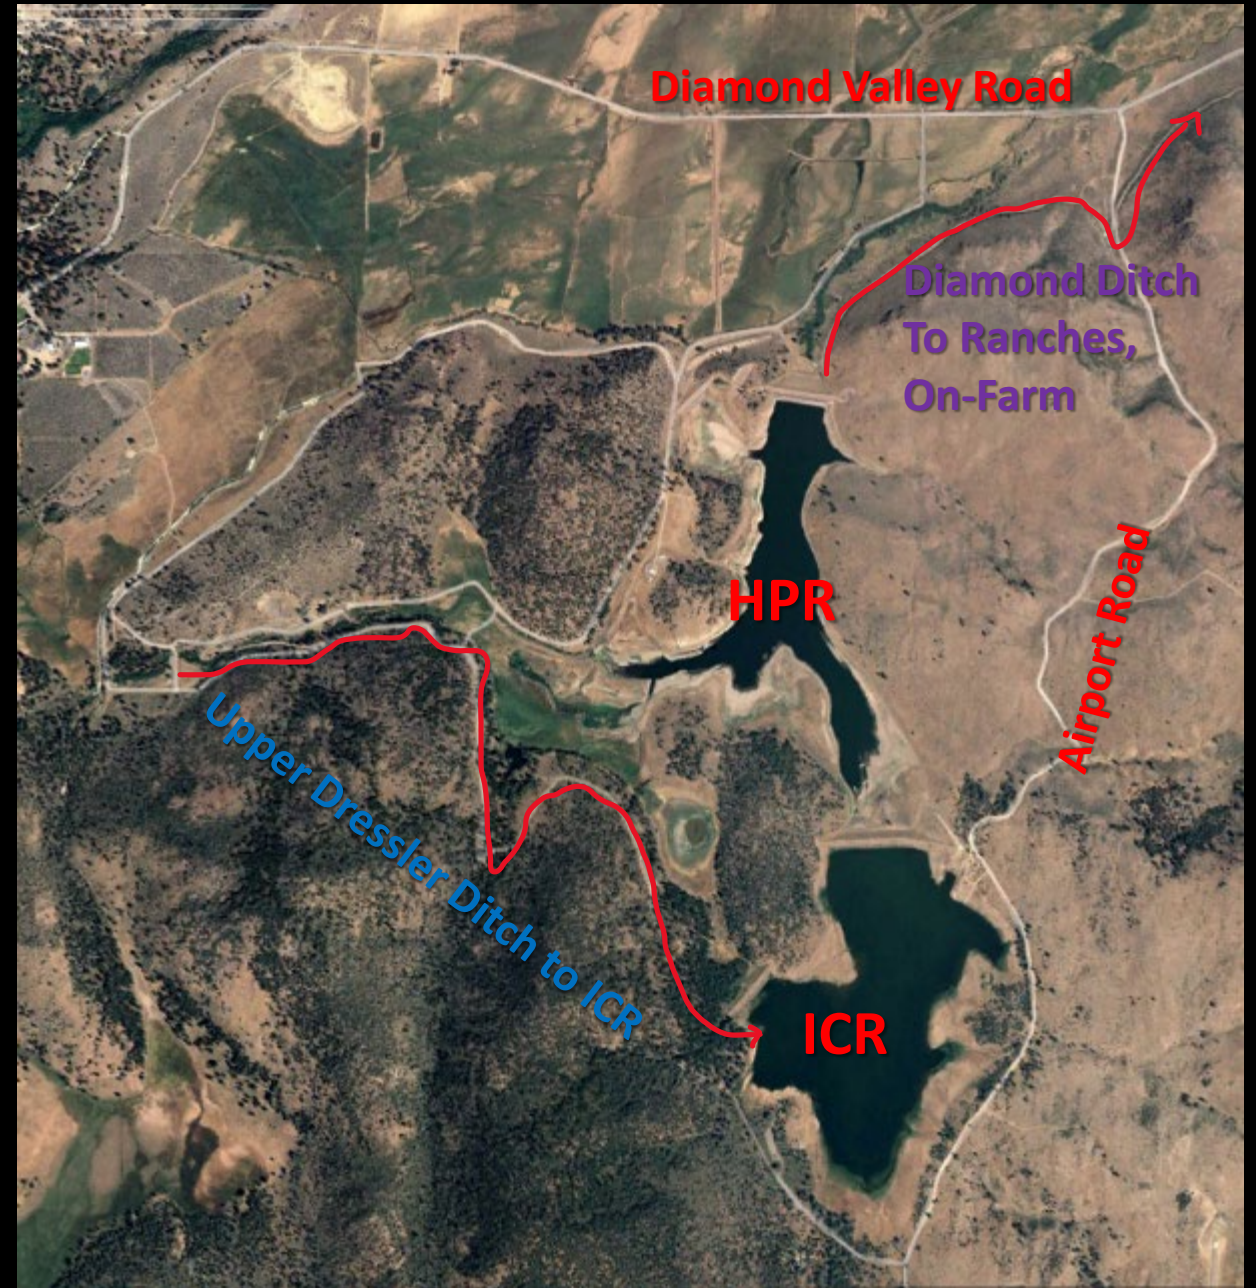
# DVR Overview

- Harvey Place Reservoir
  - Releasing @ 5 cfs since April 1<sup>st</sup>
  - 5' below overflow, minimal level change
- Indian Creek Reservoir – 11 cfs flushing flow
- On-farm System - Emergency release location and conveyance to downstream ranches
- Ditches (canals), roads, and culverts impacted by heavy runoff, current debris removal & repair work

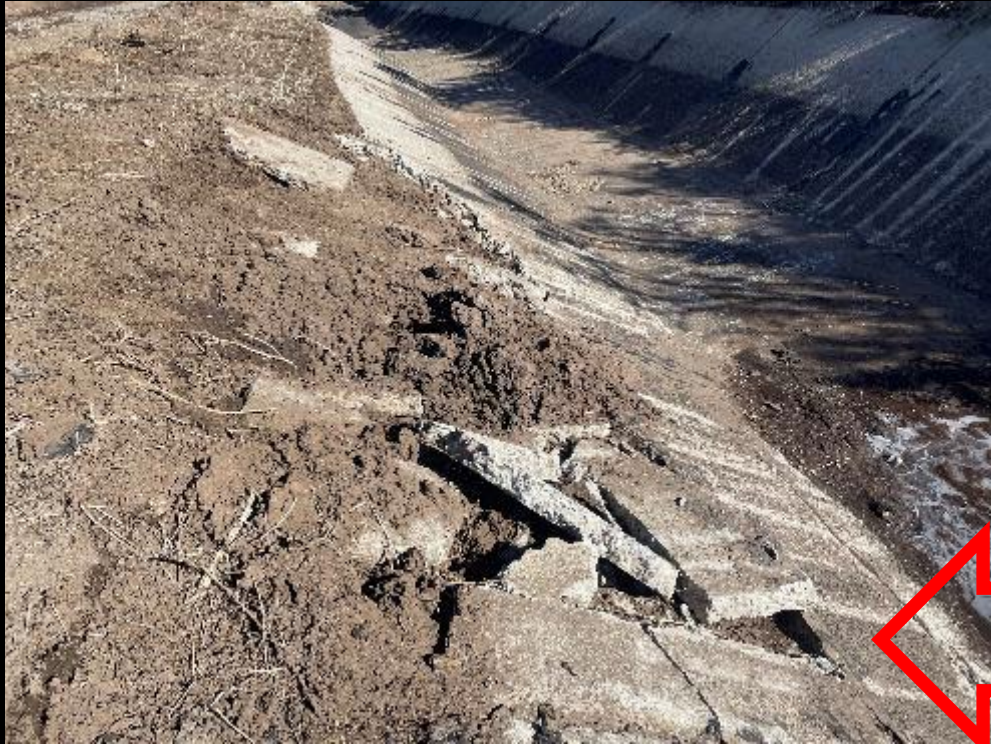
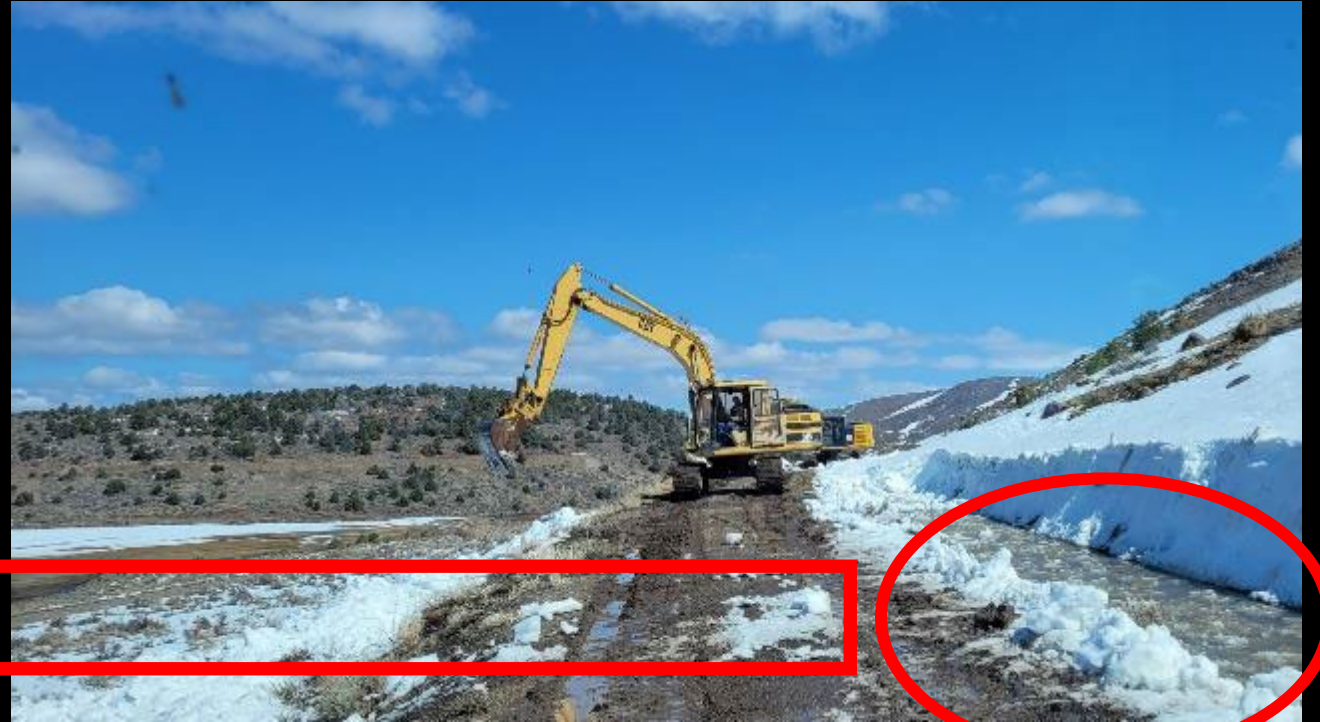
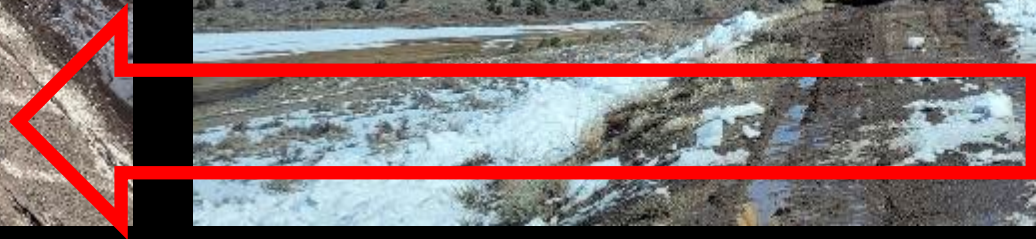
# Diamond Ditch

- Conveys recycled water from HPR
- Currently Restricted to 5 cfs, pending repair from snow removal work

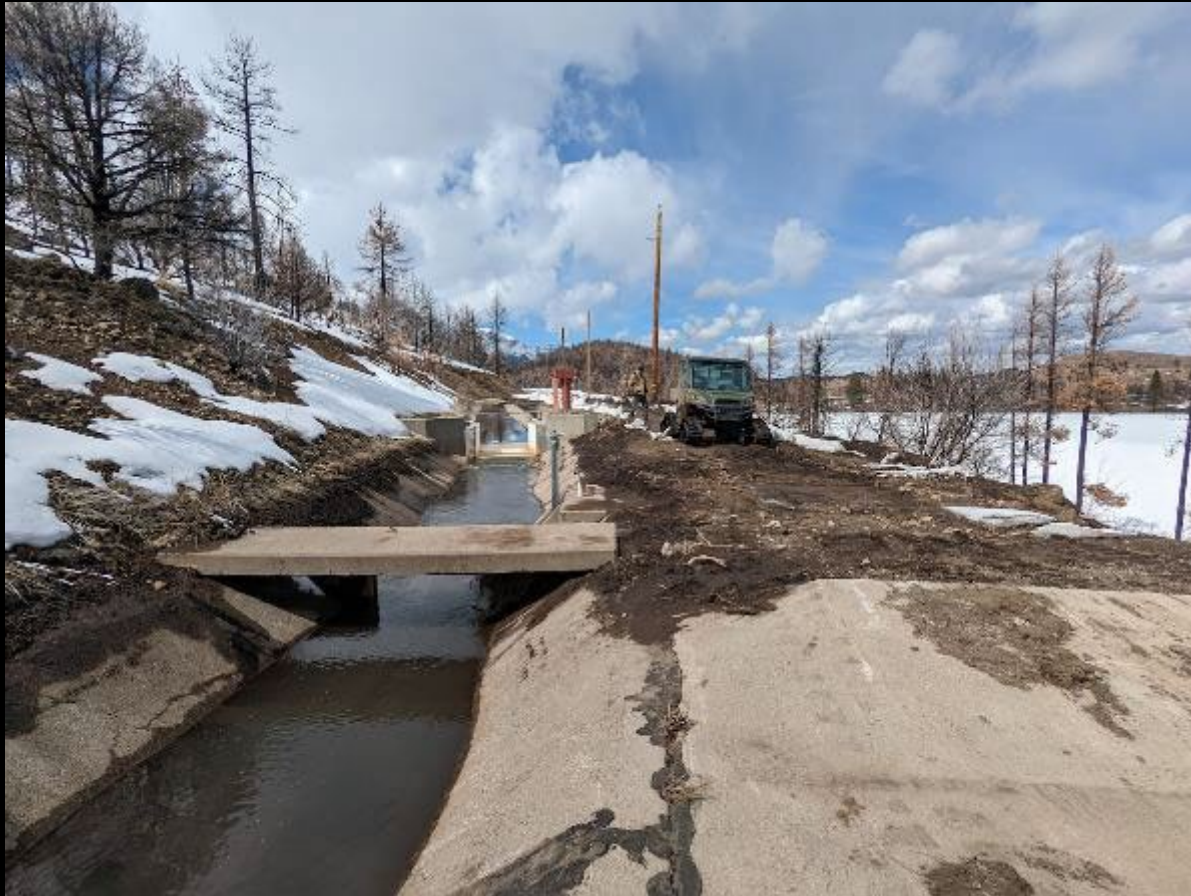
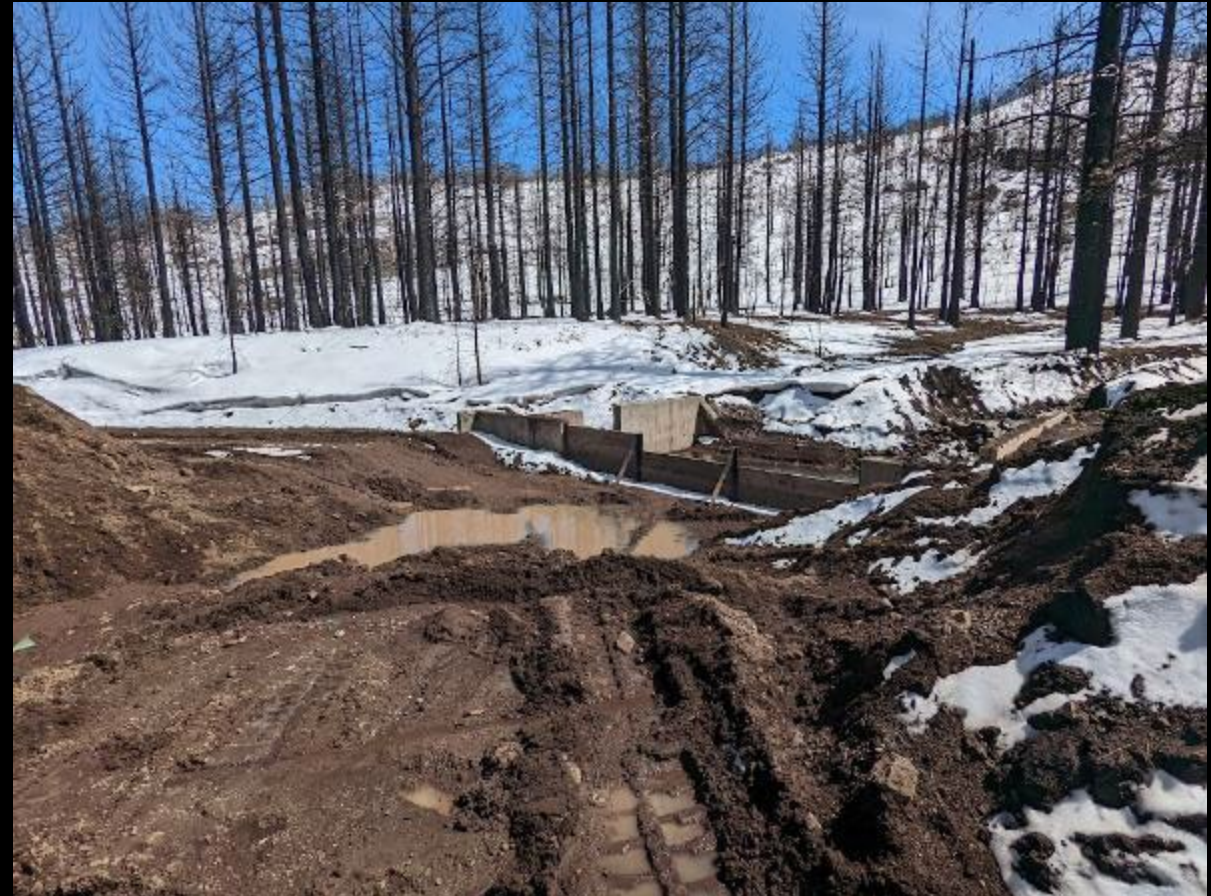
# Dressler Ditch

- Intercepts natural runoff, conveys freshwater to ICR
- Functioning, but major access road and drainage issues
