UPPER TRUCKEE MARSH SEWER FACILITIES ADAPTIVE MANAGEMENT PLAN

2015 ANNUAL REPORT

South Tahoe Public Utility District

Northwest Hydraulic Consultants Inc.

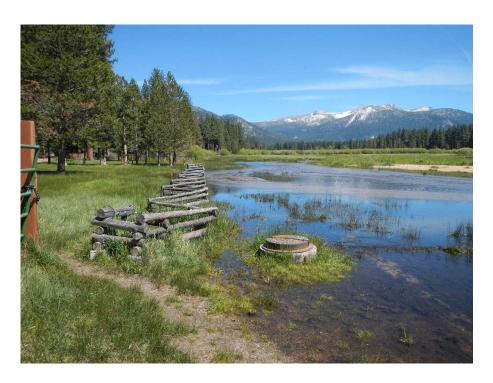
Figure 2-4. Inundation of the sewer easement near Bellevue Avenue at a flow of approximately 40 cfs, looking upstream, 20 May 2013

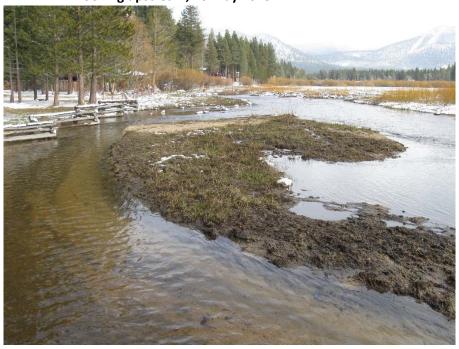
Figure 2-5. Inundation of the sewer easement near Bellevue Avenue at a flow of approximately 20 cfs, looking upstream, 1 Apr 2014

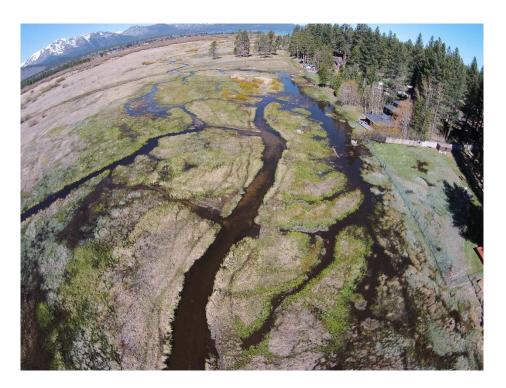
Figure 4-5. Upstream of Bellevue work area looking west, 17 Apr 2015 (pilot channels diverting flow to left overbank and right overbank plugs as disconnections in channels on right overbank)

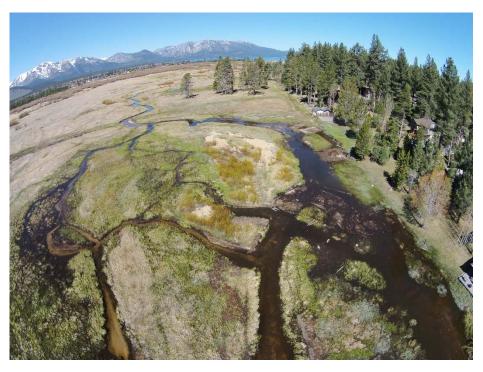
Figure 4-6. Easement and avulsed channel area looking west, 17 Apr 2015 (hummocks in right center of frame and along fence, pilot channels on left overbank)

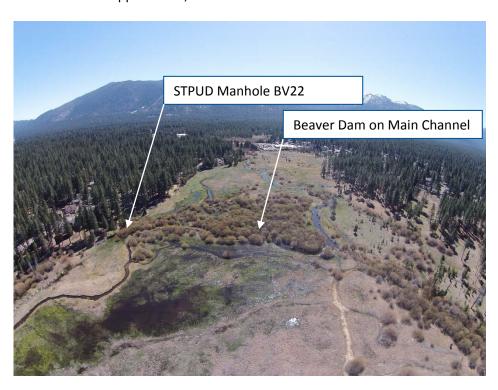
meadow. A main dam is currently located on Trout Creek in the location shown in Figure 4-8, and several auxiliary dams are in place to block return or distributary channels. The result is widespread flooding of the meadow at very low flows in the area upstream of Bellevue Avenue. This flooding has created new challenges for the District associated with flooding in the easement and persistent water around manholes (see Figure 4-9). Although some potential solutions were considered in the Year 2 planning (see Section 5), these efforts were postponed to allow sufficient time for planning and environmental support work, and to assess the effects of other Year 2 work on water levels.

Figure 4-8. Inundation of meadow at low flow (approximately 25 cfs) due to beaver activity, looking east upstream of Bellevue Avenue, 17 Apr 2015

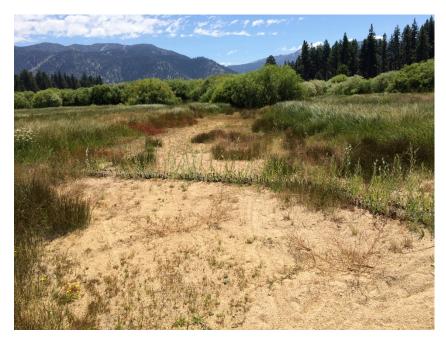
Photo 4. Willow brush fence

Willows in the sausal was not done to spec, with many of the stakes branched (Photo 1), and not planted to the optimum depth. However, the three live stakes are coincidentally located in strategic areas and if they continue to grow, as expected, they should serve their purpose (Photo 2). Similarly, although the willow brush fence did not meet the performance criteria, the surviving stakes, along with the coir log, will serve as intended (Photos 3, 4).
