South Tahoe Public Utility District

## STPUD Water Facilities CIP

*Final Report - Appendices*

# Water System Optimization Plan

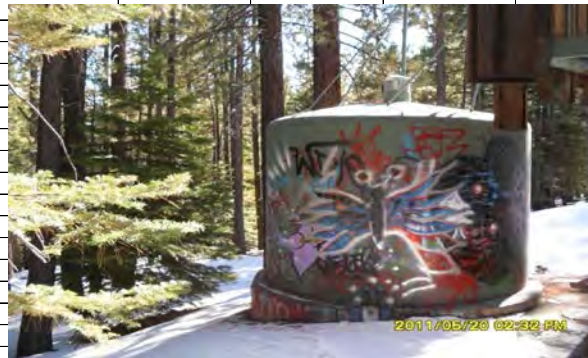
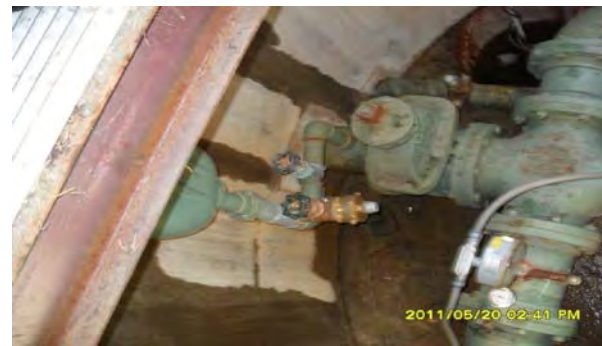
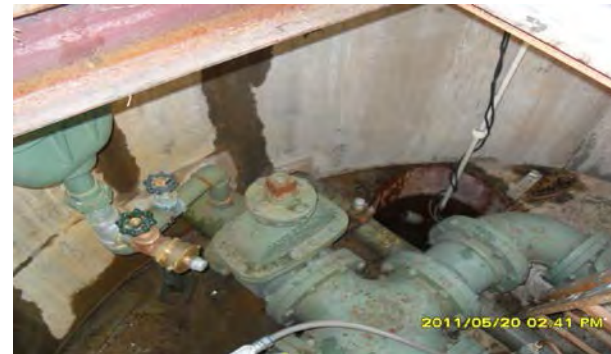
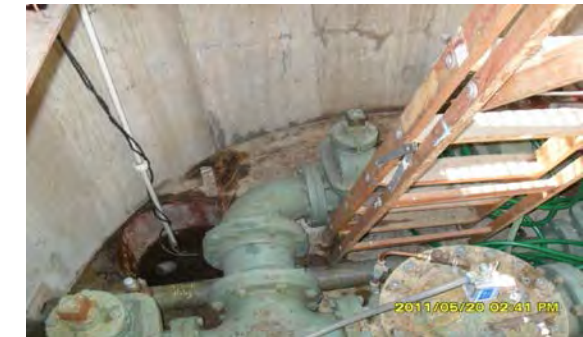
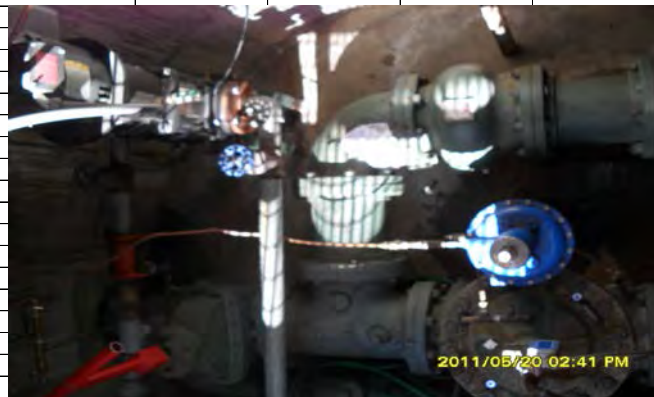
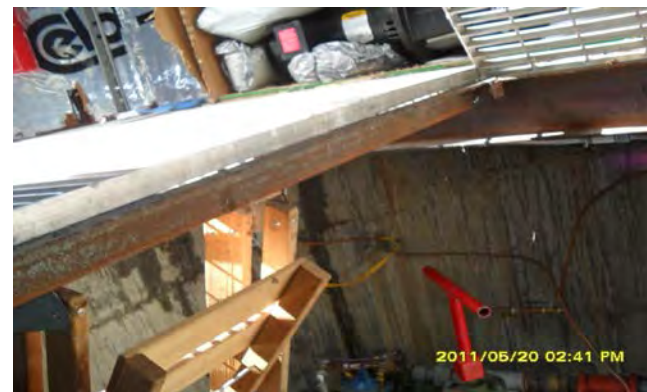
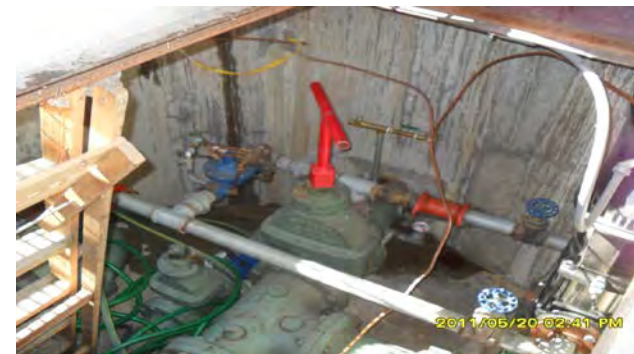
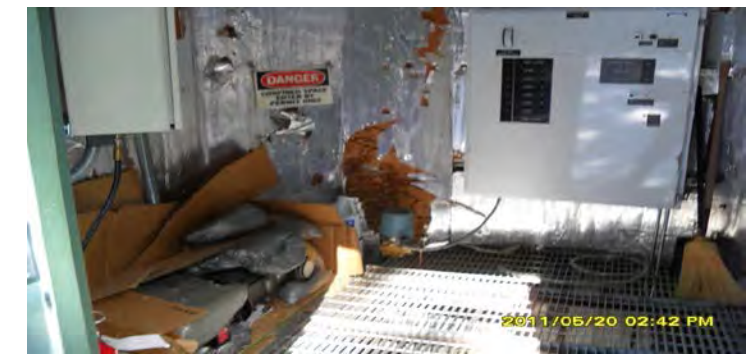
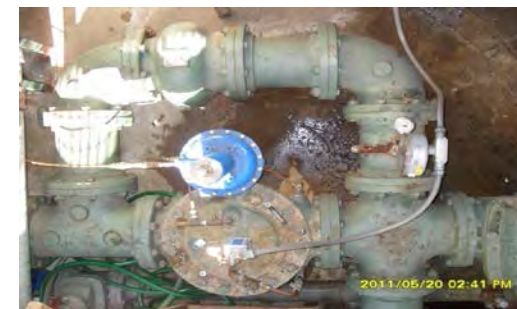
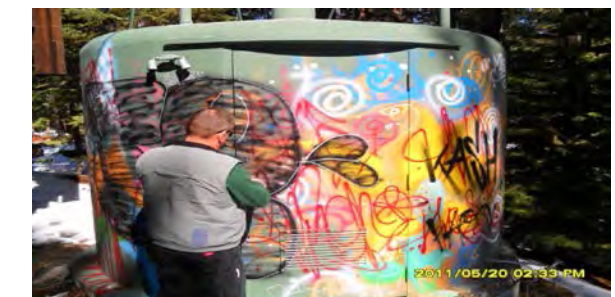
Photo Evidence for PM, Fn, R, FE

South Tahoe PUD	Location Description:	On David Lane	K/J Project Number:	1270004*00	
				Water System Optimization Plan	Pump Station Facility ID #:	DLBP3	Date:	3/7/2012	
					Pump Station Facility Name:	David Lane Booster	Condition Assessment Inspectors:	Peter Lavallee and Phill Torney	
					Pressure Zones Served:	Heavenly zone	Adjacent Pressure Zones:	Stateline Zone	
				Notes:	Failure Mode Scoring (1 - 5)

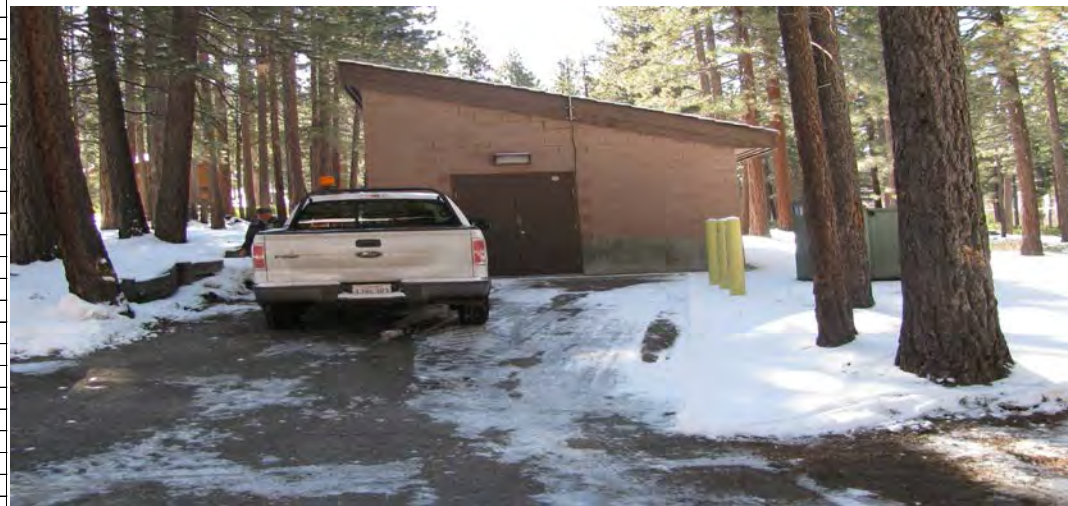
Photo Evidence for PM, Fn, R, FE

South Tahoe PUD	Location Description:	Apache Dr. Behind the Tahoe Paradise Golf Course	K/J Project Number:	1270004*00	
				Water System Optimization Plan	Pump Station Facility ID #:	APBSP1 and APBSP2	Date:	3/8/2012	
					Pump Station Facility Name:	South Apache Booster	Condition Assessment Inspectors:	Peter Lavallee and Mark Gray	
					Pressure Zones Served:	Iroquois Zone	Adjacent Pressure Zones:	Arrowhead Zone	
				Notes:	Failure Mode Scoring (1 - 5)

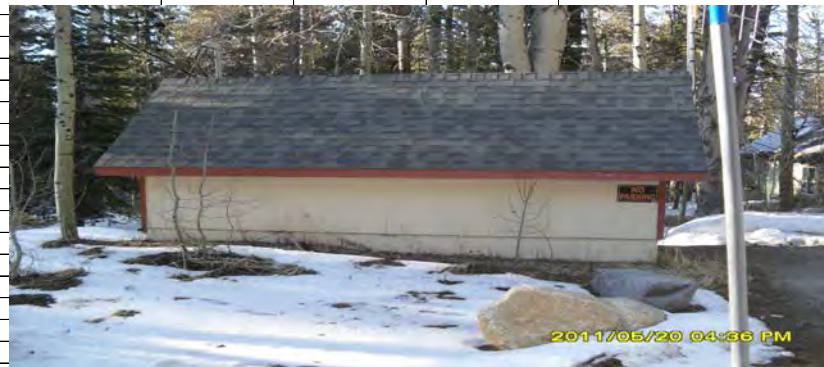
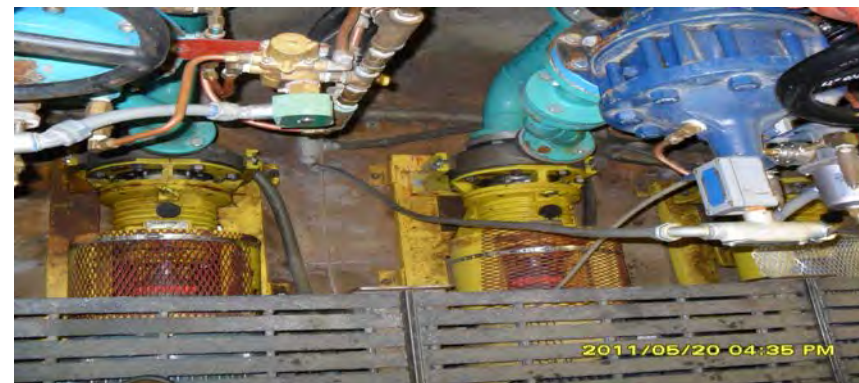
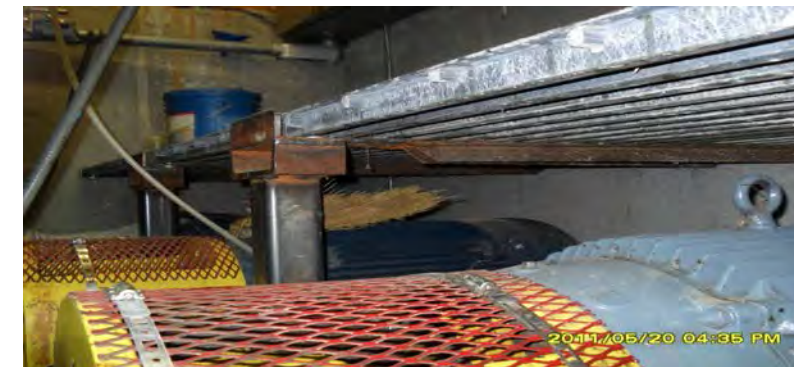
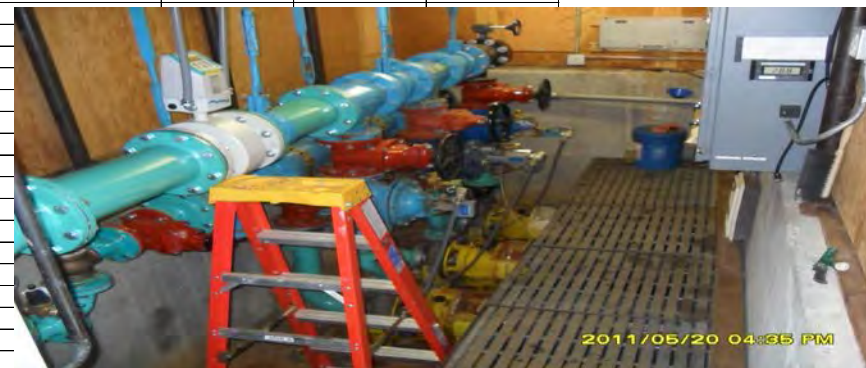
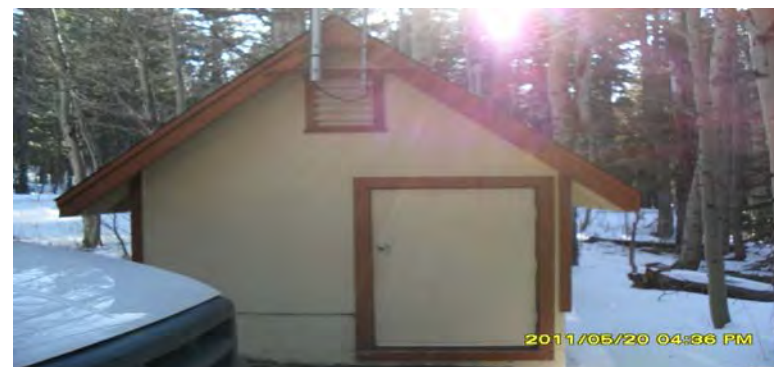
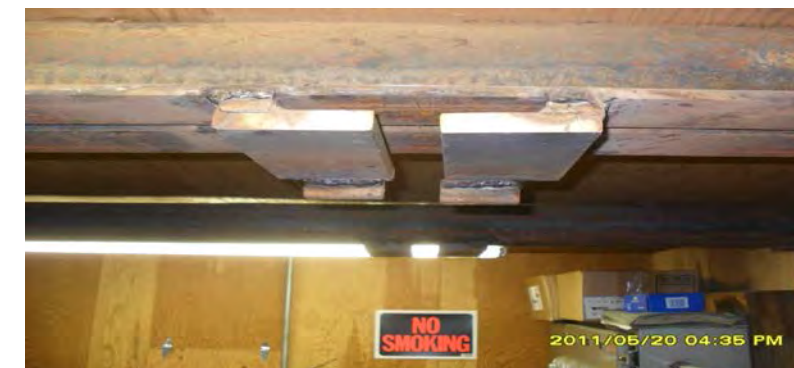
Photo Evidence for PM, Fn, R, FE

South Tahoe PUD	Location Description:	Apache Dr.	K/J Project Number:	1270004*00	
				Water System Optimization Plan	Pump Station Facility ID #:	NAPBS1, NAPBS2, and NAPBS3	Date:	3/8/2012	
					Pump Station Facility Name:	North Apache Booster	Condition Assessment Inspectors:	Peter Lavallee and Mark Gray	
					Pressure Zones Served:	Iroquois Zone	Adjacent Pressure Zones:	Comanche and Arrowhead Zones	
				Notes:	Failure Mode Scoring (1 - 5)

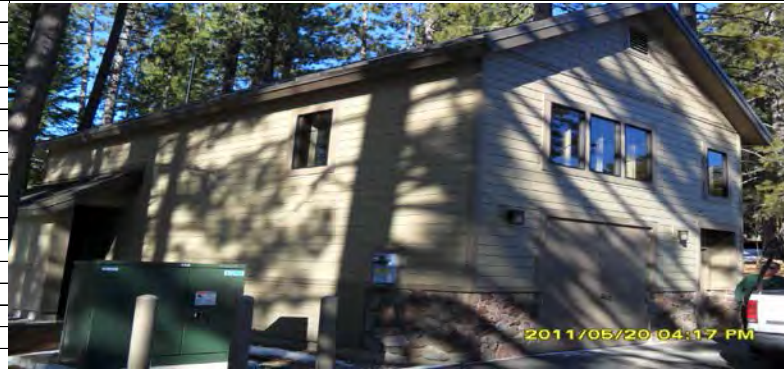
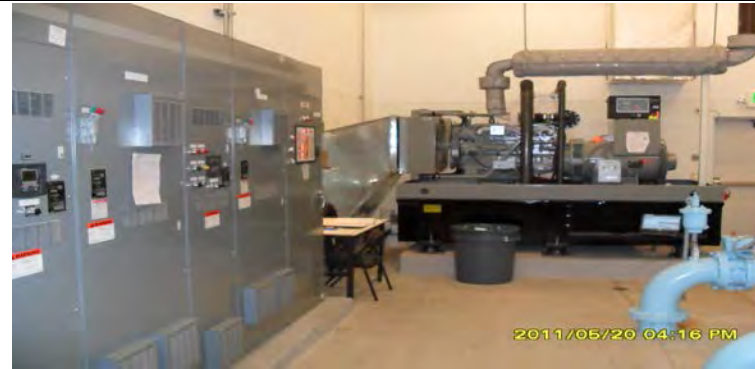
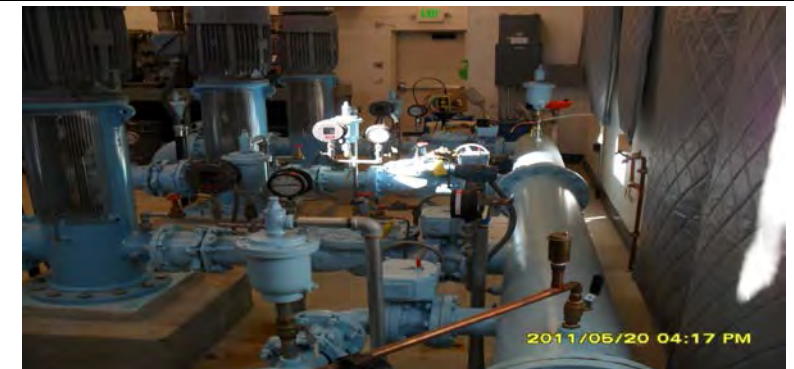
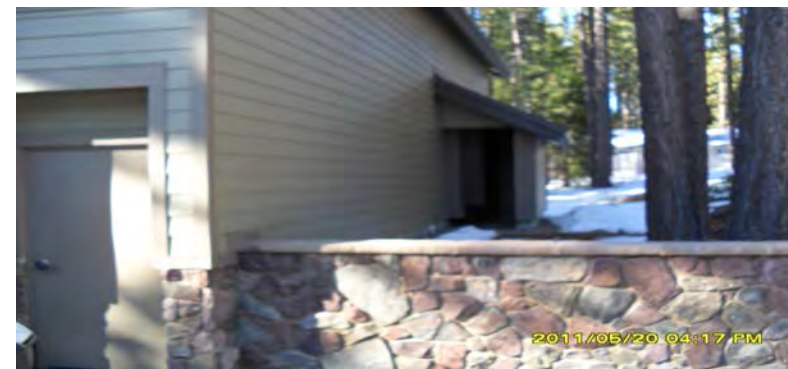
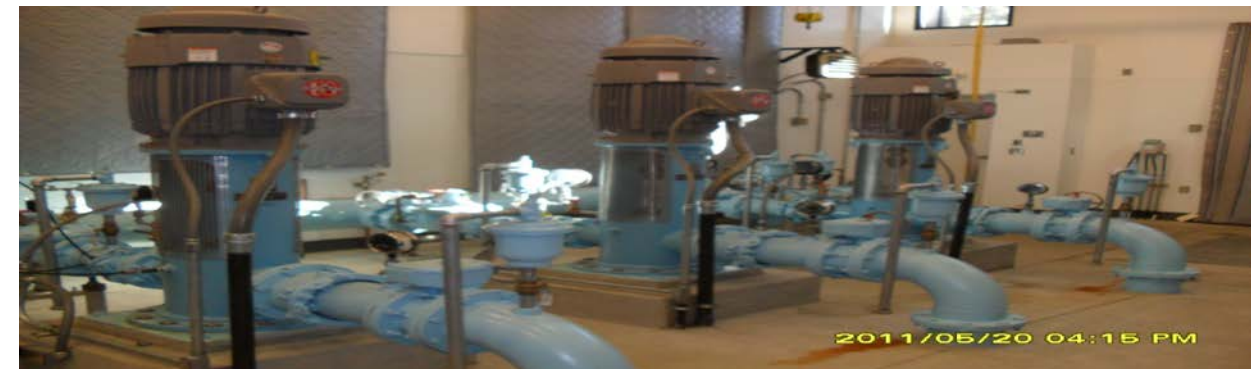
Photo Evidence for PM, Fn, R, FE

South Tahoe PUD	Location Description:	Keller Rd	K/J Project Number:	1270004*00	
				Water System Optimization Plan	Pump Station Facility ID #:	KLRBP1 and KLRBP2	Date:	3/7/2012	
					Pump Station Facility Name:	Keller Booster	Condition Assessment Inspectors:	Peter Lavallee and Phill Torney	
					Pressure Zones Served:	Keller Zone	Adjacent Pressure Zones:	Stateline Zone	
				Notes:	Failure Mode Scoring (1 - 5)

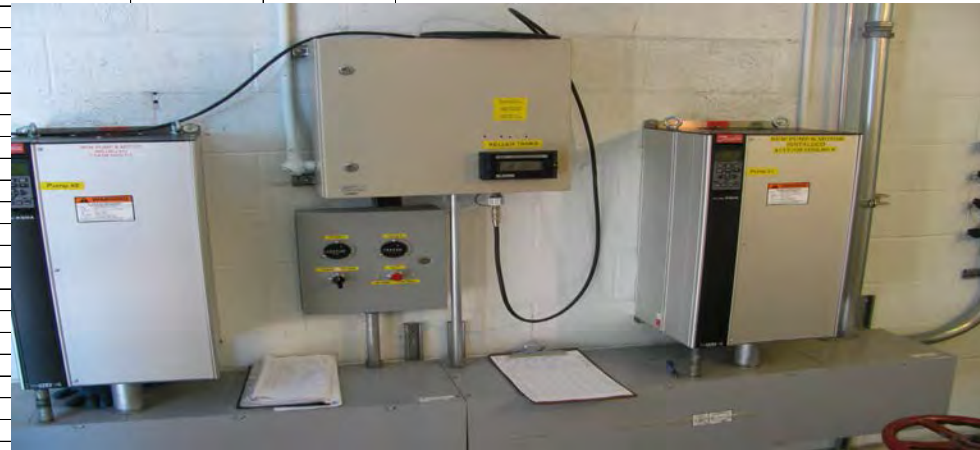
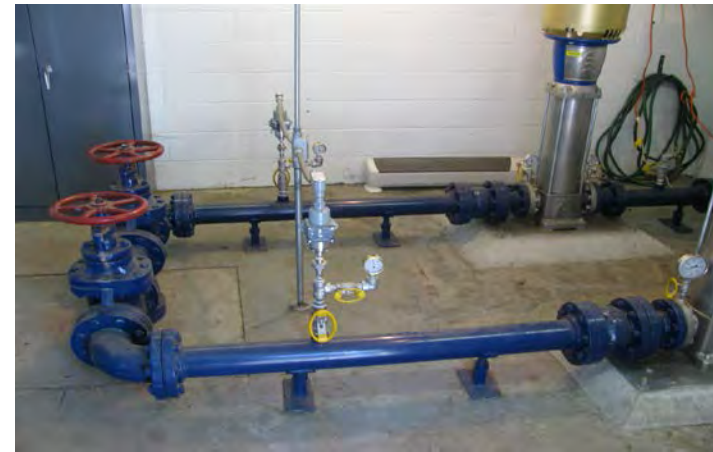
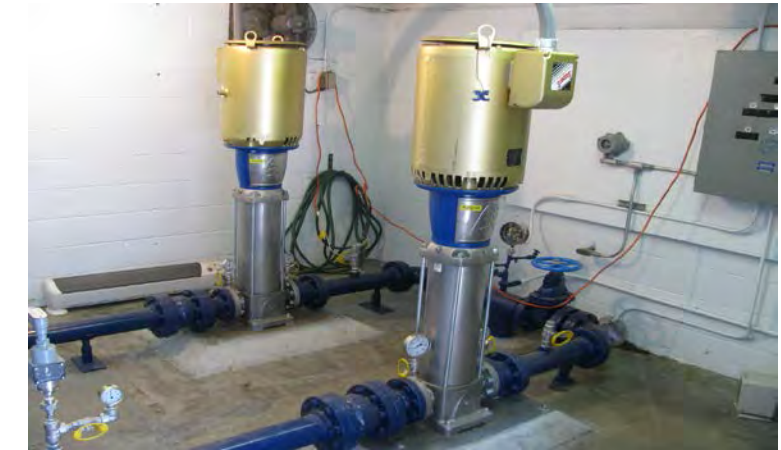
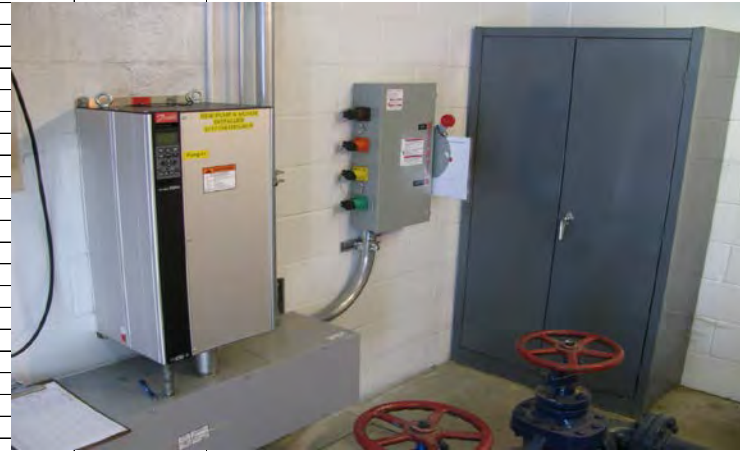
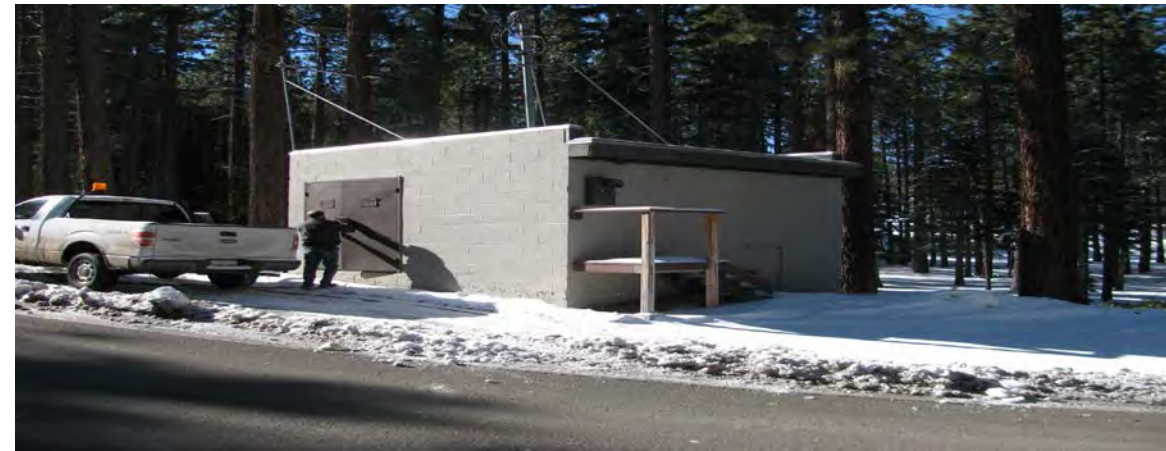
Photo Evidence for PM, Fn, R, FE

South Tahoe PUD	Location Description:	On Pioneer Trail	K/J Project Number:	1270004*00	
				Water System Optimization Plan	Pump Station Facility ID #:	CCBP1 and CCBP2	Date:	3/8/2012	
					Pump Station Facility Name:	Cold Creek Tank Booster Station (aka Upper Cold Creek BS)	Condition Assessment Inspectors:	Peter Lavallee and Mark Gray	
					Pressure Zones Served:	Montgomery Estates	Adjacent Pressure Zones:	Stateline Zone	
				Notes:	Failure Mode Scoring (1 - 5)

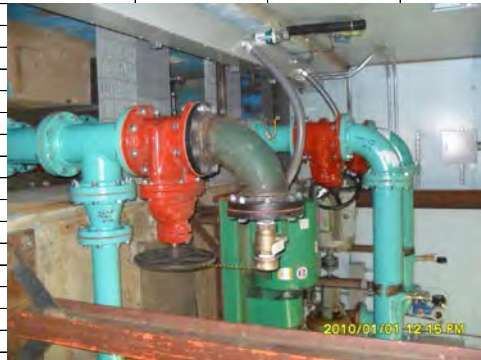
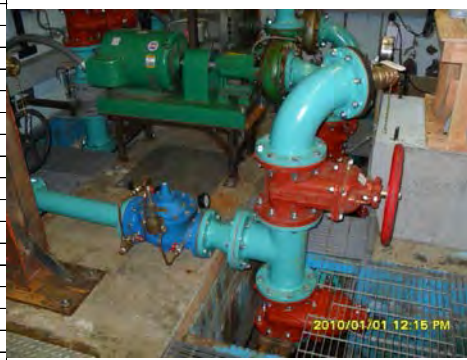
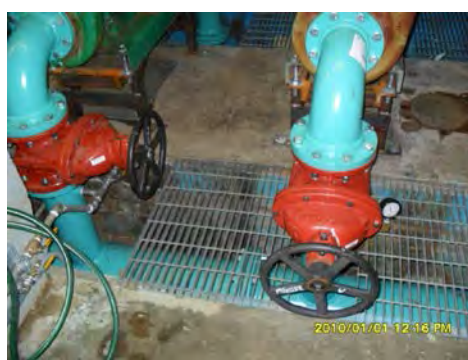
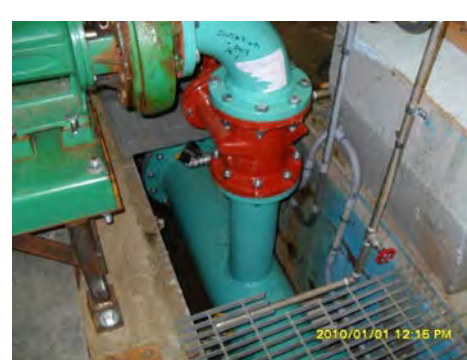
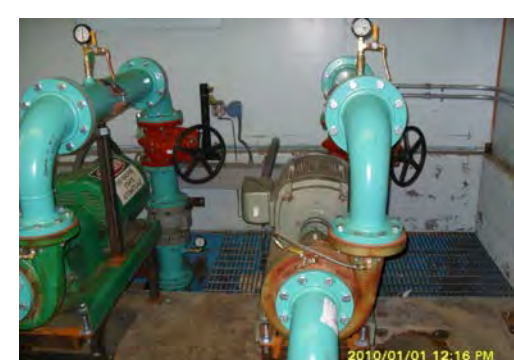
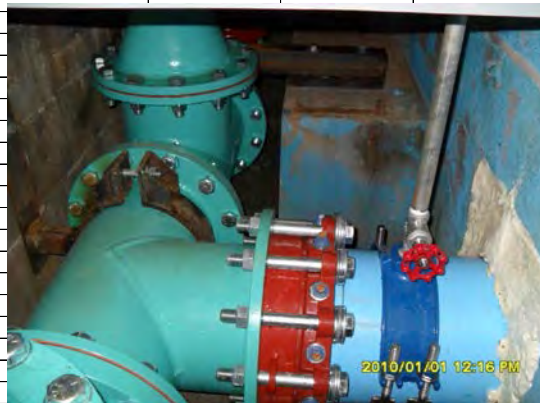
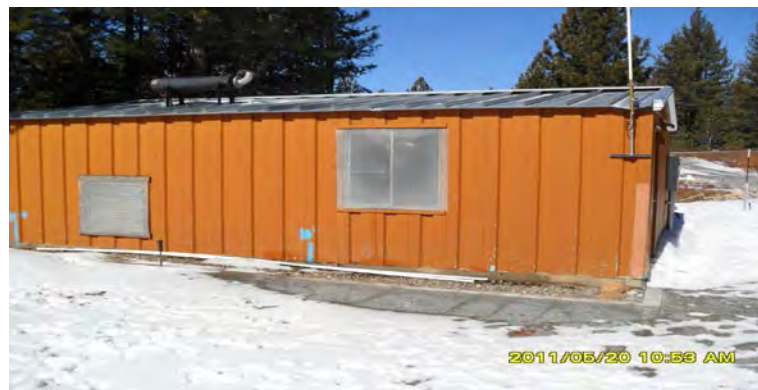
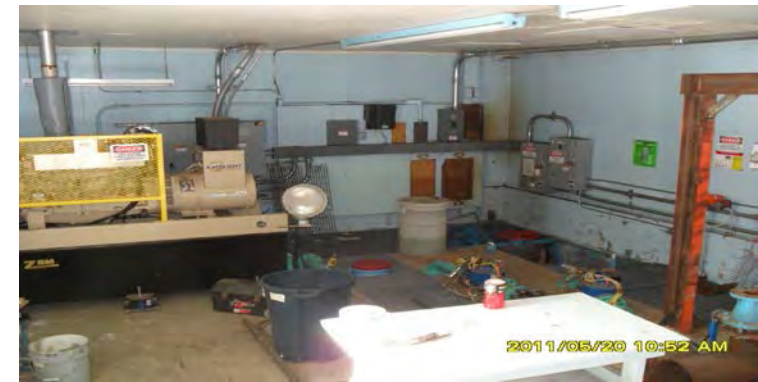
Photo Evidence for PM, Fn, R, FE

South Tahoe PUD	Location Description:	Black Bart Ct & Rd. 2421	K/J Project Number:	1270004*00	
				Water System Optimization Plan	Pump Station Facility ID #:	BLBTBP1, BLBTBP2, and BLBTBP3	Date:	3/8/2012	
					Pump Station Facility Name:	Black Bart Booster	Condition Assessment Inspectors:	Peter Lavallee and Mark Gray	
					Pressure Zones Served:	Montgomery Estates Zone	Adjacent Pressure Zones:	Stateline Zone	
				Notes:	Failure Mode Scoring (1 - 5)

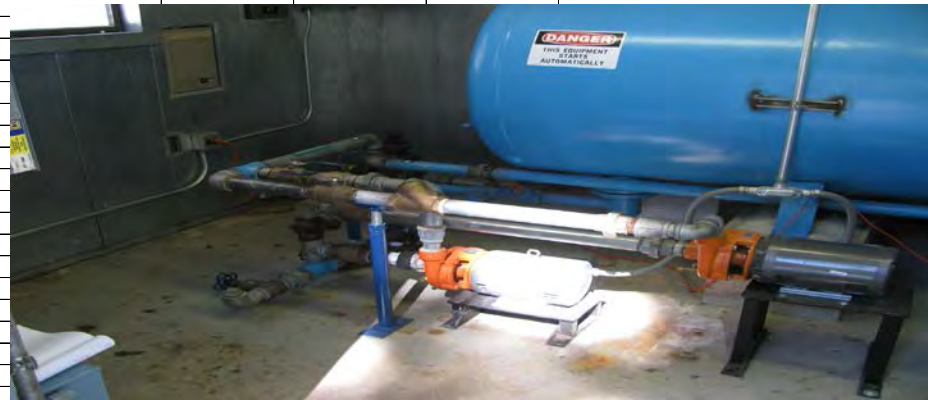
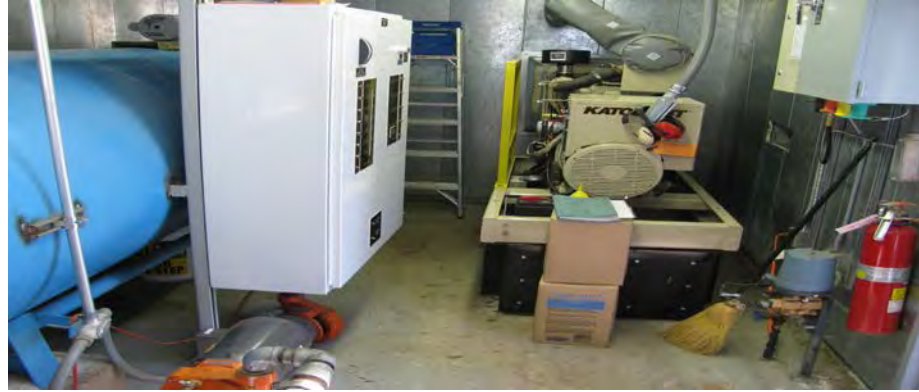
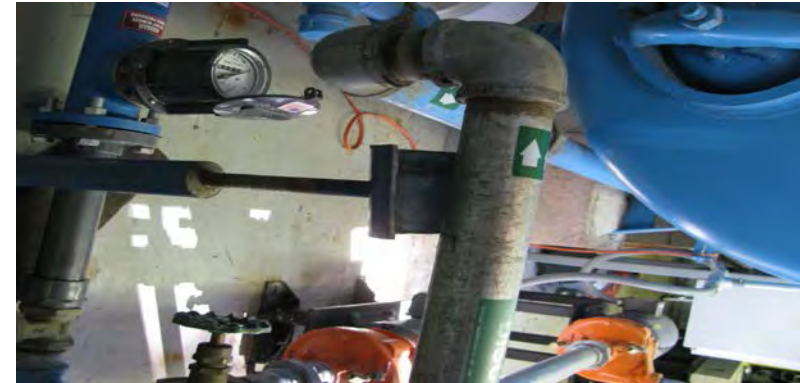
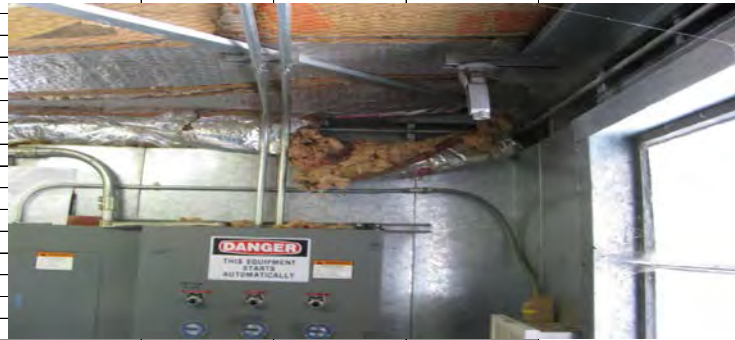
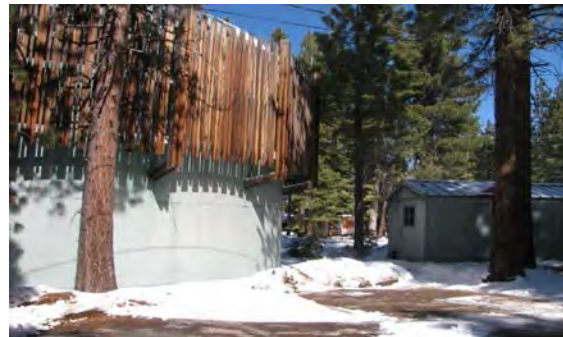
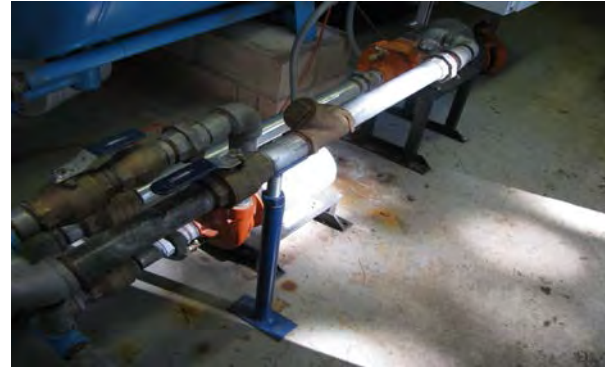
PHOTOS

<b>Additional Data</b>								
				Nameplate duty conditions (rated flow and head, nominal motor horsepower):				
INFORMATION				Pump No. 1	45gpm, 7.5hp,			
INFORMATION				Pump No. 2	45gpm, 7.5hp,			
INFORMATION				Pump No. 3				
INFORMATION				Pump No. 4				
				See Photo below of coupling which has no support and is not seated correctly

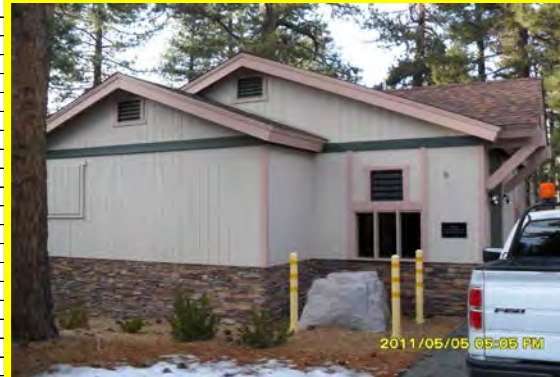
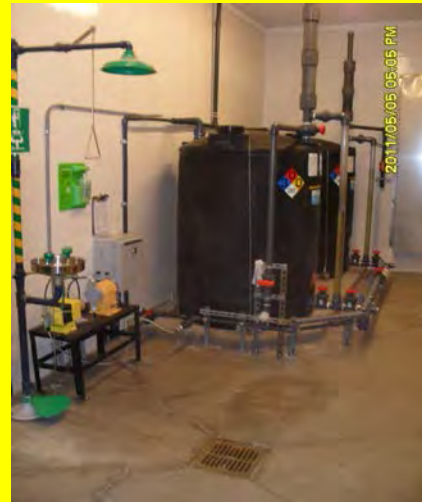
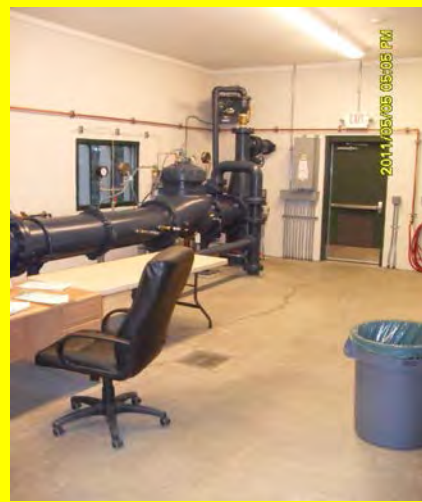
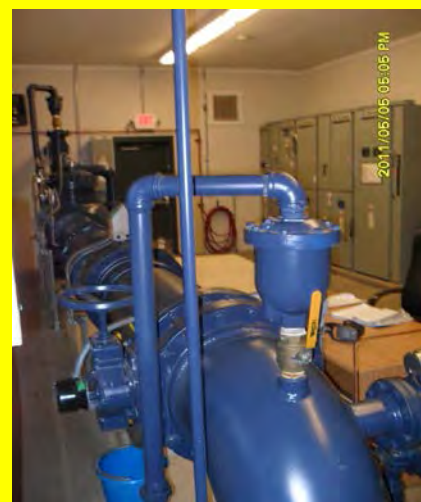
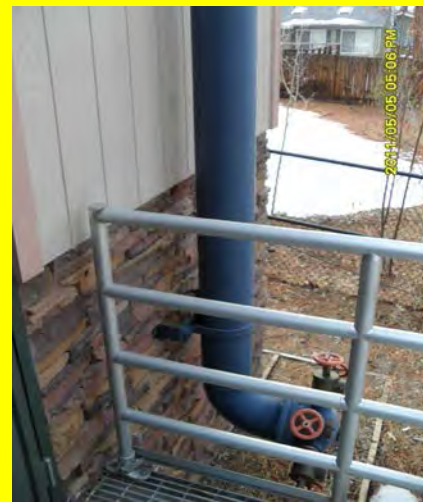
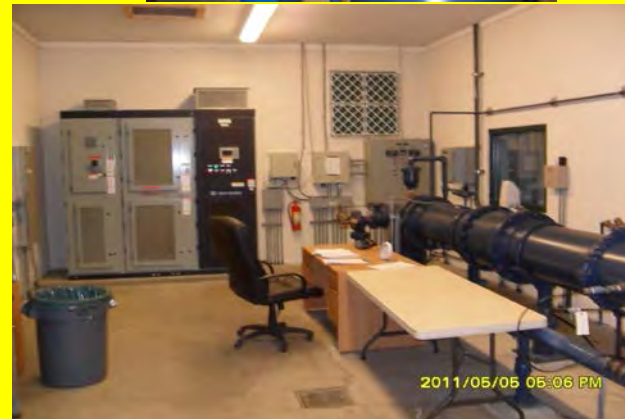
PETER - PHOTO ON FAR RIGHT WITH BLUE PIPE WE BELIEVE IT GOES TO ANOTHER WELL SITE AS OTHER PHOTOS SHOW BLACK PIPE - Tim Williams  
 TIM- IT IS THE LIGHTING IN THE ROOM. PLEASE SEE THE AIR RELEASE IN THE PICTURE JUST NEXT TO IT FOR COMPARISON. I THOUGHT YOU WERE RIGHT TILL I WENT BACK TO THE STATION!

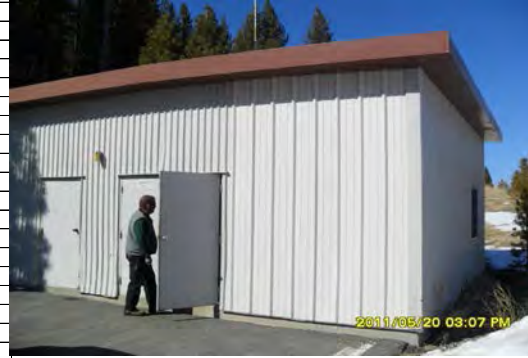
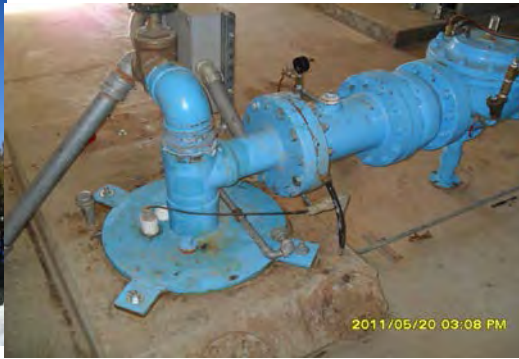
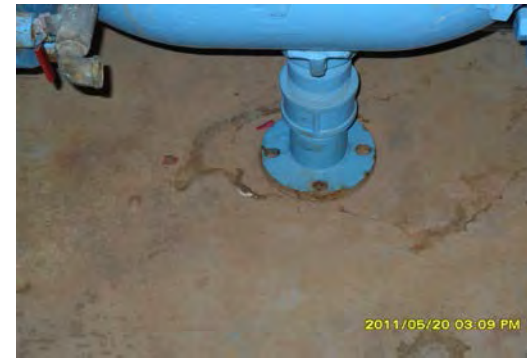
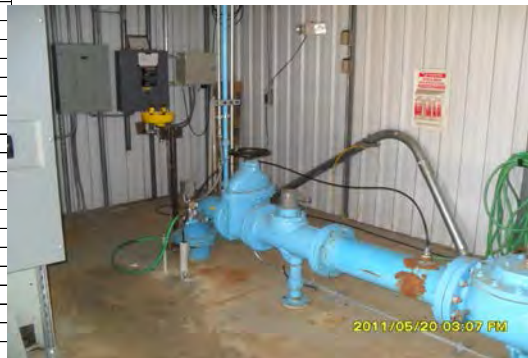
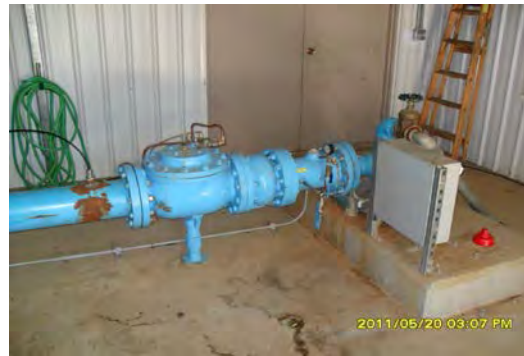
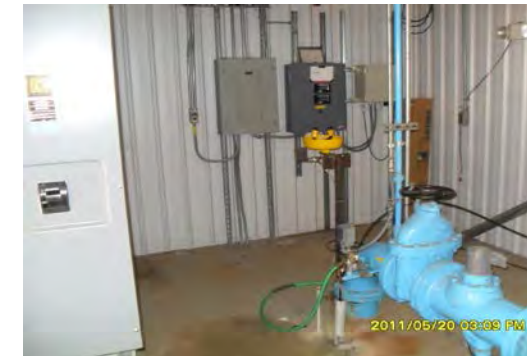
PHOTOS

WELL OFFLINE DUE TO ARSENIC LEVELS THAT HAVE BEEN DETECTED WITHIN THE WELL - WELL NOT RATED  
Photo Evidence for PM, Fn, R, FE

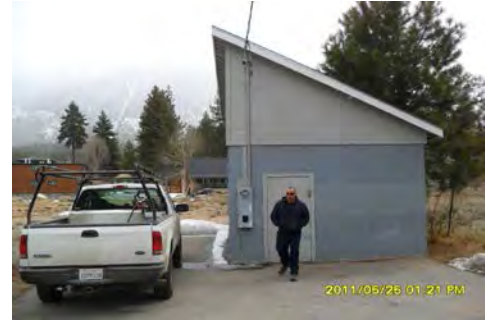
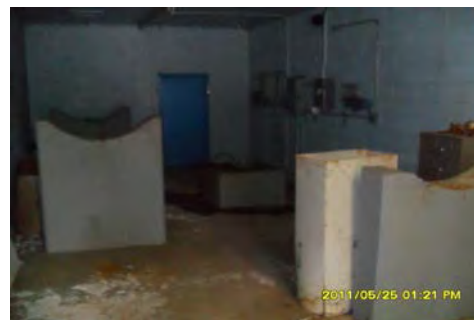
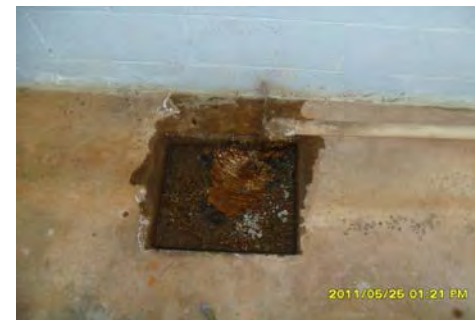
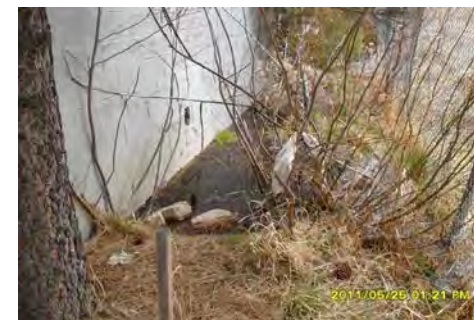
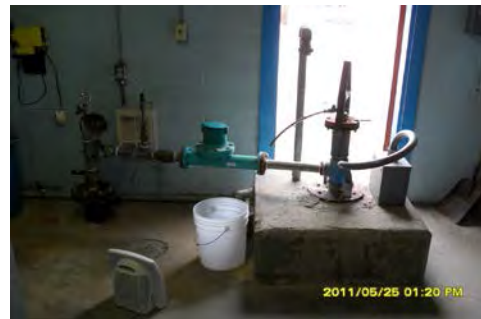
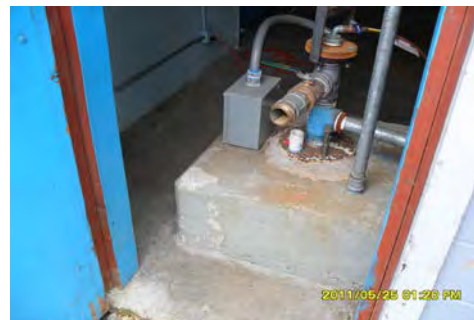
PHOTOS

WELL OFFLINE DUE TO MTBE LEVELS THAT HAVE BEEN DETECTED WITHIN THE WELL. WELL NOT RATED.  
Photo Evidence for PM, Fn, R, FE

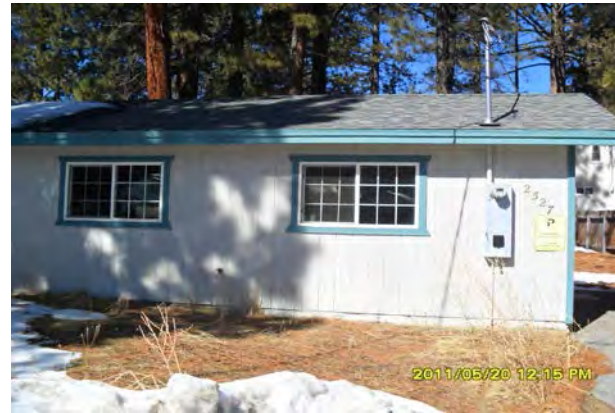
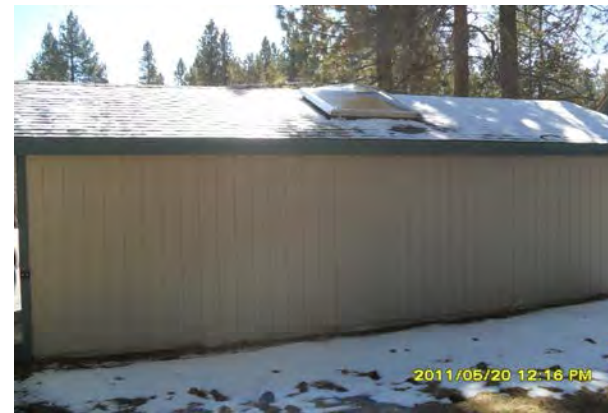
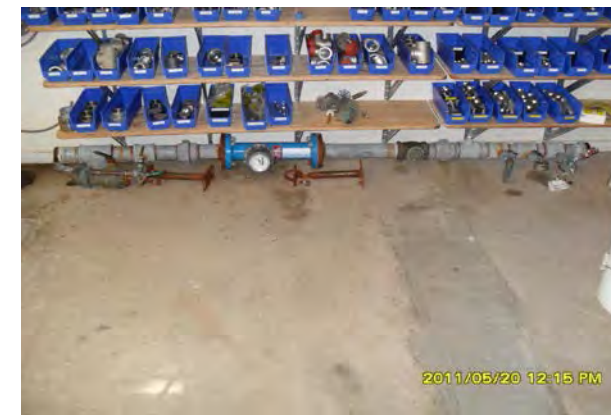
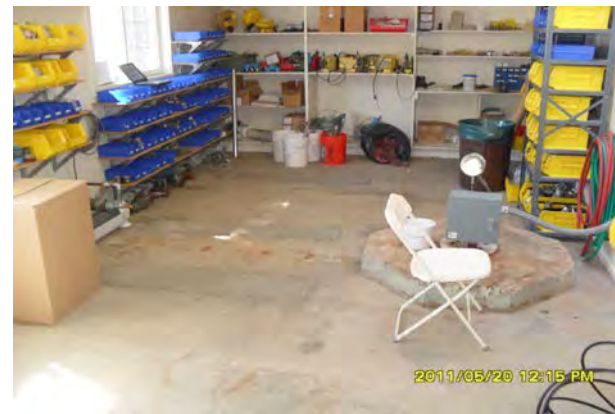
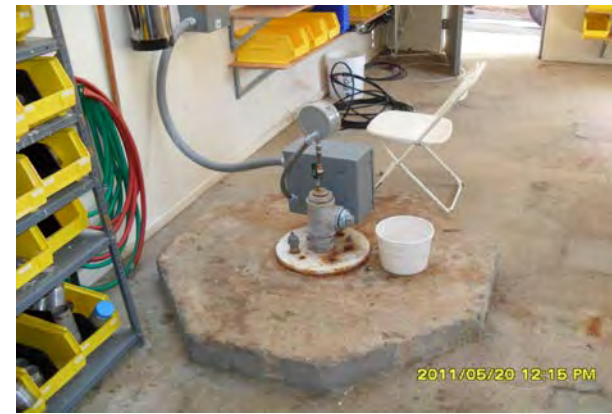
PHOTOS

Photo Evidence for PM, Fn, R, FE

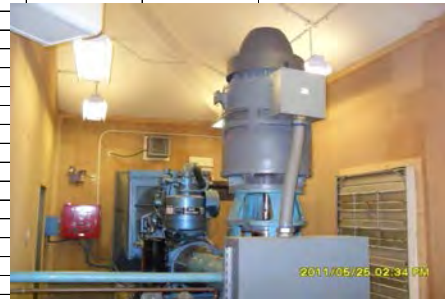
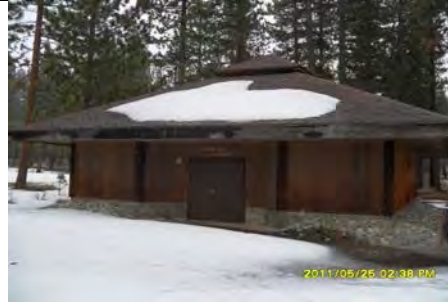
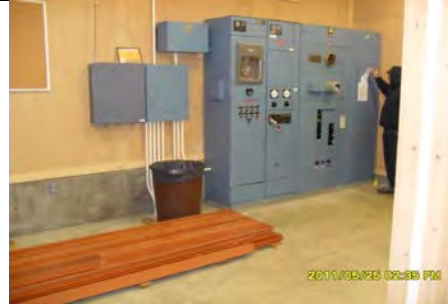
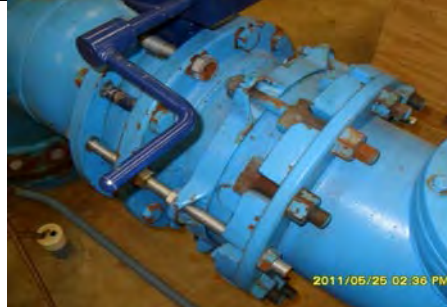
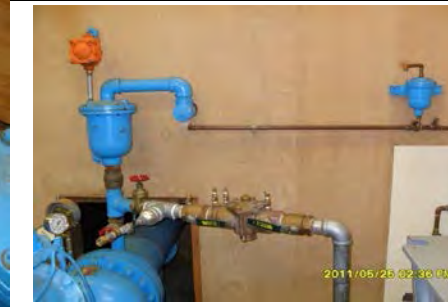
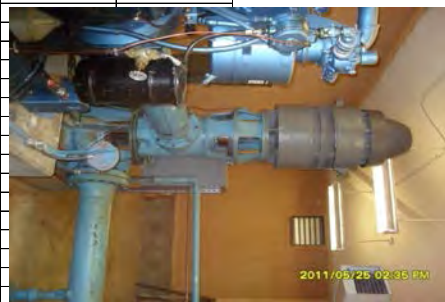
**PHOTOS**

**WELL OFFLINE DUE TO URANIUM LEVELS THAT HAVE BEEN DETECTED WITHIN THE WELL. WELL NOT RATED.**  
Photo Evidence for PM, Fm, R, FE

<b>Well Pump</b>					
INFORMATION	N/A	N/A	N/A	Right angle drive motor powered by propane	Right angle drive motor powered by propane
INFORMATION	N/A	N/A	N/A	pump type?	Vertical Turbine
INFORMATION	N/A	N/A	N/A	pump manufacturer?	Peabody Floway
INFORMATION			0	pump capacity?	unknown
PM			0	pump rebuilt (list year) and describe work done?	Well is offline due to Uranium
Fe			0	pump curves available?	No
R			0	known history of pump/motor failures? If so, explain the nature of the failure(s).	None
R			0	number of service calls/repairs in the last year?	None
INFORMATION			0	what is firm capacity of well pump based on flow test?	unknown
C		3	0	Does zone serviced by pump have adequate capacity to be served?	Evaluation in block diagram
Pm			0	coatings adequate to provide corrosion protection?	The coatings are adequate and there are no visual defects
Fe			0	pumps operate efficiently (>70% bowl efficiency)?	unknown

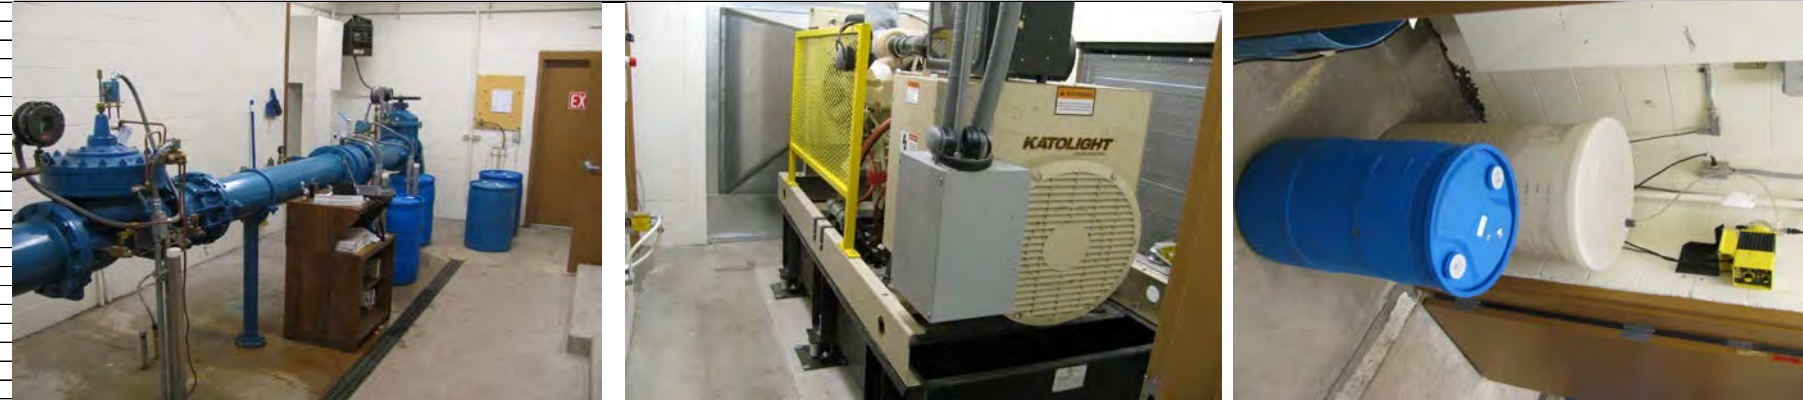
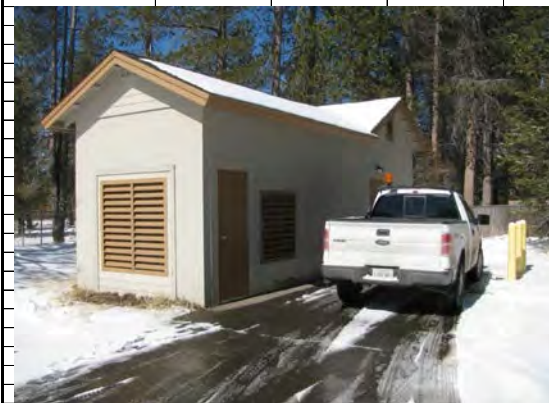
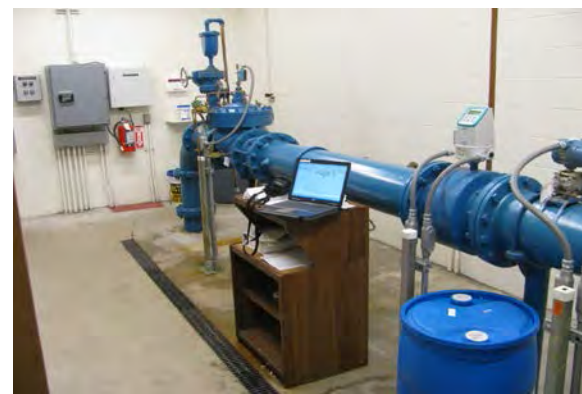
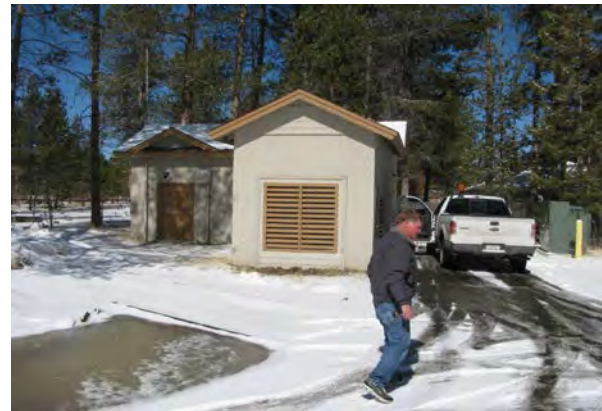
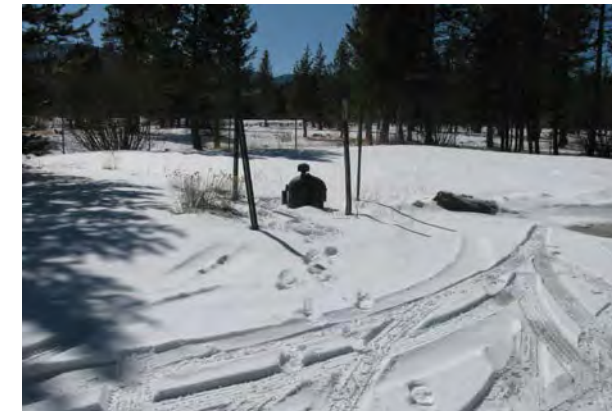
PHOTOS

Photo Evidence for PM, Fn, R, FE

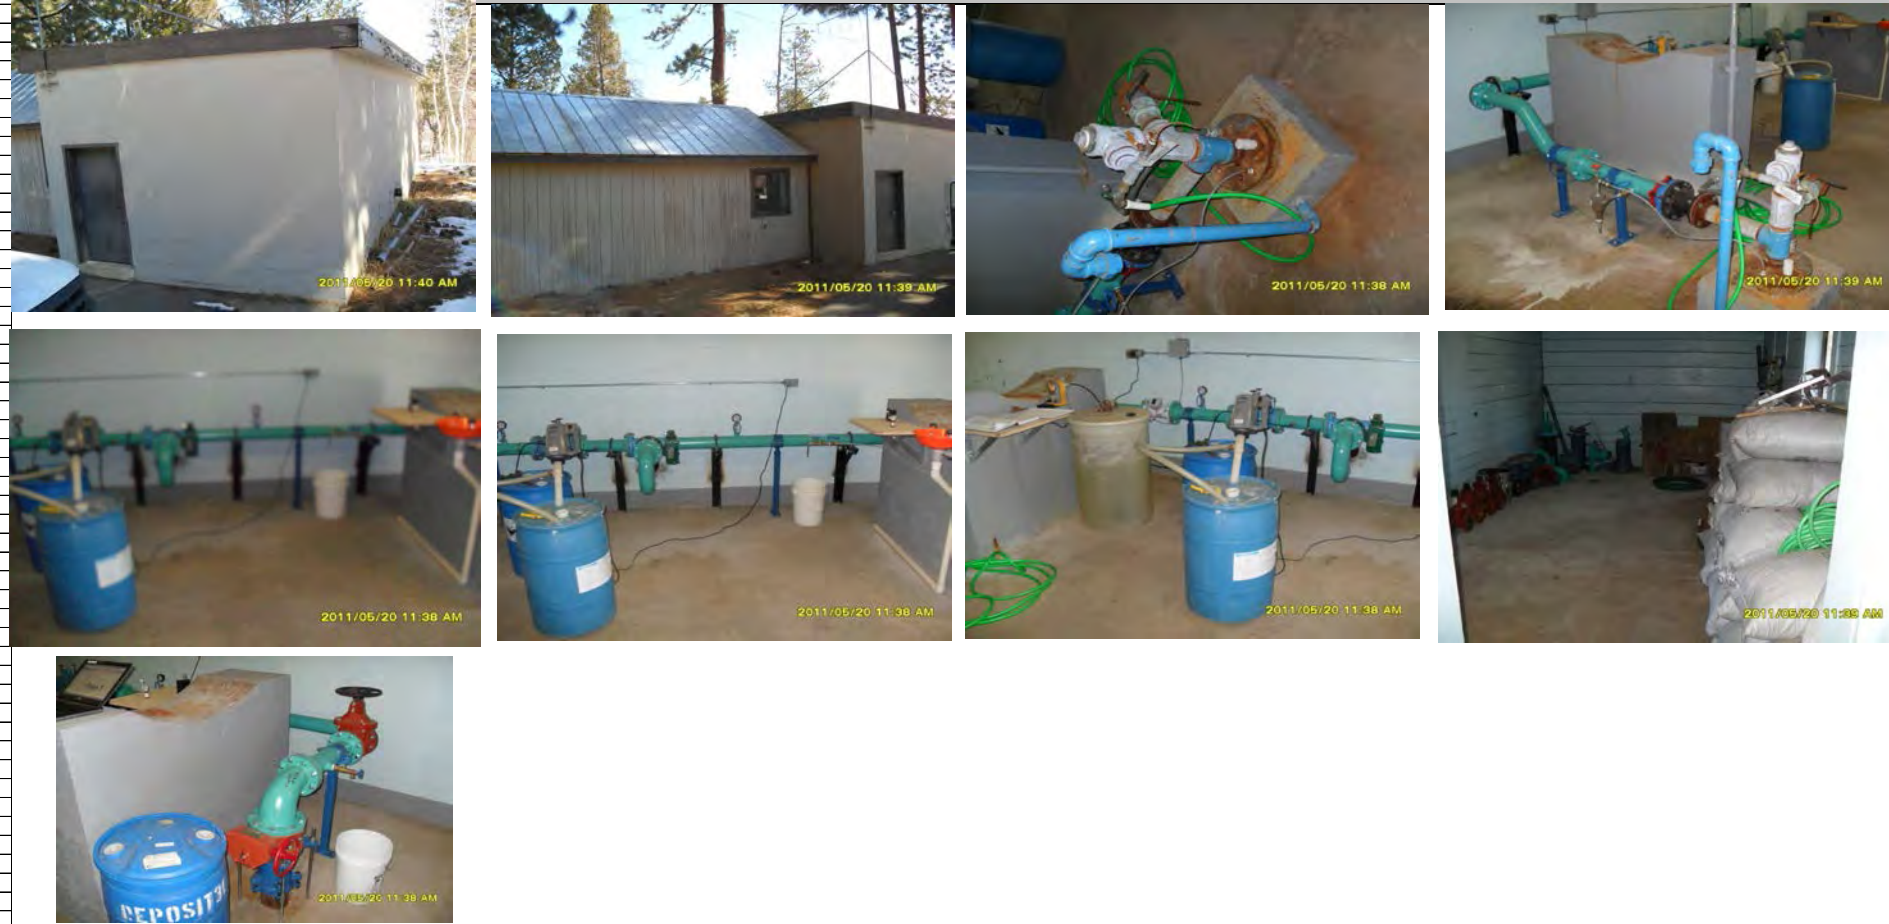
PHOTOS

Photo Evidence for PM, Fn, R, FE

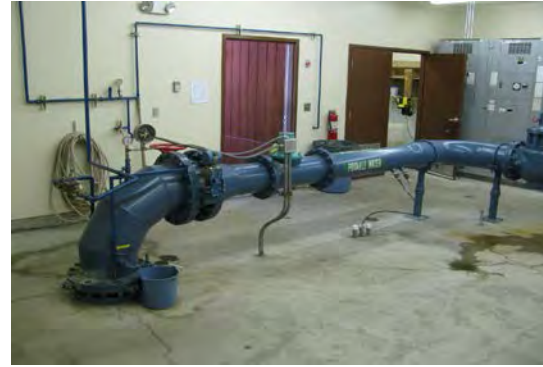
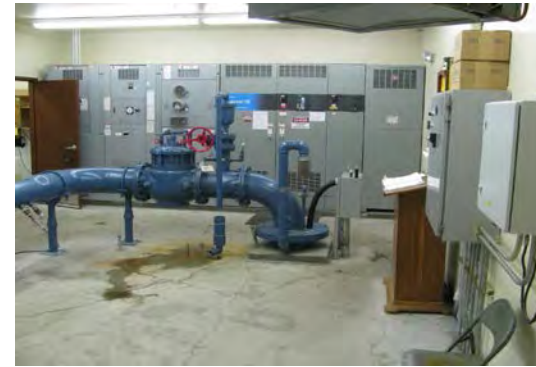
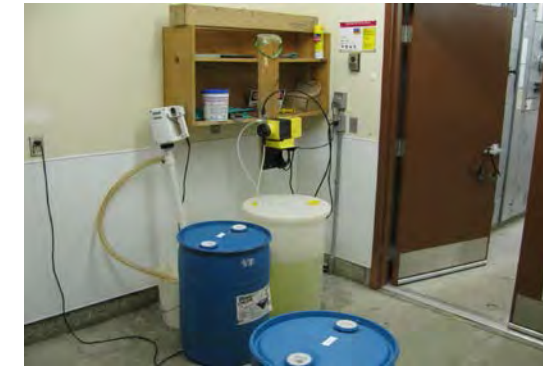
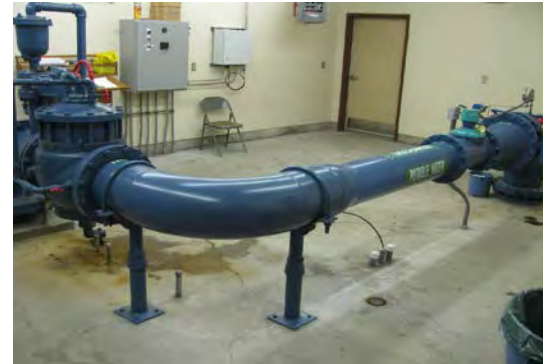
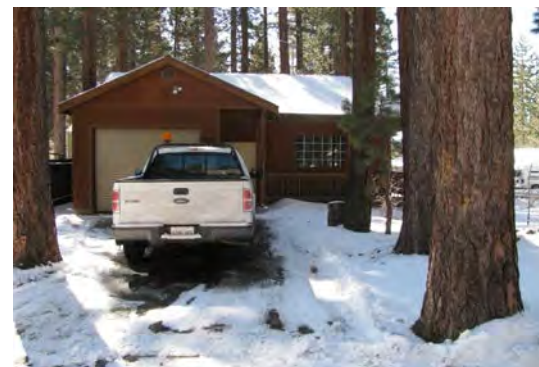
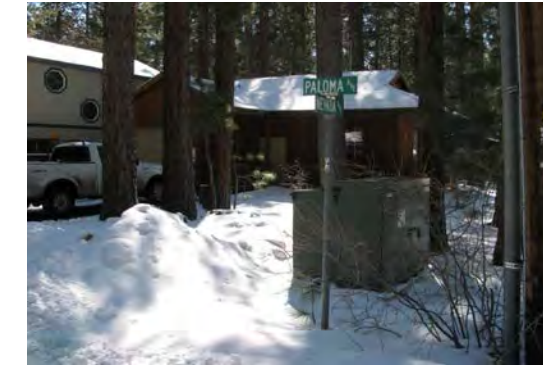
PHOTOS

Photo Evidence for PM, Fn, R, FE
