South Tahoe Public Utility District

## STPUD Water Facilities CIP

*Final Report - Appendices*

# Water System Optimization Plan

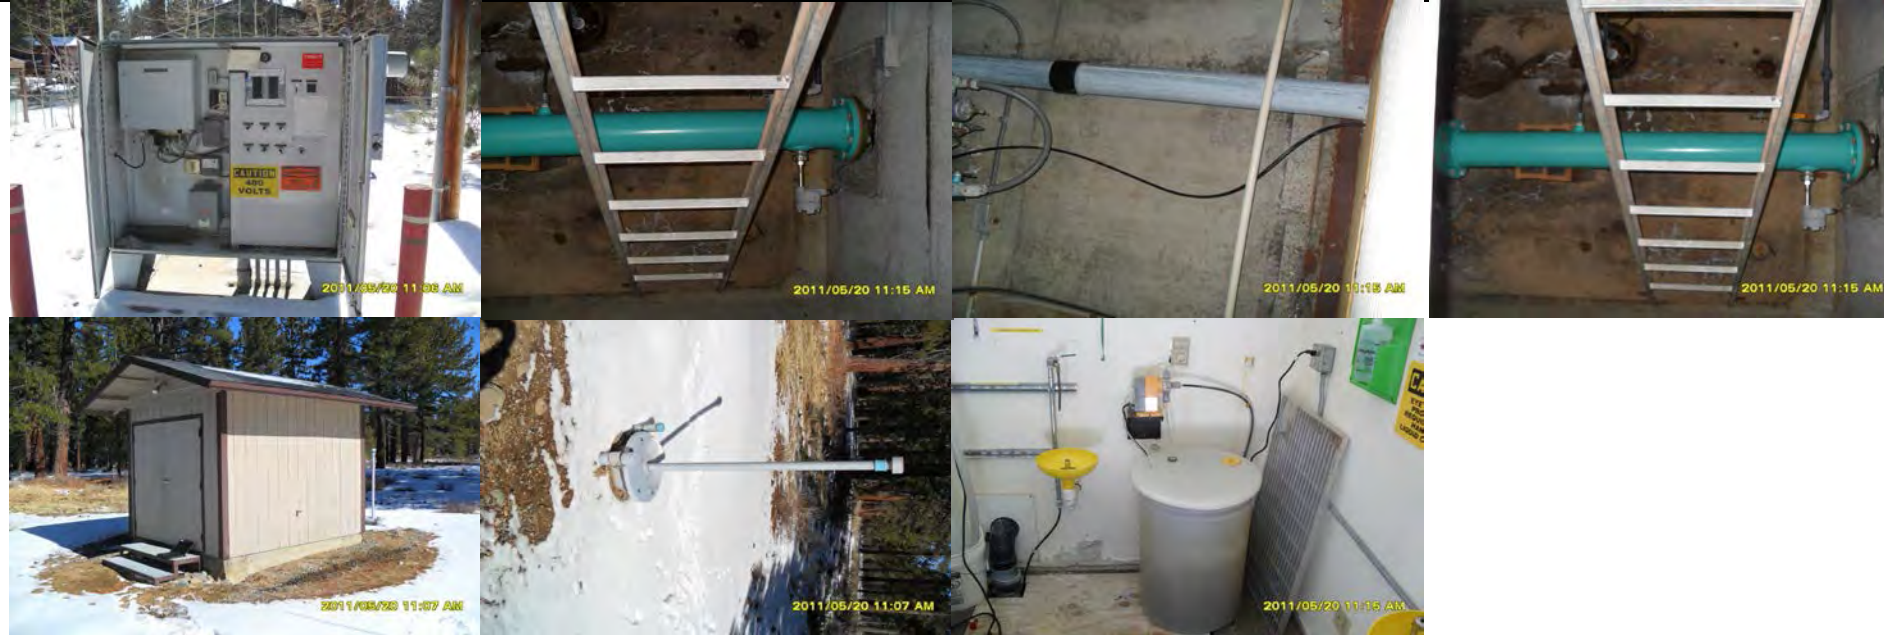
PHOTOS

Photo Evidence for PM, Fn, R, FE

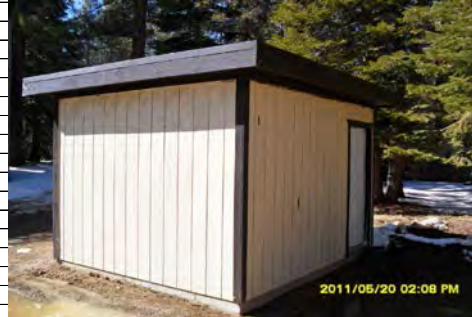
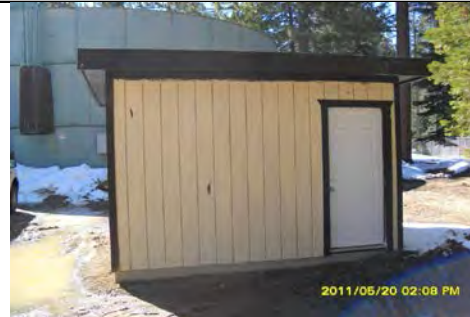
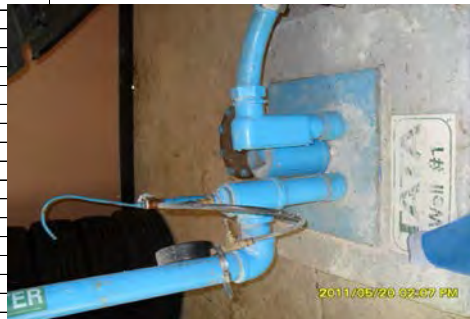
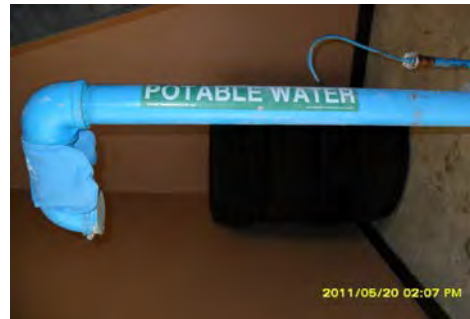
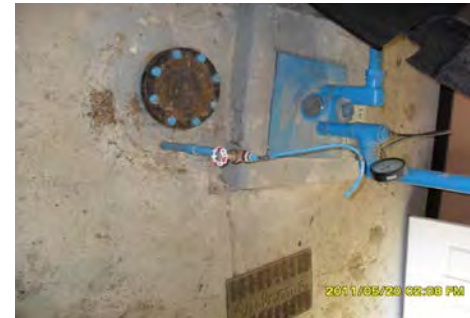
Photo Evidence for PM, Fn, R, FE

South Tahoe PUD	Location Description:	1128 Tata Lane	K/J Project Number:	1270004*00		
				Water System Optimization Plan	Wells Facility ID #:	TLWL2	Date:	3/8/2012		
					Wells Facility Name:	Tata Well #2	Condition Assessment Inspectors:	Peter Lavallee and Mark Gray		
					Pressure Zones Served:	Stateline Zone	Adjacent Pressure Zones:	Twin Peaks Zone or Gardner Mountain Zone depending on Valving		
WELL OFFLINE DUE TO ARSENIC LEVELS THAT HAVE BEEN DETECTED WITHIN THE WELL. WELL NOT RATED.										
				Notes:	Failure Mode Scoring (1 - 5)

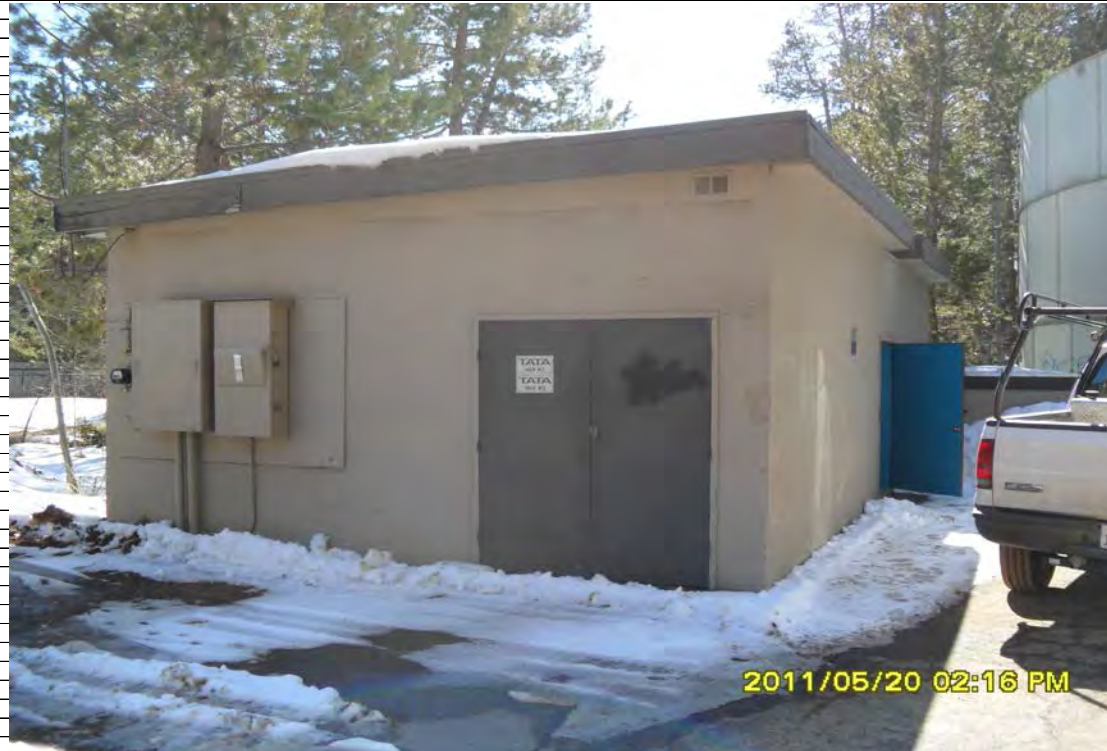
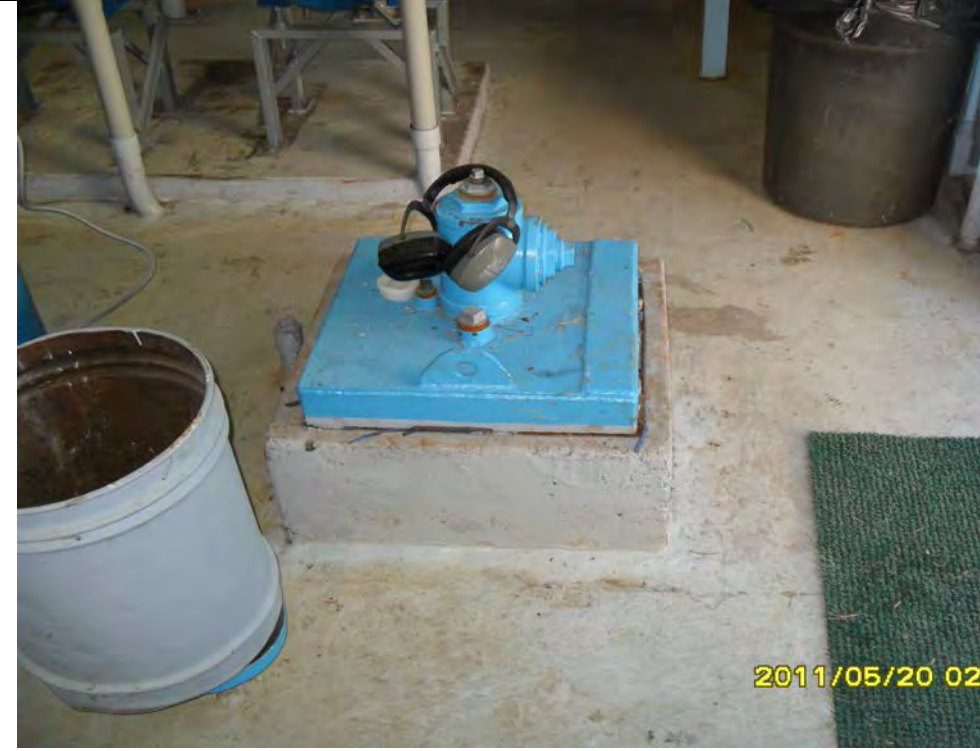
Photo Evidence for PM, Fn, R, FE

South Tahoe PUD	Location Description:	1128 Tata Lane	K/J Project Number:	1270004*00		
				Water System Optimization Plan	Wells Facility ID #:	TLWL3	Date:	3/8/2012		
					Wells Facility Name:	Tata Well #3	Condition Assessment Inspectors:	Peter Lavallee and Mark Gray		
					Pressure Zones Served:	Stateline Zone	Adjacent Pressure Zones:	Twin Peaks Zone or Gardner Mountain Zone depending on valving		
WELL OFFLINE DUE TO ARSENIC LEVELS THAT HAVE BEEN DETECTED WITHIN THE WELL. WELL NOT RATED.										
				Notes:	Failure Mode Scoring (1 - 5)

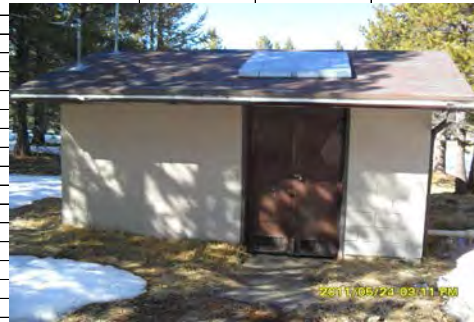
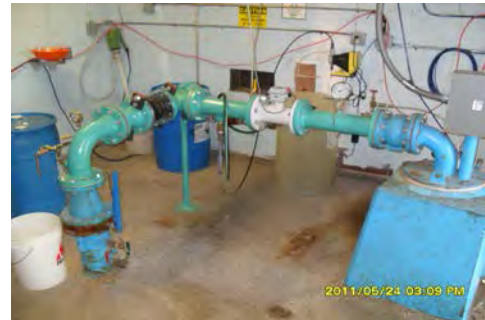
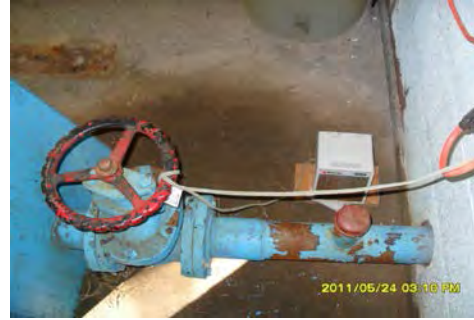
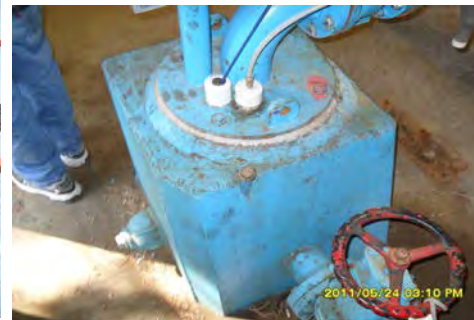
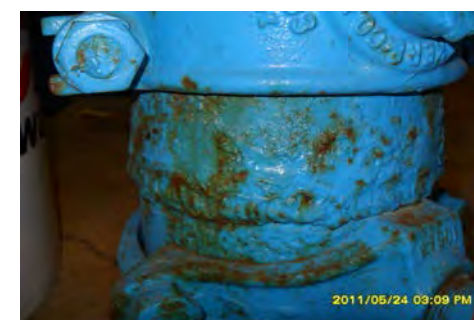
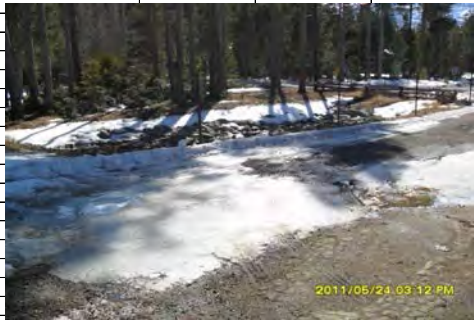
Photo Evidence for PM, Fn, R, FE

South Tahoe PUD	Location Description:	Barbara Ave and Martin Ave	K/J Project Number:	1270004*00		
				Water System Optimization Plan	Wells Facility ID #:	MRTNWL	Date:	3/13/2012		
					Wells Facility Name:	Martin Well	Condition Assessment Inspectors:	Peter Lavallee and Jeremy Rutherfordale		
					Pressure Zones Served:	Stateline Zone	Adjacent Pressure Zones:	Twin Peaks Zone		
Well has been abandoned but not destroyed. It was very high in iron and manganese and it does not have any of the equipment the pump has been pulled as well. Well not rated.										
				Notes:	Failure Mode Scoring (1 - 5)

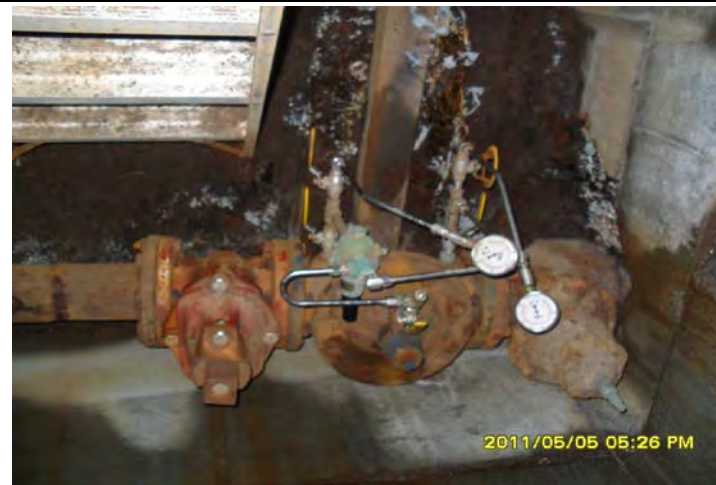
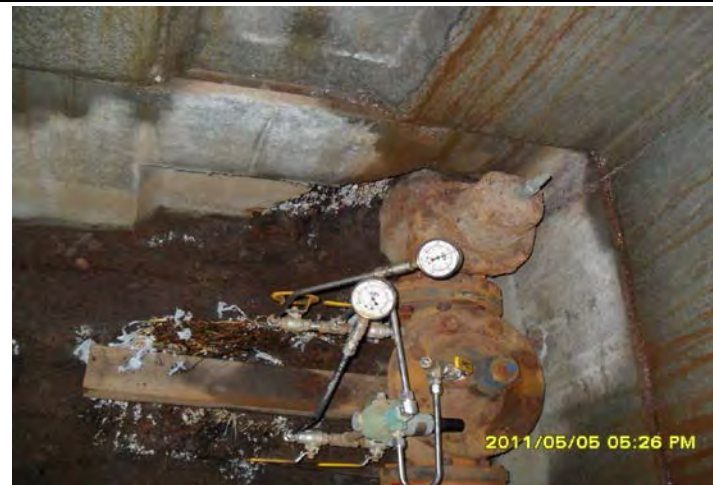
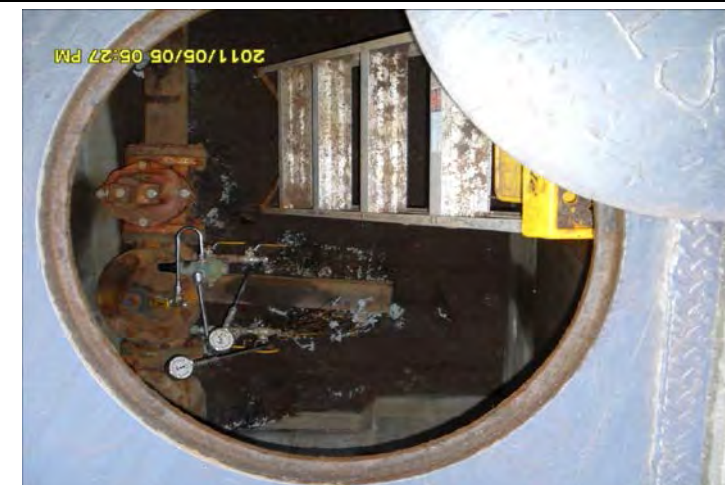
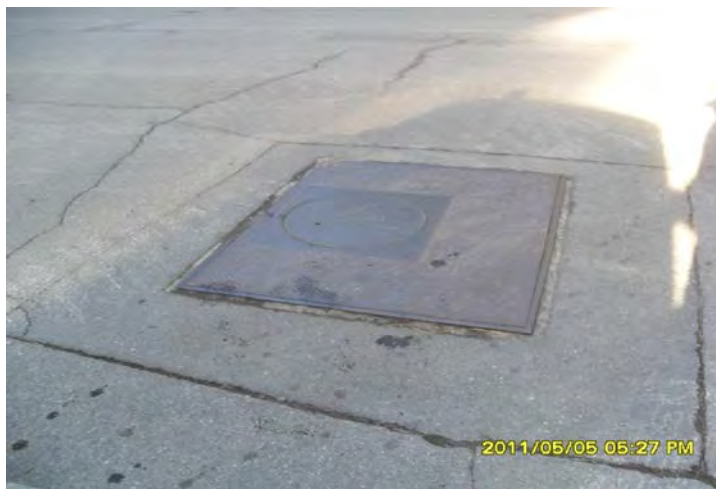
Photo Evidence for PM, Fn, R, FE Bolts appear rusted and unservicable, requires confined space entry, not adequate space to work on piping and valves

<b>South Tahoe PUD</b>	<b>Location Description:</b>	In westbound lane of Comanche Rd near intersection of Comanche and Apache	<b>K/J Project Number:</b>	1270004*00
				<b>Water System Optimization Plan</b>	<b>PRV Facility ID #:</b>	L38-014	<b>Date:</b>	2/23
					<b>PRV Facility Name:</b>	Comanche PRV	<b>Condition Assessment Inspectors:</b>	Peter Lavallee
					<b>Pressure Zones Served:</b>	Comanche Zone	<b>Adjacent Pressure Zones:</b>	Arrowhead Zone

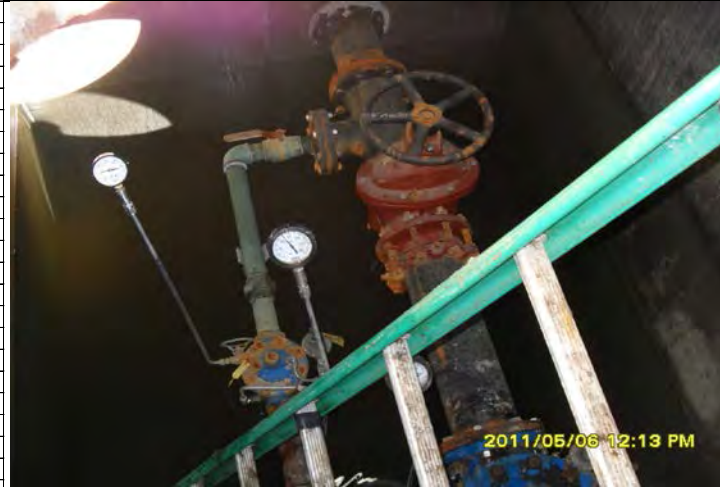
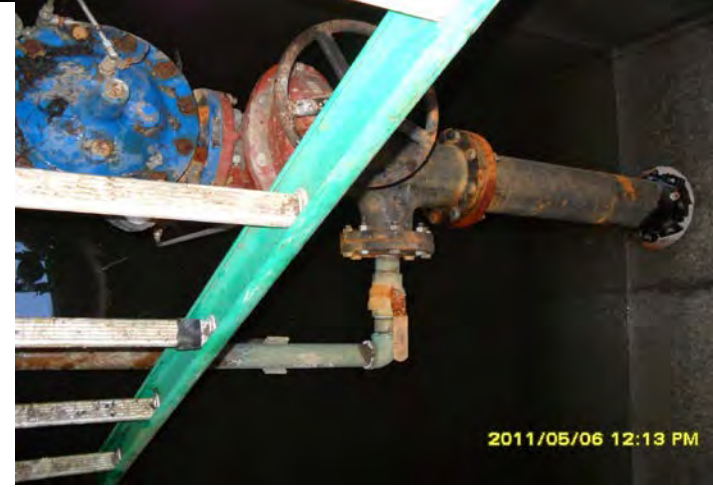
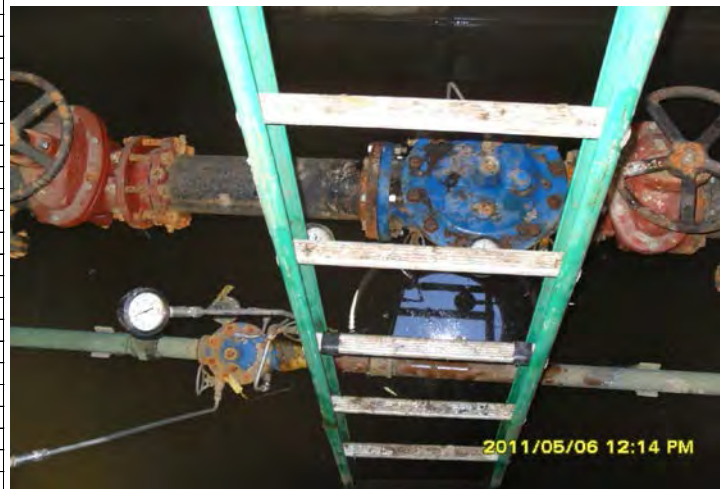
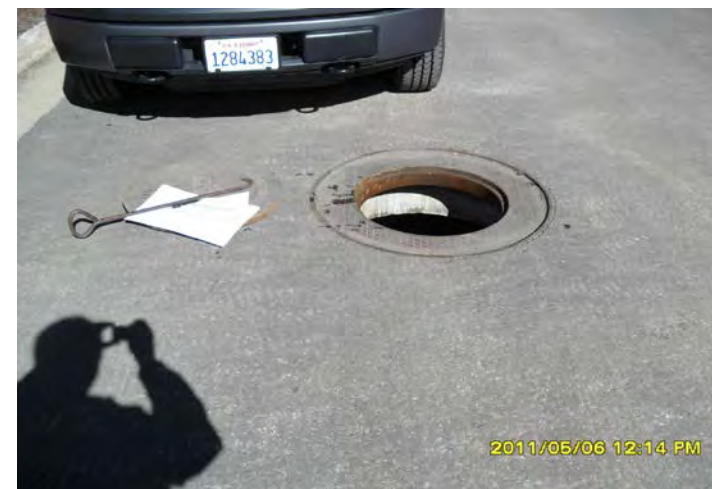
Photo Evidence for PM, Fn, R, FE

<b>South Tahoe PUD</b>	<b>Location Description:</b>	Intersection of Apache and Ottawa	<b>K/J Project Number:</b>	1270004*00
				<b>Water System Optimization Plan</b>	<b>PRV Facility ID #:</b>	K-39-014	<b>Date:</b>	5/1/2012
					<b>PRV Facility Name:</b>	Ottawa	<b>Condition Assessment Inspectors:</b>	Peter Lavallee and Glenn Roderick
					<b>Pressure Zones Served:</b>	Ottawa Zone	<b>Adjacent Pressure Zones:</b>	Arrowhead Zone and Iroquois Zone

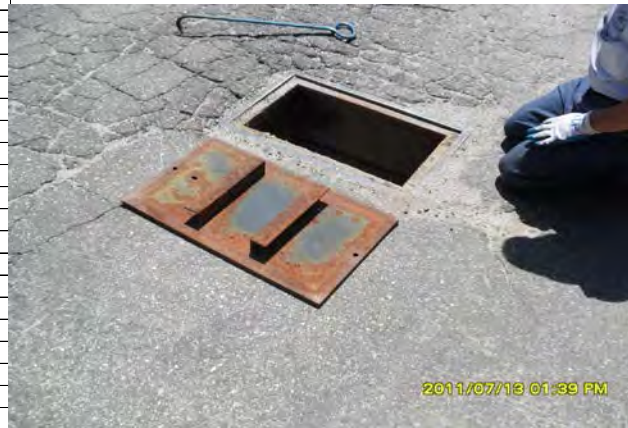
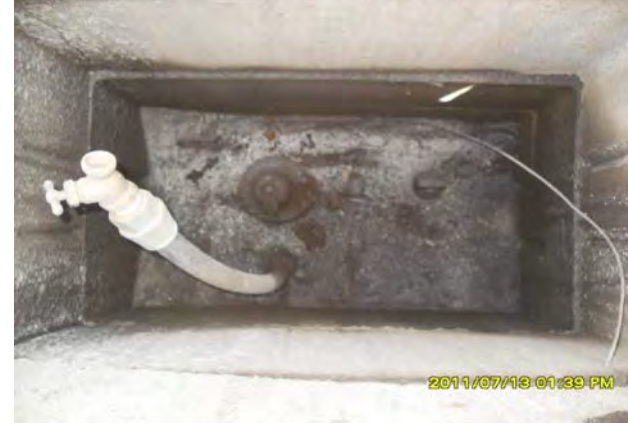
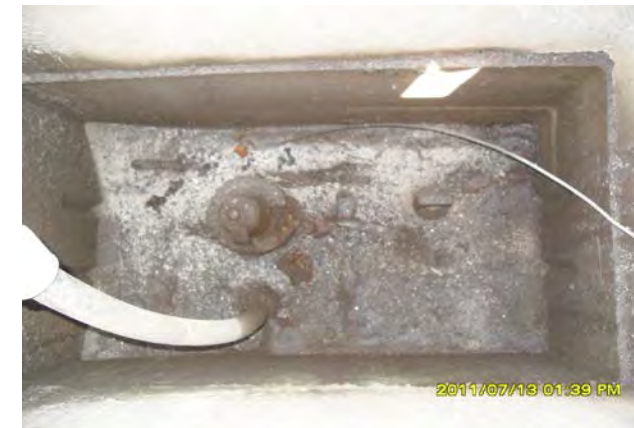
Photo Evidence for PM, Fn, R, FE

<b>South Tahoe PUD</b>	<b>Location Description:</b>	On Bakersfield near intersection with Country Club Drive	<b>K/J Project Number:</b>	1270004*00
				<b>Water System Optimization Plan</b>	<b>PRV Facility ID #:</b>	K36-002	<b>Date:</b>	5/1/2012
					<b>PRV Facility Name:</b>	Country Club PRV	<b>Condition Assessment Inspectors:</b>	Peter Lavallee and Glenn Roderick
					<b>Pressure Zones Served:</b>	Country Club Zone	<b>Adjacent Pressure Zones:</b>	Iroquois and Arrowhead Zones

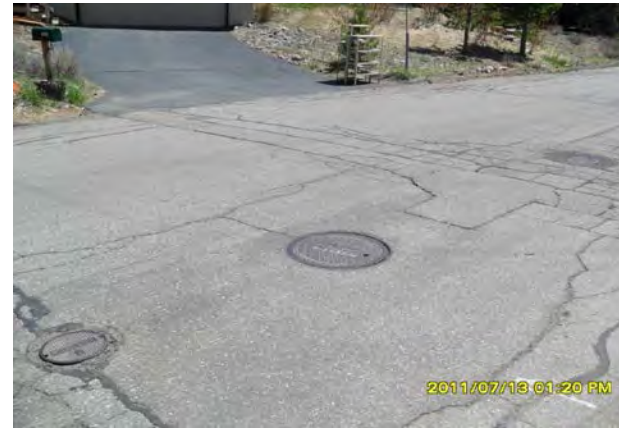
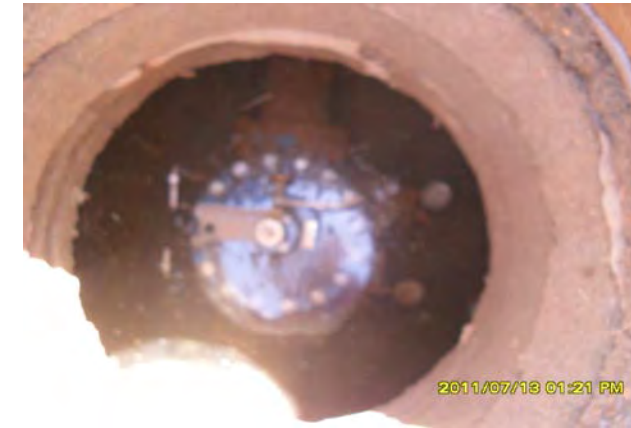
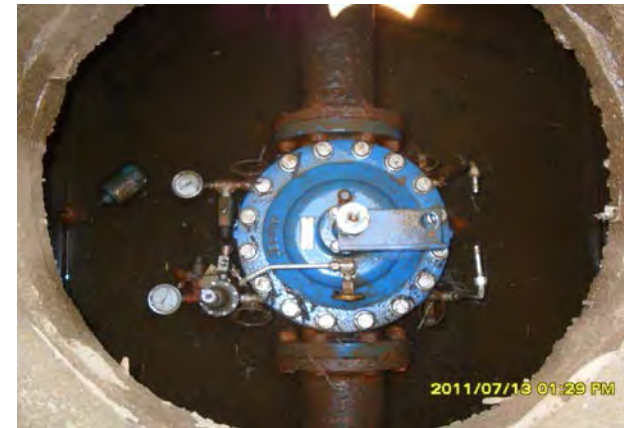
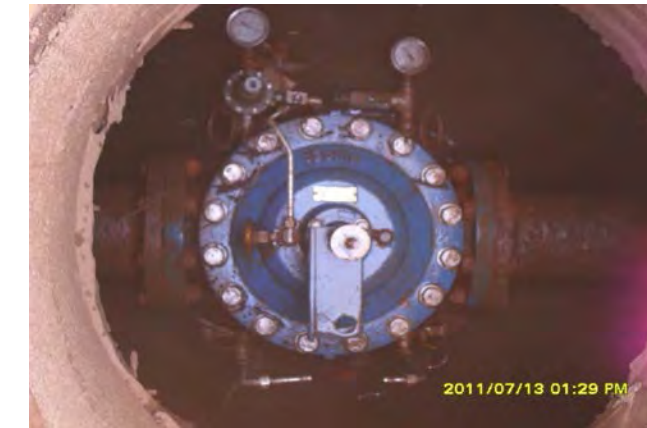
Photo Evidence for PM, Fn, R, FE

<b>South Tahoe PUD</b>	<b>Location Description:</b>	Offlying Rd	<b>K/J Project Number:</b>	1270004*00
				<b>Water System Optimization Plan</b>	<b>PRV Facility ID #:</b>	L37-012	<b>Date:</b>	5/1/2012
					<b>PRV Facility Name:</b>	Offlying PRV	<b>Condition Assessment Inspectors:</b>	Peter Lavallee and Glenn Roderick
					<b>Pressure Zones Served:</b>	Country Club Zone	<b>Adjacent Pressure Zones:</b>	Iroquois Zone

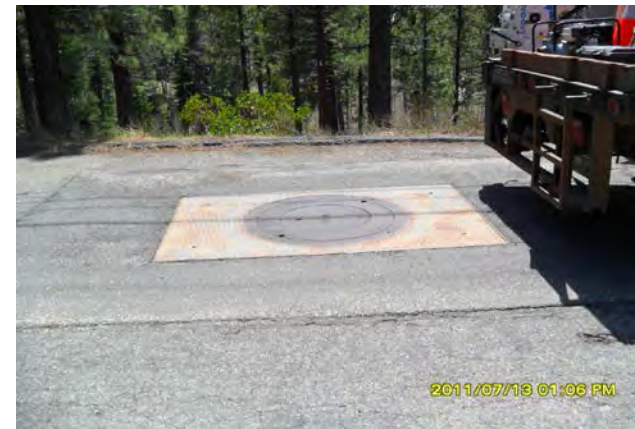
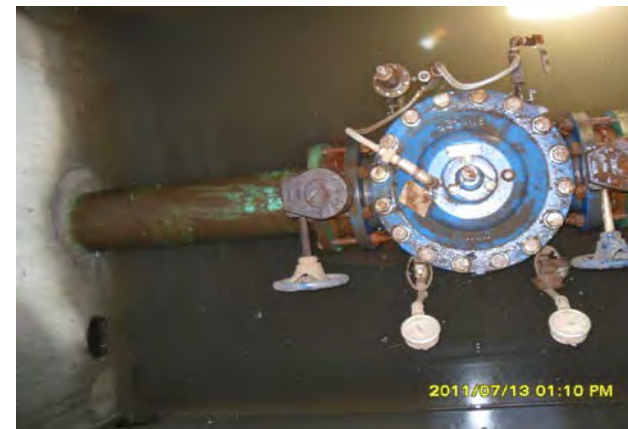
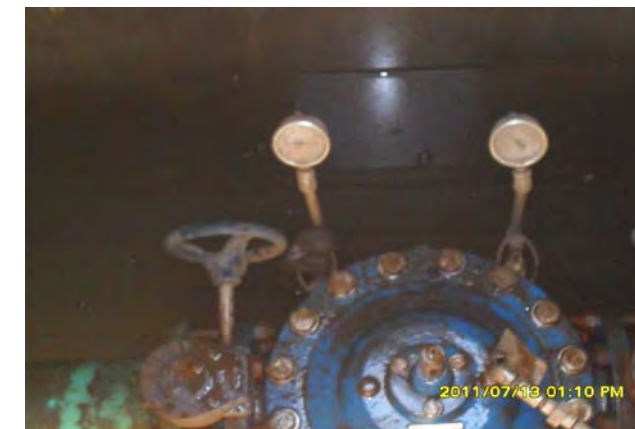
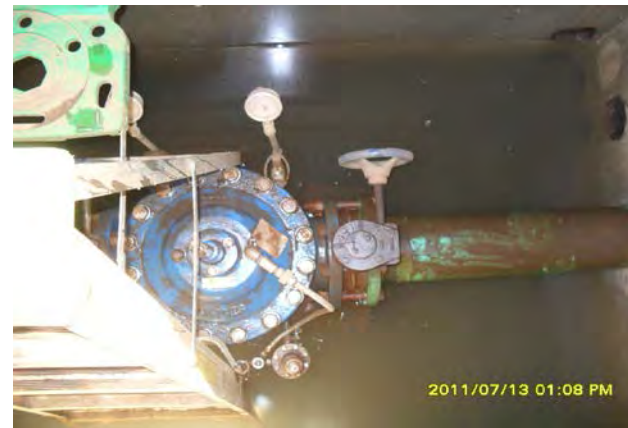
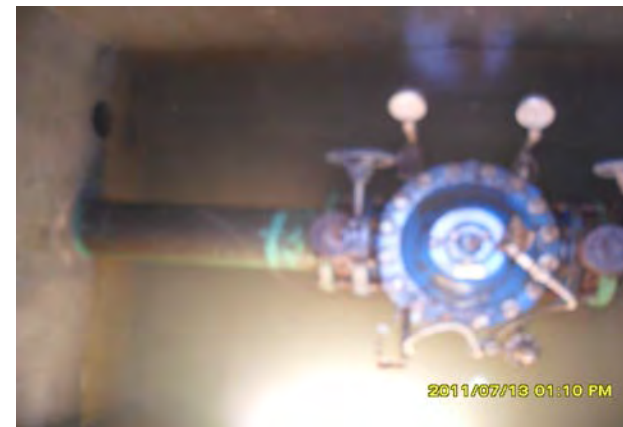
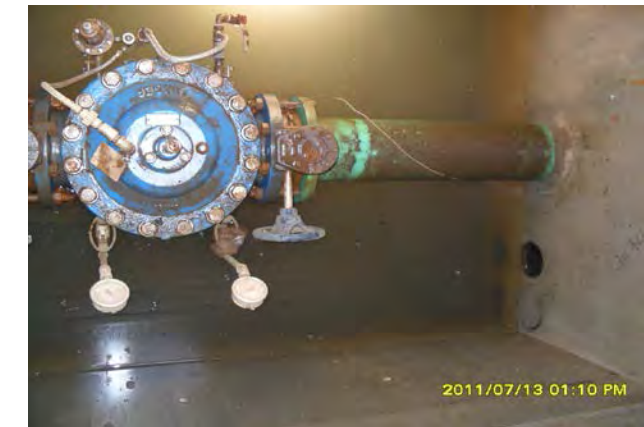
PHOTOS

Photo Evidence for PM, Fn, R, FE

Failure Mode Type	Score	Importance Weighting (1-5)	Final Score	
<b>PRV Site</b>				
Fn	5	1	5	site is secured adequately to prevent unauthorized access/vandalism? Lid is not locked
Fn	4	2	8	adequate vehicle access for year-round maintenance? Behind curb and gutter and the box is raised above grade by 3 inches but can be covered by snow in the wintertime
Fn	5	3	15	site/vault drainage adequate to prevent flooding of valve vault? Dirt floor and there has been no issue with flooding in the past
Fn	1	4	4	PRV vault adequately designed to prevent vehicle damage? Not necessary as it is outside of the roadway
Fn	1	5	5	any site stability issues (if yes, describe)? None
INFORMATION	N/A	N/A	N/A	valve elevation (use Google earth, as-builts, or surveyed elevation)? 6728 from Google Earth
Fn	1	3	3	other known problems? No other known problems
<b>Piping, Valves and Instrumentation</b>				
Fn	5	1	5	pipe supports adequate to prevent movement or vibration? Resting on the dirt

PM	5	2	10	coatings adequate to protect piping and valves? No coatings left
C	1	3	3	pipes adequately sized to prevent excessive noise (e.g. rattling) or headloss (velocity > 10 fps)? The pipes are sized adequately and there is no excessive noise or headloss noted
Fn	1	4	4	valves are suitable for efficient and reliable service? Valves have no issues
Fn	5	5	25	site has flowmeter? No flowmeter at this site
Fn	1	1	1	site has pressure upstream/downstream pressure gages? There are pressure gages on both sides of the prv
PM	4	2	8	estimated service life remaining? Valve coatings are completely gone - assume 5 yr life remaining before complete rebuild
Fn	4	3	12	other known problems? Inlet pipe is deflected between inlet of PRV and Vault wall
<b>Additional Data</b>				
INFORMATION	N/A	N/A	N/A	nominal size (e.g. 6-inch)? 6" PRV
INFORMATION	N/A	N/A	N/A	setpoint pressure(s)? 100 Upstream and 100 Downstream
				Feeds a single fire hydrant with an closed valve after the hydrant same pressure due to closed valve on D/S side of PRV.

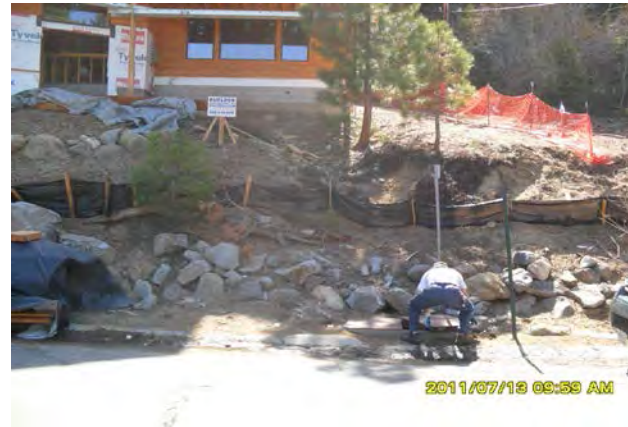
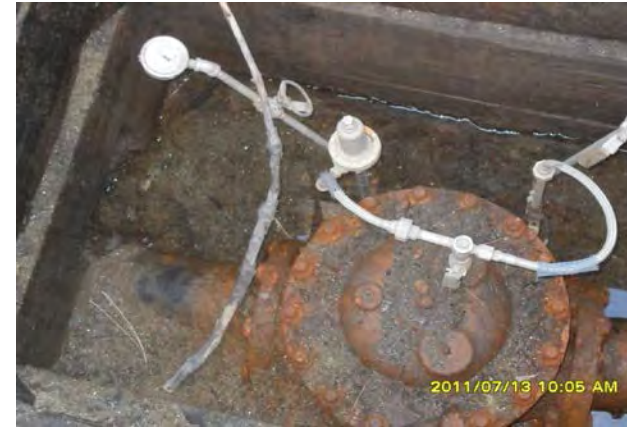
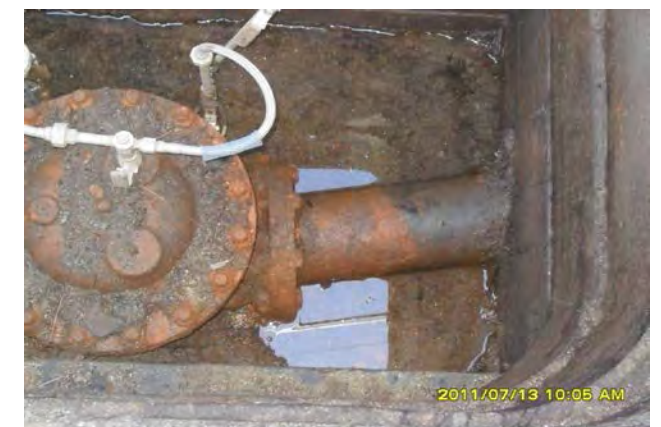
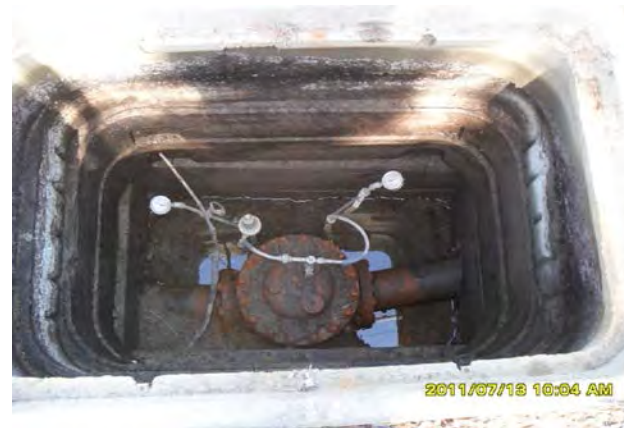
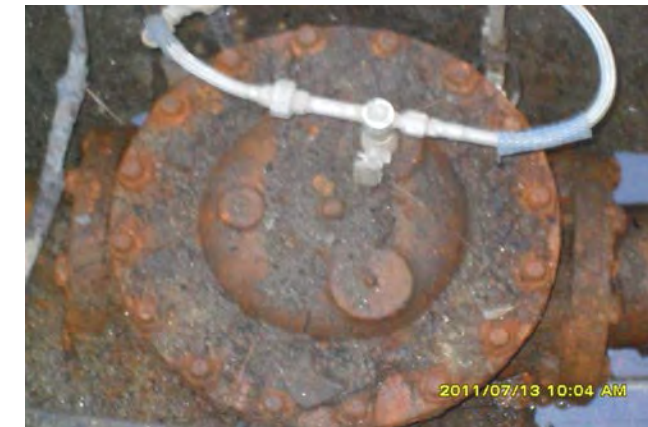
PHOTOS

Photo Evidence for PM, Fn, R, FE

Failure Mode Type	Score	Importance Weighting (1-5)	Final Score	
<b>PRV Site</b>				
Fn	5	1	5	site is secured adequately to prevent unauthorized access/vandalism? The facility is in the roadway and can be accessed easily as the lid is not locked
Fn	1	2	2	adequate vehicle access for year-round maintenance? Within roadway so no access issues
Fn	5	3	15	site/vault drainage adequate to prevent flooding of valve vault? No drain and when opened the vault had standing water a few inches above the PRV
Fn	1	4	4	PRV vault adequately designed to prevent vehicle damage? Vault is designed to prevent vehicle damage
Fn	1	5	5	any site stability issues (if yes, describe)? None
INFORMATION	N/A	N/A	N/A	valve elevation (use Google earth, as-builts, or surveyed elevation)? 6877 from Google Earth
Fn	1	3	3	other known problems? No other known problems
<b>Piping, Valves and Instrumentation</b>				
Fn	5	1	5	pipe supports adequate to prevent movement or vibration? No pipe supports

PM	3	2	6	coatings adequate to protect piping and valves? Coatings on the piping are in poor condition and the coating on the prv shows signs of rust
C	1	3	3	pipes adequately sized to prevent excessive noise (e.g. rattling) or headloss (velocity > 10 fps)? The pipes are sized adequately and there is no excessive noise or headloss noted
Fn	1	4	4	valves are suitable for efficient and reliable service? No operational issues with the valves
Fn	5	5	25	site has flowmeter? No flowmeter at this site
Fn	1	1	1	site has pressure upstream/downstream pressure gages? There are pressure gages on both sides of the prv
PM	3	2	6	estimated service life remaining? Assume 20 years based on AWU Useful Life
Fn	2	3	6	other known problems? There are no other known problems with this prv however the bypass has had a number of leaks
<b>Additional Data</b>				
INFORMATION	N/A	N/A	N/A	nominal size (e.g. 6-inch)? 6" PRV with a 1/2" low flow Bypass

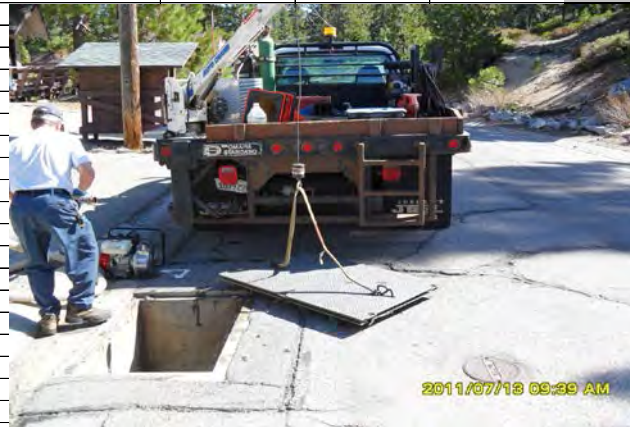
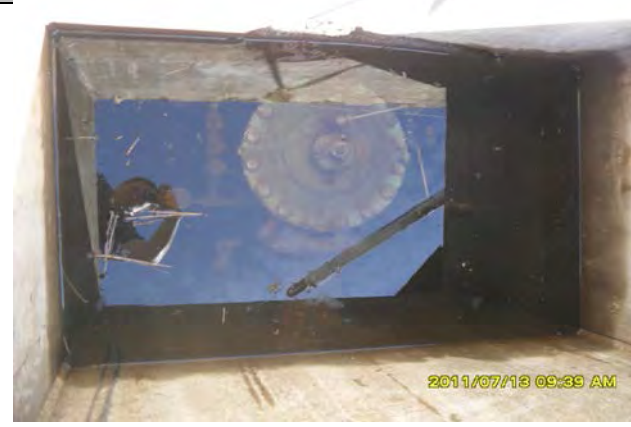
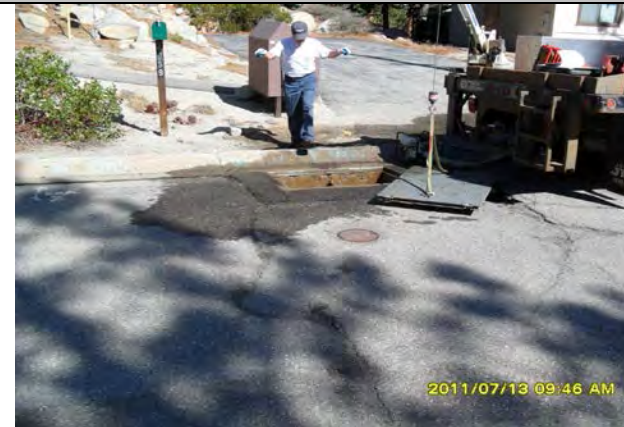
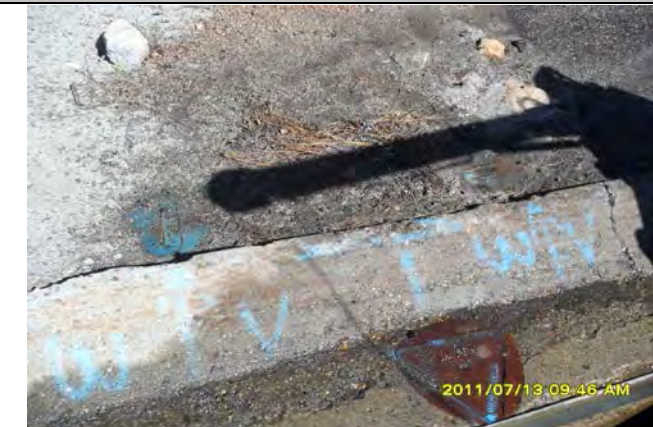
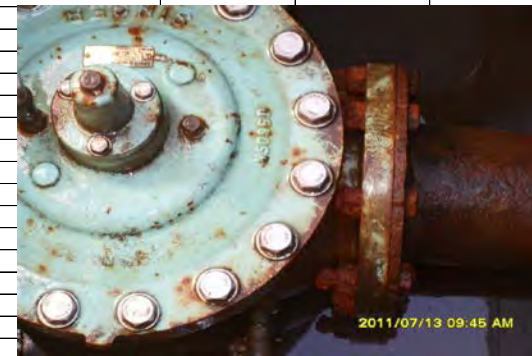
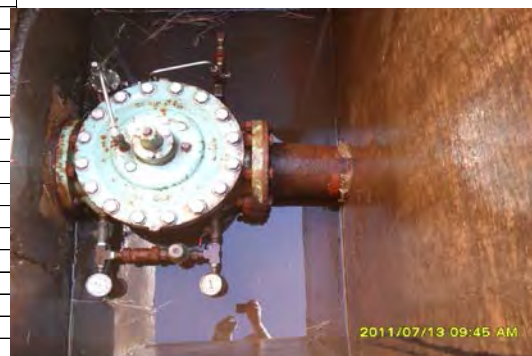
PHOTOS

Photo Evidence for PM, Fn, R, FE

Failure Mode Type	Score	Importance Weighting (1-5)	Final Score	
<b>PRV Site</b>				
Fn	1	1	1	site is secured adequately to prevent unauthorized access/vandalism? The facility is in the roadway and the lid is locked
Fn	1	2	2	adequate vehicle access for year-round maintenance? Within roadway so no access issues
Fn	5	3	15	site/vault drainage adequate to prevent flooding of valve vault? No drain and when opened the vault had standing water a few inches below the top of the PRV
Fn	1	4	4	PRV vault adequately designed to prevent vehicle damage? Vault is designed to prevent vehicle damage
Fn	1	5	5	any site stability issues (if yes, describe)? None
INFORMATION	N/A	N/A	N/A	valve elevation (use Google earth, as-builts, or surveyed elevation)? 6847 from Google Earth
Fn	1	3	3	other known problems? No other known problems
<b>Piping, Valves and Instrumentation</b>				
Fn	1	1	1	pipe supports adequate to prevent movement or vibration? No supports

PM	3	2	6	coatings adequate to protect piping and valves? PRV Coating is acceptable, but starting to deteriorate and pipe wrap appears to be in adequate condition. Fasteners are unserviceable and bolts rusted.
C	1	3	3	pipes adequately sized to prevent excessive noise (e.g. rattling) or headloss (velocity > 10 fps)? The pipes are sized adequately and there is no excessive noise or headloss noted
Fn	1	4	4	valves are suitable for efficient and reliable service? Valves are suitable and efficient
Fn	5	5	25	site has flowmeter? No flowmeter at this site
Fn	1	1	1	site has pressure upstream/downstream pressure gages? There are pressure gages on both sides of the prv
PM	3	2	6	estimated service life remaining? Assume 20 years based on AWU Useful Life
Fn	1	3	3	other known problems? No other known problems.
<b>Additional Data</b>				
INFORMATION	N/A	N/A	N/A	nominal size (e.g. 6-inch)? 6" PRV
INFORMATION		1	0	setpoint pressure(s)? 94 Upstream and 60 Downstream

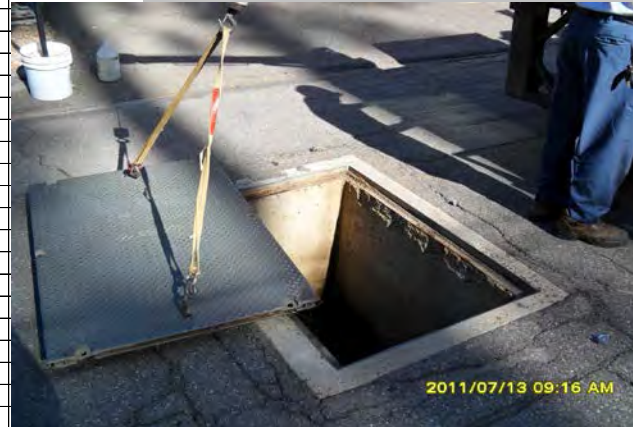
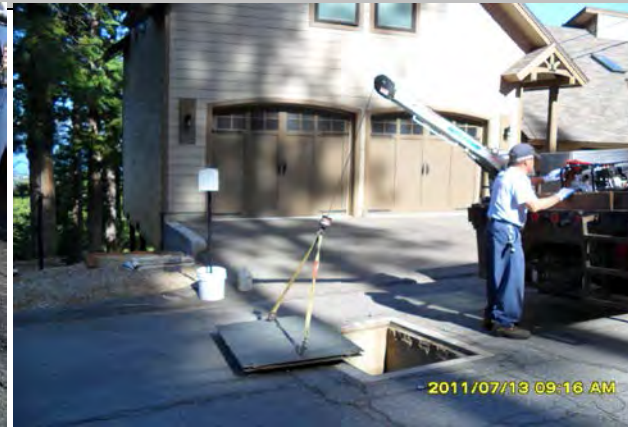
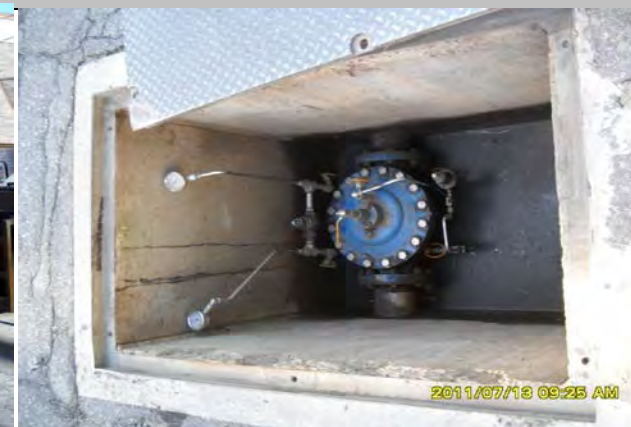
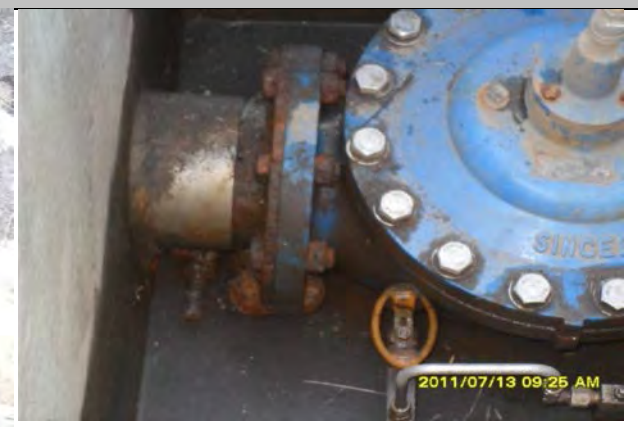
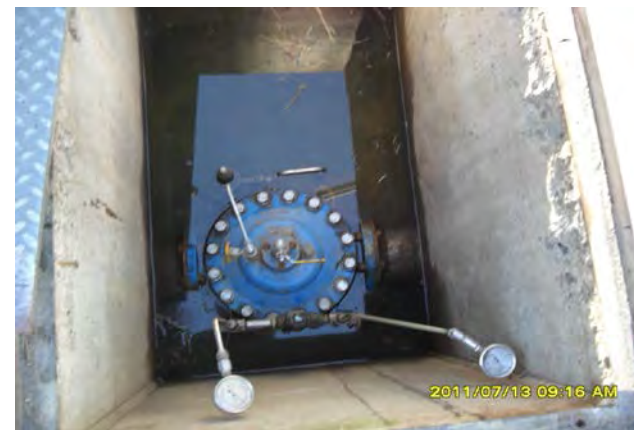
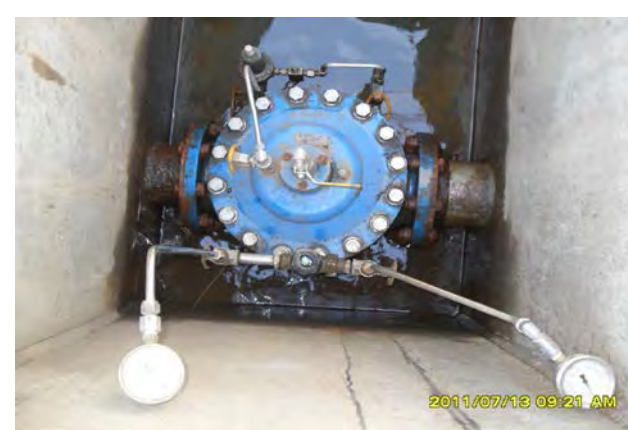
PHOTOS

Photo Evidence for PM, Fn, R, FE

Failure Mode Type	Score	Importance Weighting (1-5)	Final Score	
<b>PRV Site</b>				
Fn	5	1	5	site is secured adequately to prevent unauthorized access/vandalism? The facility is in the roadway and can be accessed easily as the lid is not locked
Fn	1	2	2	adequate vehicle access for year-round maintenance? Within roadway so no access issues
Fn	5	3	15	site/vault drainage adequate to prevent flooding of valve vault? Always filled with water and there is no drain. The vault must be pumped out whenever work is to be completed.
Fn	1	4	4	PRV vault adequately designed to prevent vehicle damage? Vault is designed to prevent vehicle damage
Fn	1	5	5	any site stability issues (if yes, describe)? None
INFORMATION	N/A	N/A	N/A	valve elevation (use Google earth, as-builts, or surveyed elevation)? 6752 from Google Earth
Fn	5	3	15	other known problems? PRV is on a blind corner and is extremely dangerous to perform maintenance on

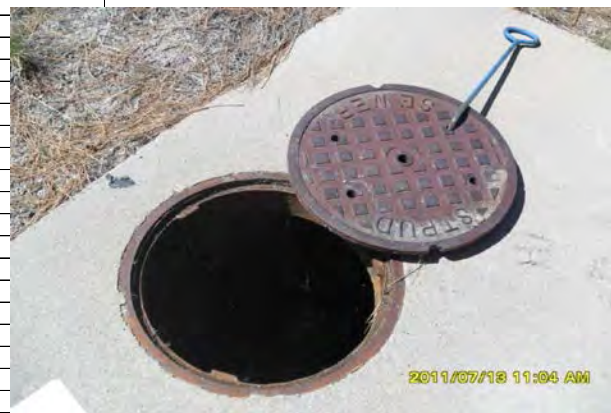
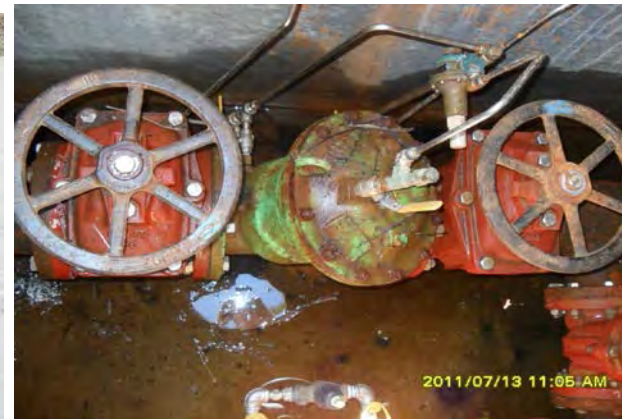
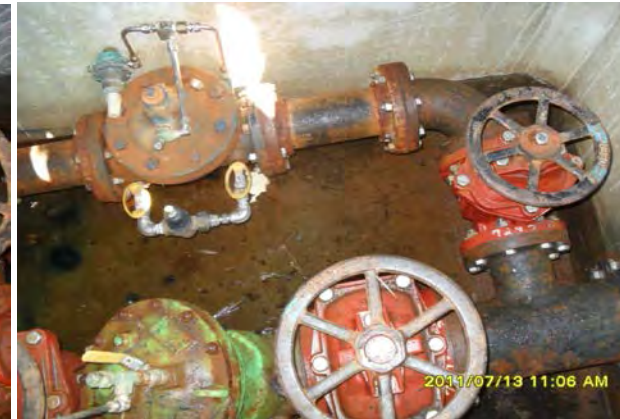
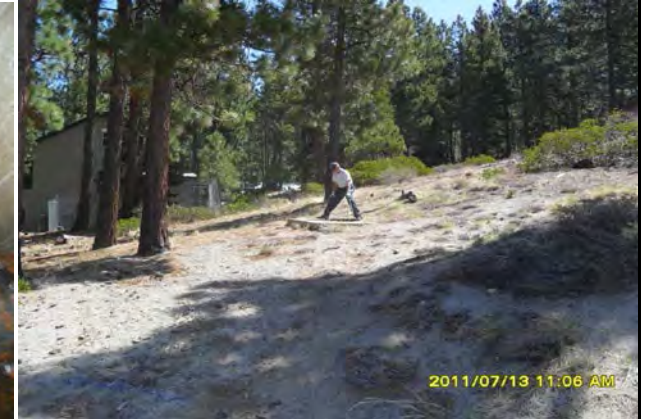
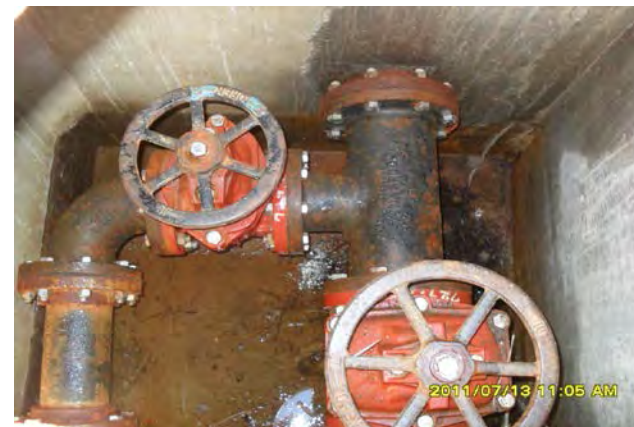
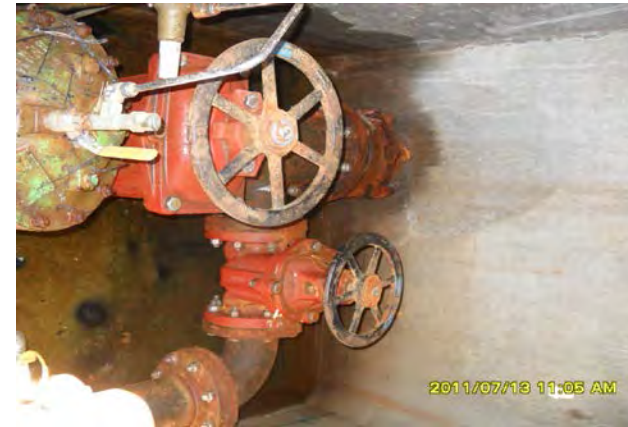
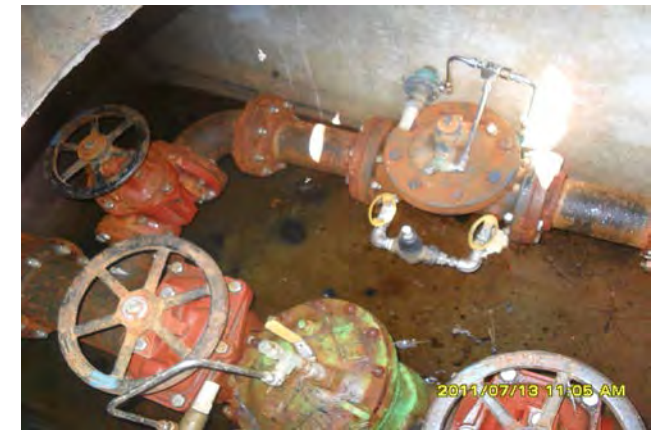
PHOTOS

Photo Evidence for PM, Fn, R, FE

Failure Mode Type	Score	Importance Weighting (1-5)	Final Score	
<b>PRV Site</b>				
Fn	5	1	5	site is secured adequately to prevent unauthorized access/vandalism? The facility is in the roadway and can be accessed easily as the lid is not locked
Fn	4	2	8	adequate vehicle access for year-round maintenance? Within roadway so no access issues
Fn	4	3	12	site/vault drainage adequate to prevent flooding of valve vault? No drain and when opened the vault had standing water at springline of piping
Fn	1	4	4	PRV vault adequately designed to prevent vehicle damage? Vault is designed to prevent vehicle damage
Fn	1	5	5	any site stability issues (if yes, describe)? None
INFORMATION	N/A	N/A	N/A	valve elevation (use Google earth, as-builts, or surveyed elevation)? 6456 from Google Earth
Fn	1	3	3	other known problems? No other known problems
<b>Piping, Valves and Instrumentation</b>				
Fn	5	1	5	pipe supports adequate to prevent movement or vibration? No pipe supports

PM	5	2	10	coatings adequate to protect piping and valves? Coatings are gone and there is visible rust
C	1	3	3	pipes adequately sized to prevent excessive noise (e.g. rattling) or headloss (velocity > 10 fps)? The pipes are sized adequately and there is no excessive noise or headloss noted
Fn	1	4	4	valves are suitable for efficient and reliable service? No valving issues
Fn	5	5	25	site has flowmeter? No flowmeter at this site
Fn	1	1	1	site has pressure upstream/downstream pressure gages? There are pressure gages on both sides of the prv
PM	4	2	8	estimated service life remaining? Assume 5 years based on AWU Useful Life
Fn	1	3	3	other known problems? There are no other known problems with this prv station
<b>Additional Data</b>				
INFORMATION	N/A	N/A	N/A	nominal size (e.g. 6-inch)? 4" PRV with a 2" Direct action bypass and a 1/2" low flow bypass
INFORMATION	N/A	N/A	N/A	setpoint pressure(s)? 120 Upstream and 55 Downstream
