South Tahoe Public Utility District

## STPUD Water Facilities CIP

*Final Report - Appendices*

# Water System Optimization Plan

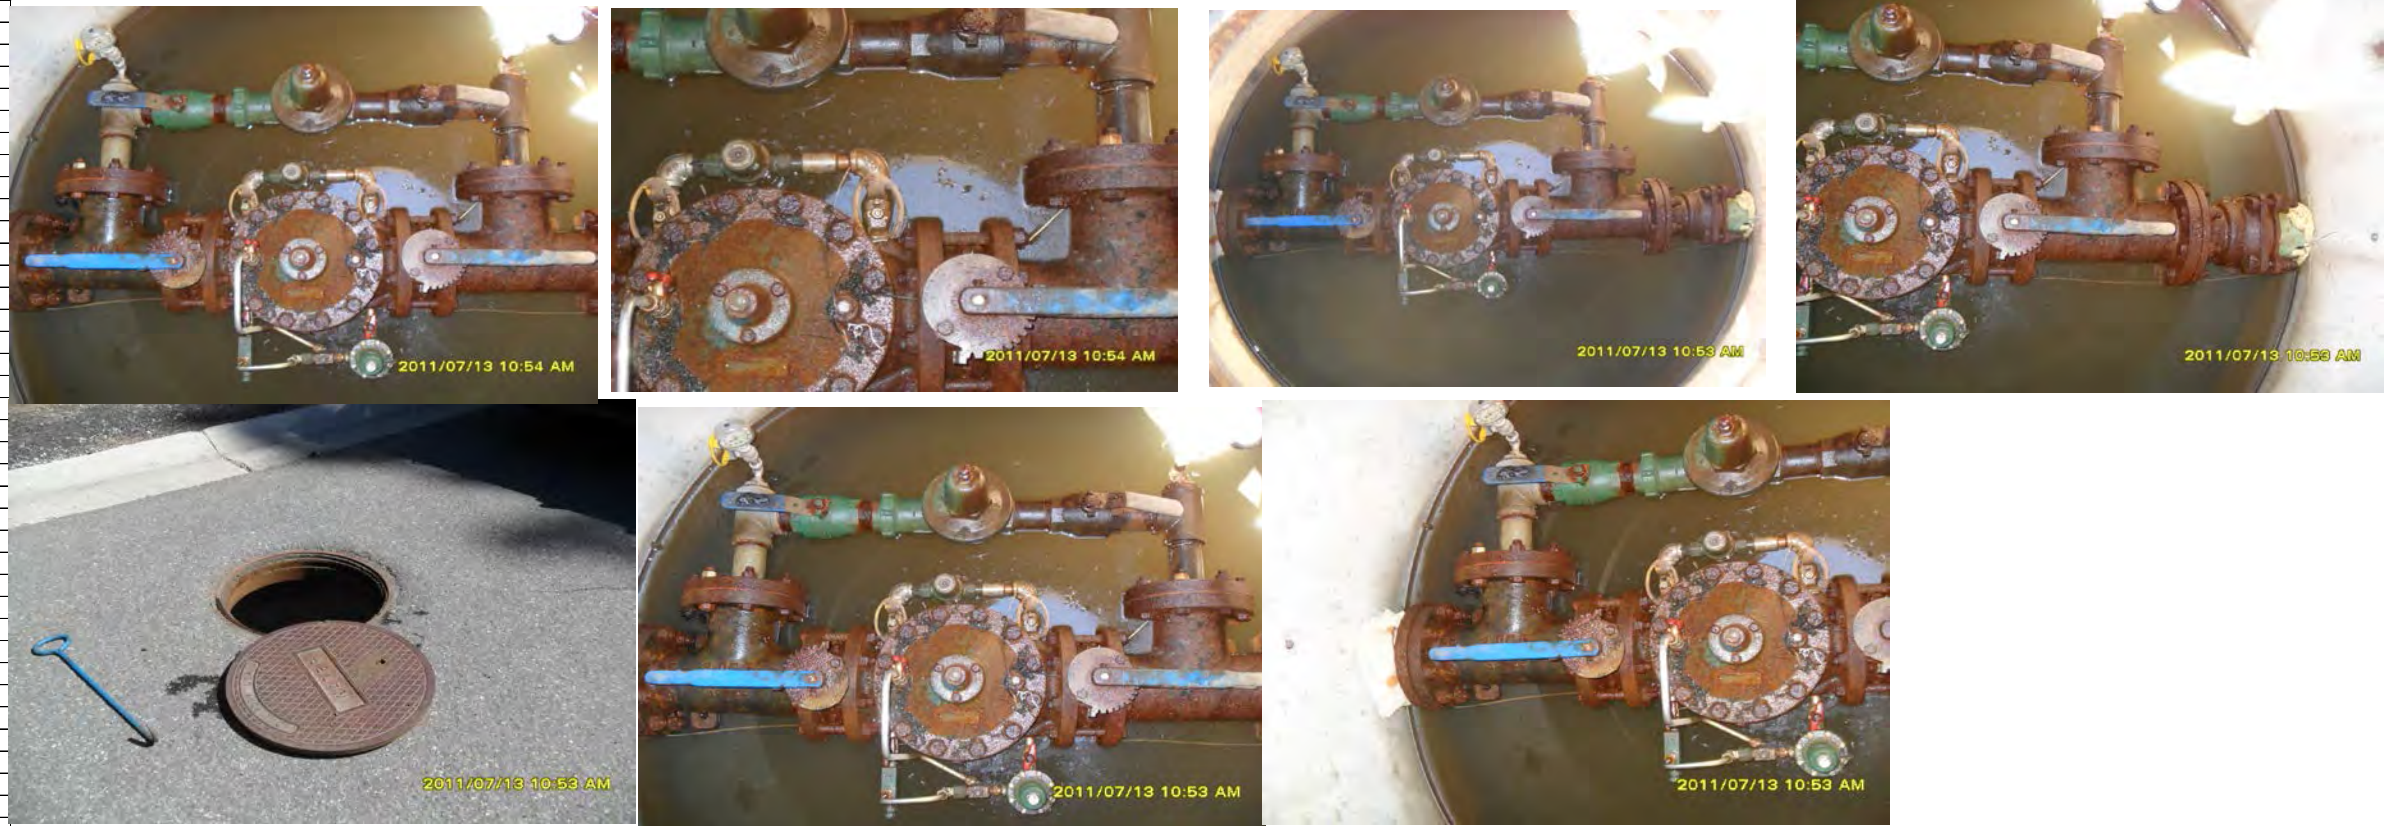
PHOTOS

Photo Evidence for PM, Fn, R, FE

Failure Mode Type	Score	Importance Weighting (1-5)	Final Score	
				<b>PRV Site</b>
Fn	5	1	5	site is secured adequately to prevent unauthorized access/vandalism? No lock on box
Fn	4	2	8	adequate vehicle access for year-round maintenance? Outside of roadway and is buried by snow during winter months
Fn	1	3	3	site/vault drainage adequate to prevent flooding of valve vault? No flooding issues
Fn	1	4	4	PRV vault adequately designed to prevent vehicle damage? Not necessary due to location outside of roadway
Fn	1	5	5	any site stability issues (if yes, describe) None
INFORMATION	N/A	N/A	N/A	valve elevation (use Google earth, as-builts, or surveyed elevation)? 6480 from Google Earth
Fn	1	3	3	other known problems? No other known problems
				<b>Piping, Valves and Instrumentation</b>
Fn	5	1	5	pipe supports adequate to prevent movement or vibration? No pipe supports
PM	2	2	4	coatings adequate to protect piping and valves? PRV Coating in good condition with galvanized pipes

C	5	3	15	pipes adequately sized to prevent excessive noise (e.g. rattling) or headloss (velocity > 10 fps)? The pipes are sized adequately and there is no excessive noise or headloss noted
Fn	1	4	4	valves are suitable for efficient and reliable service? No valving issues
Fn	5	5	25	site has flowmeter? No flowmeter at this site
Fn	1	1	1	site has pressure upstream/downstream pressure gages? There are pressure gages on both sides of the prv
PM	3	2	6	estimated service life remaining? Assume 20 years based on AWU Useful Life
Fn	1	3	3	other known problems? There are no other known problems with this prv station
				<b>Additional Data</b>
INFORMATION	N/A	N/A	N/A	nominal size (e.g. 6-inch)? 2" PRV with 1" Low flow Bypass
INFORMATION		N/A	#VALUE!	setpoint pressure(s)? 92 Upstream and 65 Downstream
				<b>Legend</b>
				PM Physical Mortality
				Fn Functionality
				R Reliability
				FE Financial Efficiency
				C Capacity

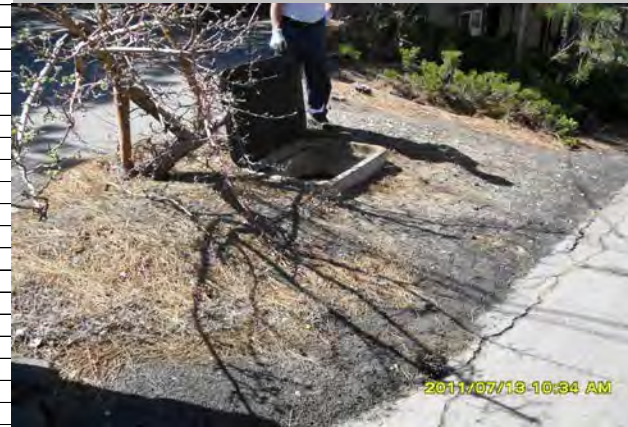
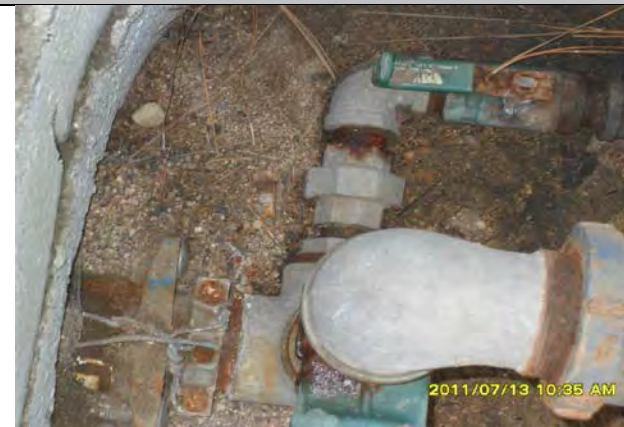
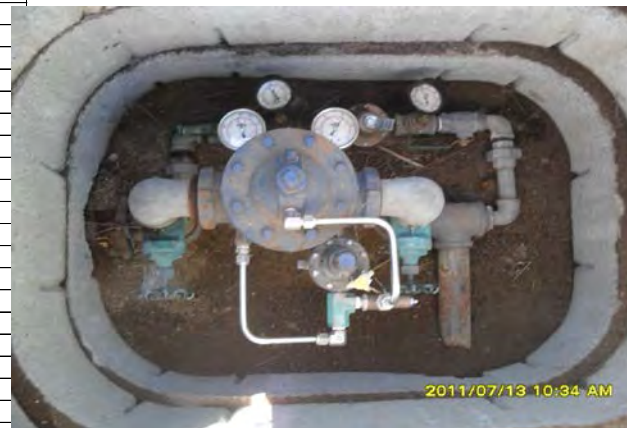
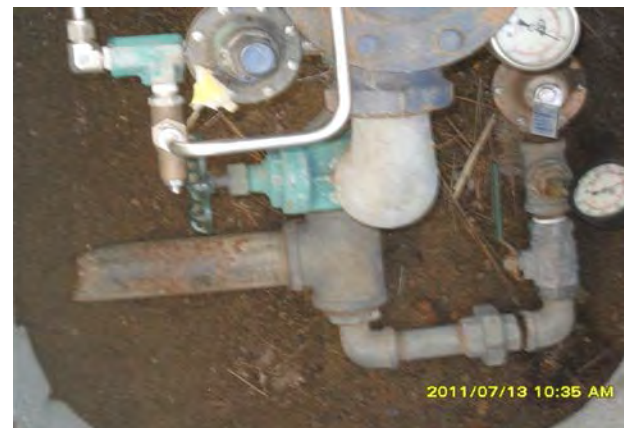
PHOTOS

Photo Evidence for PM, Fn, R, FE

<b>South Tahoe PUD</b>	<b>Location Description:</b>	Intersection of Overlook and Wildwood	<b>K/J Project Number:</b>	1270004*00
				<b>Water System Optimization Plan</b>	<b>PRV Facility ID #:</b>	Not Assigned	<b>Date:</b>	5/1/2012
					<b>PRV Facility Name:</b>	Overlook PRV	<b>Condition Assessment Inspectors:</b>	Peter Lavallee and Glenn Roderick
					<b>Pressure Zones Served:</b>	Heavenly Valley/Overlook	<b>Adjacent Pressure Zones:</b>	Heavenly Valley Zone, Stateline Zone, and Terrace Zone

This PRV has been buried and was unknown until recently when the zone boundaries were being evaluated. As such this PRV can not be evaluated.

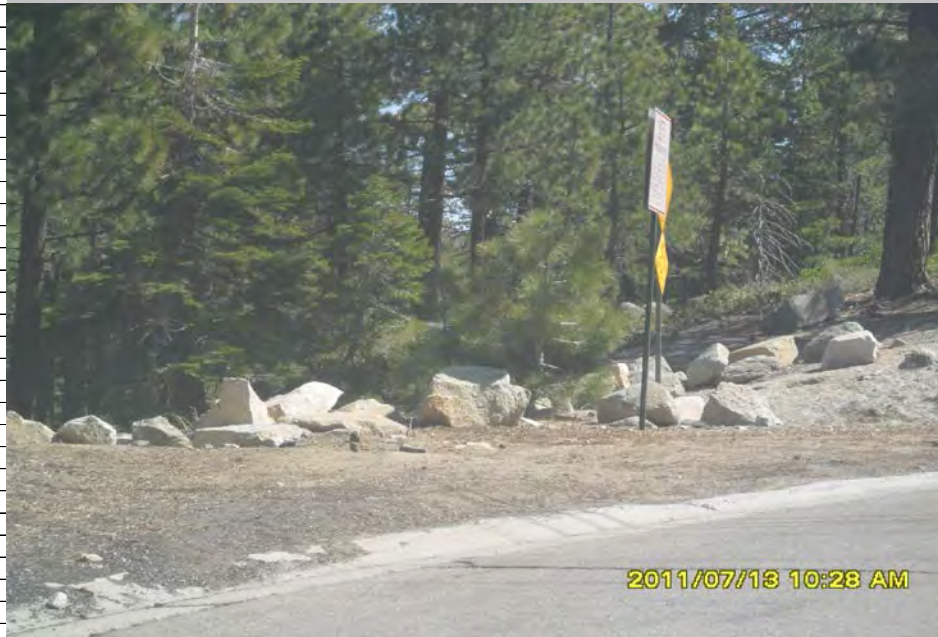
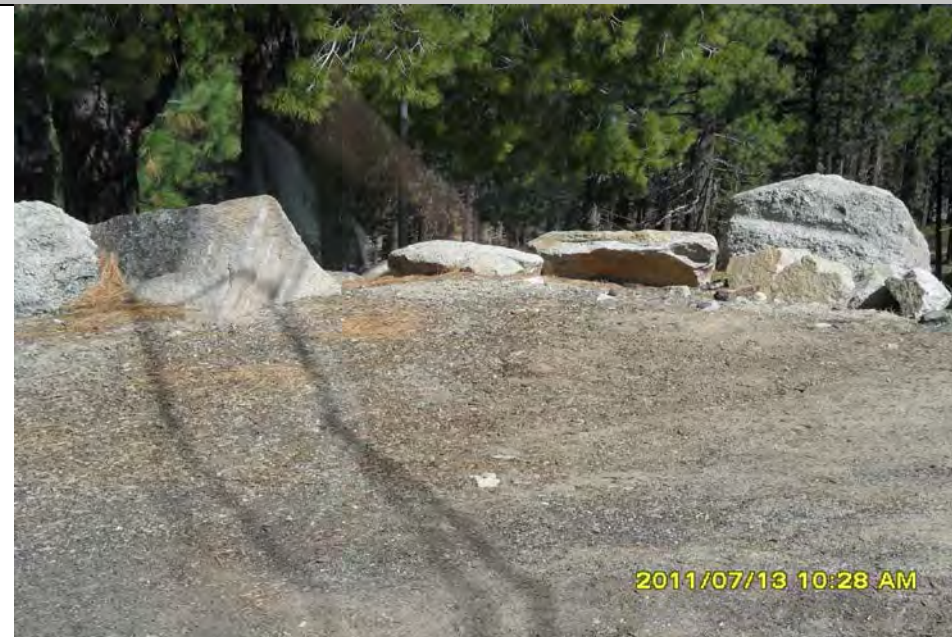
PHOTOS

Photo Evidence for PM, Fn, R, FE

<b>South Tahoe PUD</b>	<b>Location Description:</b>	Intersection of Saddle and Wildwood	<b>K/J Project Number:</b>	1270004*00
				<b>Water System Optimization Plan</b>	<b>PRV Facility ID #:</b>	Q23-021	<b>Date:</b>	5/1/2012
					<b>PRV Facility Name:</b>	Saddle #3	<b>Condition Assessment Inspectors:</b>	Peter Lavallee and Glenn Roderick
					<b>Pressure Zones Served:</b>	Heavenly Valley Zone	<b>Adjacent Pressure Zones:</b>	Stateline Zone

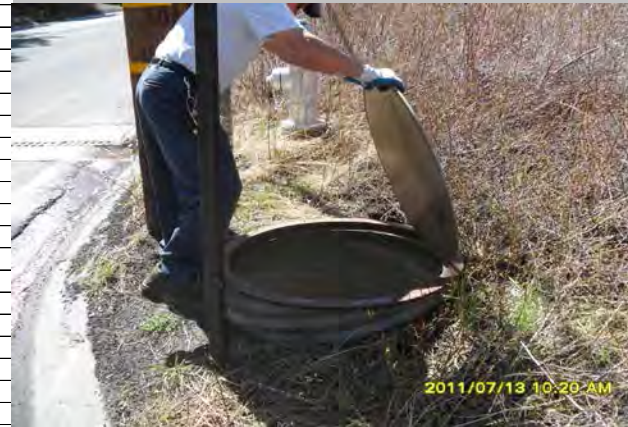
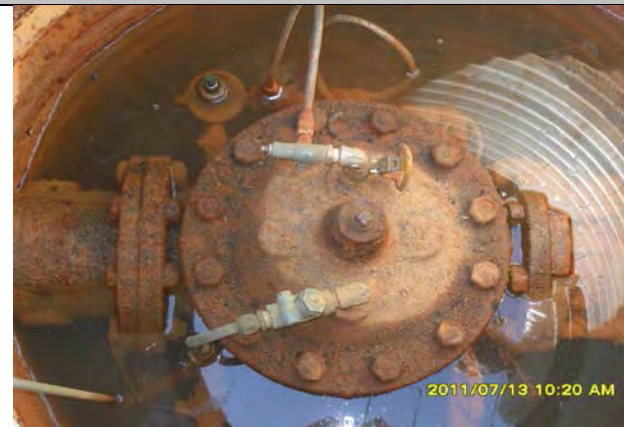
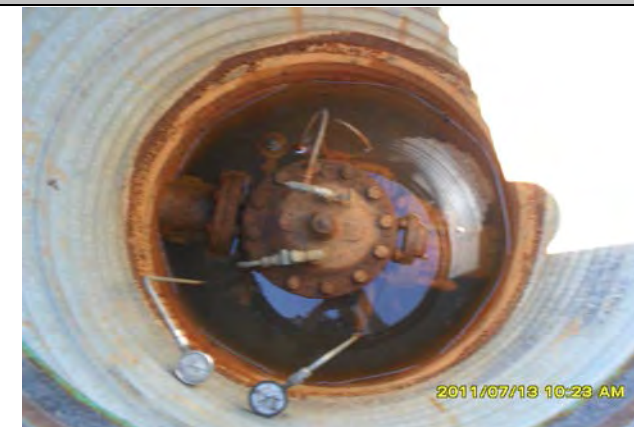
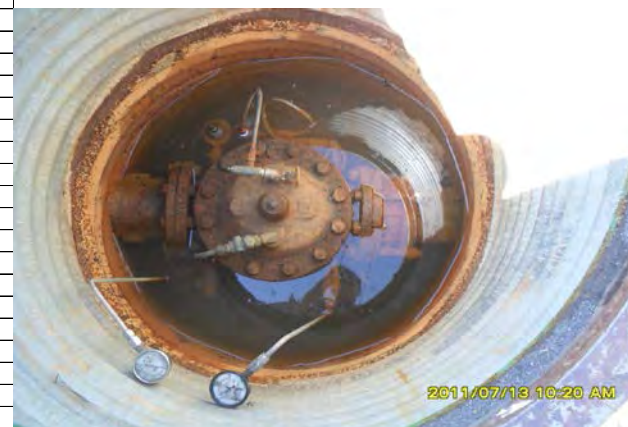
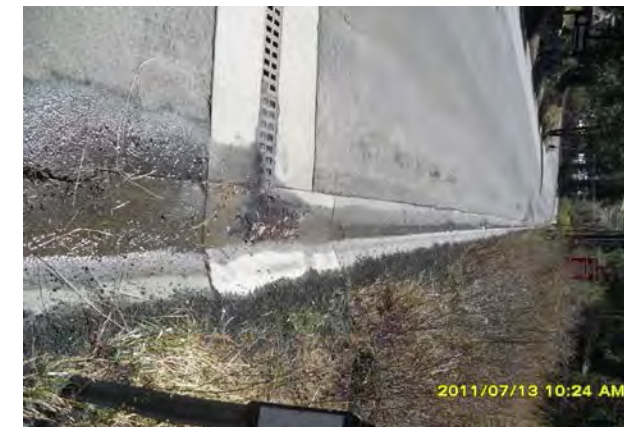
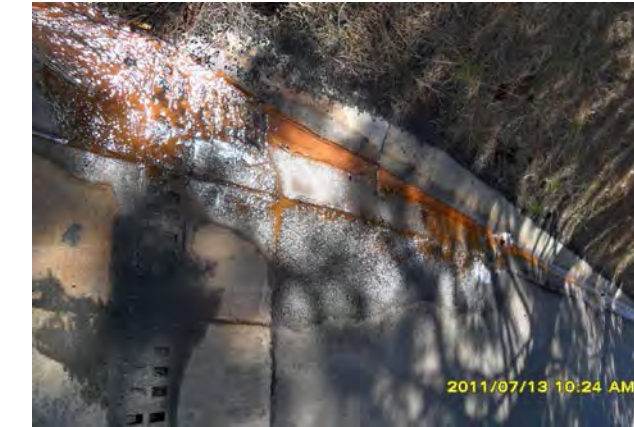
PHOTOS

Photo Evidence for PM, Fn, R, FE

<b>South Tahoe PUD</b>	<b>Location Description:</b>	Intersection of Saddle and Keller	<b>K/J Project Number:</b>	1270004*00
				<b>Water System Optimization Plan</b>	<b>PRV Facility ID #:</b>	R23-021	<b>Date:</b>	5/1/2012
					<b>PRV Facility Name:</b>	Saddle #2	<b>Condition Assessment Inspectors:</b>	Peter Lavallee and Glenn Roderick
					<b>Pressure Zones Served:</b>	Heavenly Valley Zone	<b>Adjacent Pressure Zones:</b>	Stateline Zone and Sweeping Turn PRV

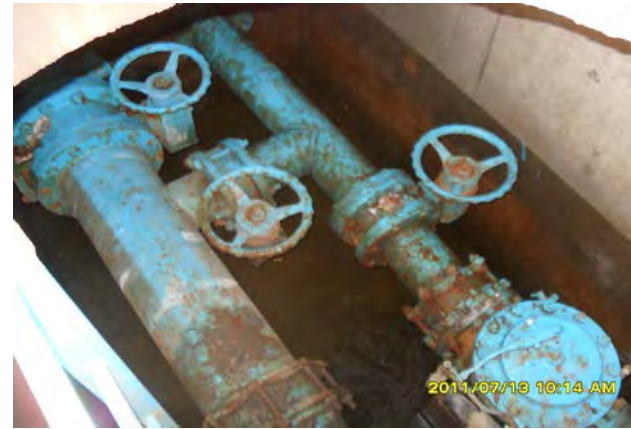
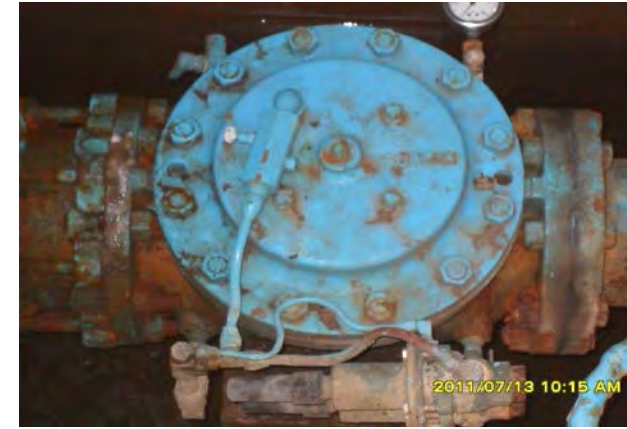
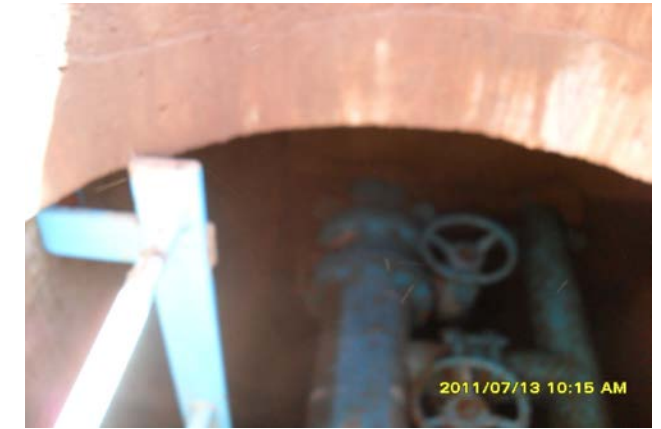
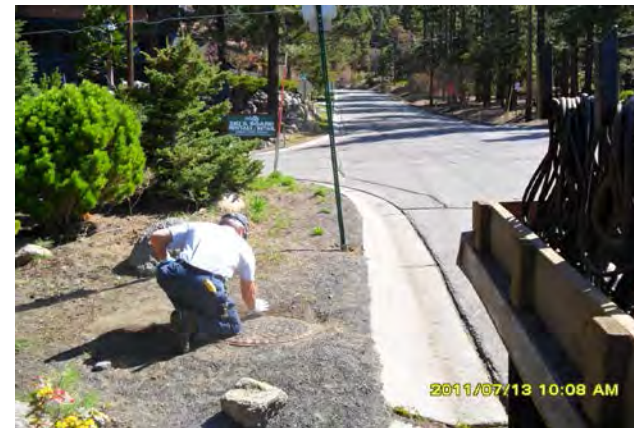
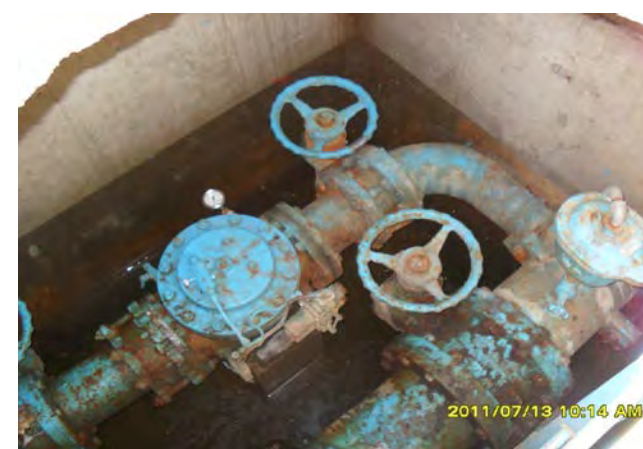
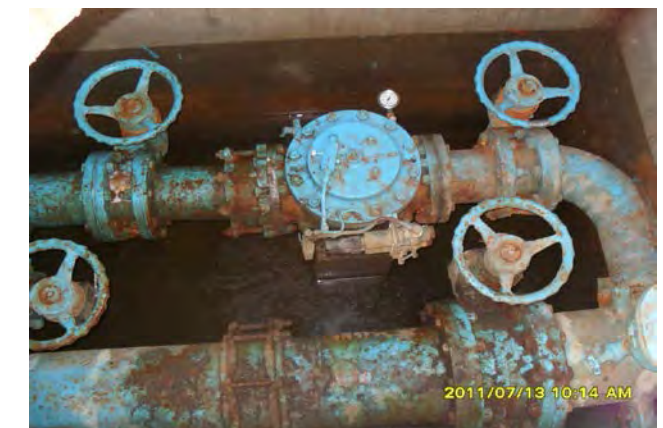
PHOTOS

Photo Evidence for PM, Fn, R, FE

<b>South Tahoe PUD</b>	<b>Location Description:</b>	Intersection of Susquehana and Minniconjou	<b>K/J Project Number:</b>	1270004*00
				<b>Water System Optimization Plan</b>	<b>PRV Facility ID #:</b>	N32-022	<b>Date:</b>	5/1/2012
					<b>PRV Facility Name:</b>	Susquehana PRV	<b>Condition Assessment Inspectors:</b>	Peter Lavallee and Glenn Roderick
					<b>Pressure Zones Served:</b>	Susquehana Zone	<b>Adjacent Pressure Zones:</b>	Pine Valley

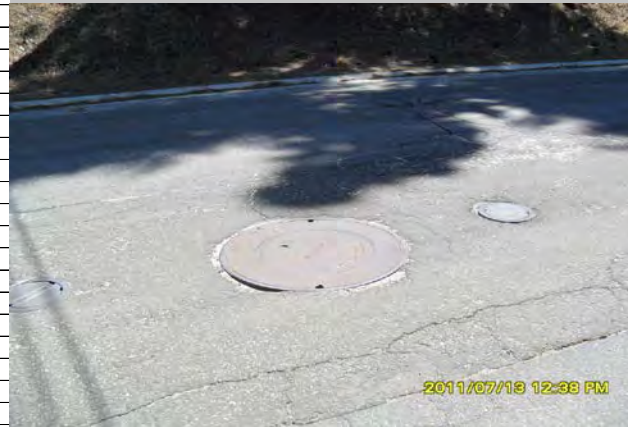
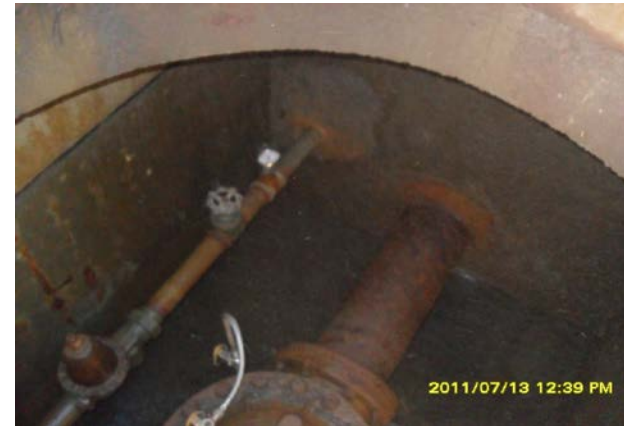
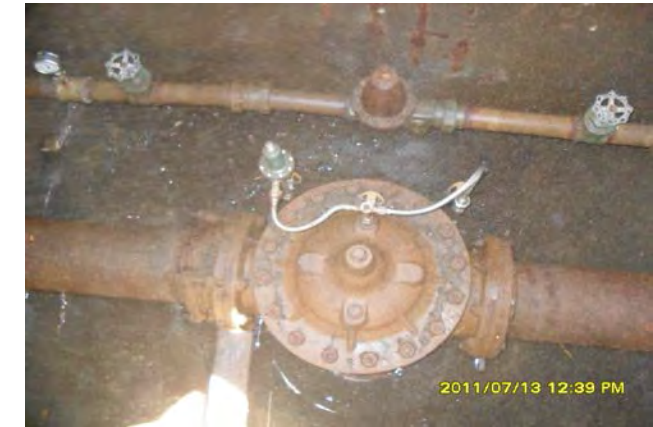
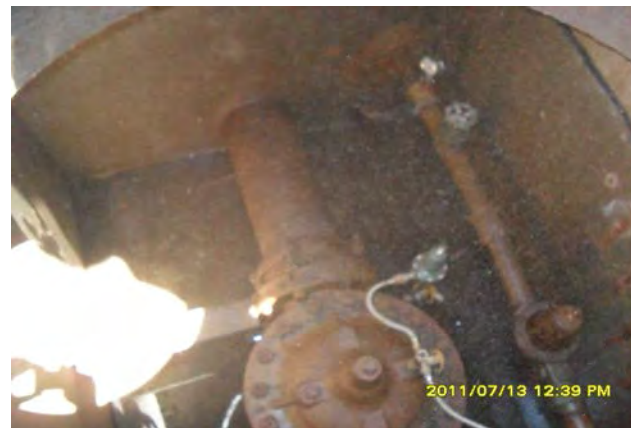
PHOTOS

Photo Evidence for PM, Fn, R, FE

<b>South Tahoe PUD</b>	<b>Location Description:</b>	In front of 1393 Pine Valley Rd.	<b>K/J Project Number:</b>	1270004*00
				<b>Water System Optimization Plan</b>	<b>PRV Facility ID #:</b>	M34-016	<b>Date:</b>	5/1/2012
					<b>PRV Facility Name:</b>	Pine Valley PRV	<b>Condition Assessment Inspectors:</b>	Peter Lavallee and Glenn Roderick
					<b>Pressure Zones Served:</b>	Pine Valley zone	<b>Adjacent Pressure Zones:</b>	Susquehana, Country Club, and Iroquois Zones

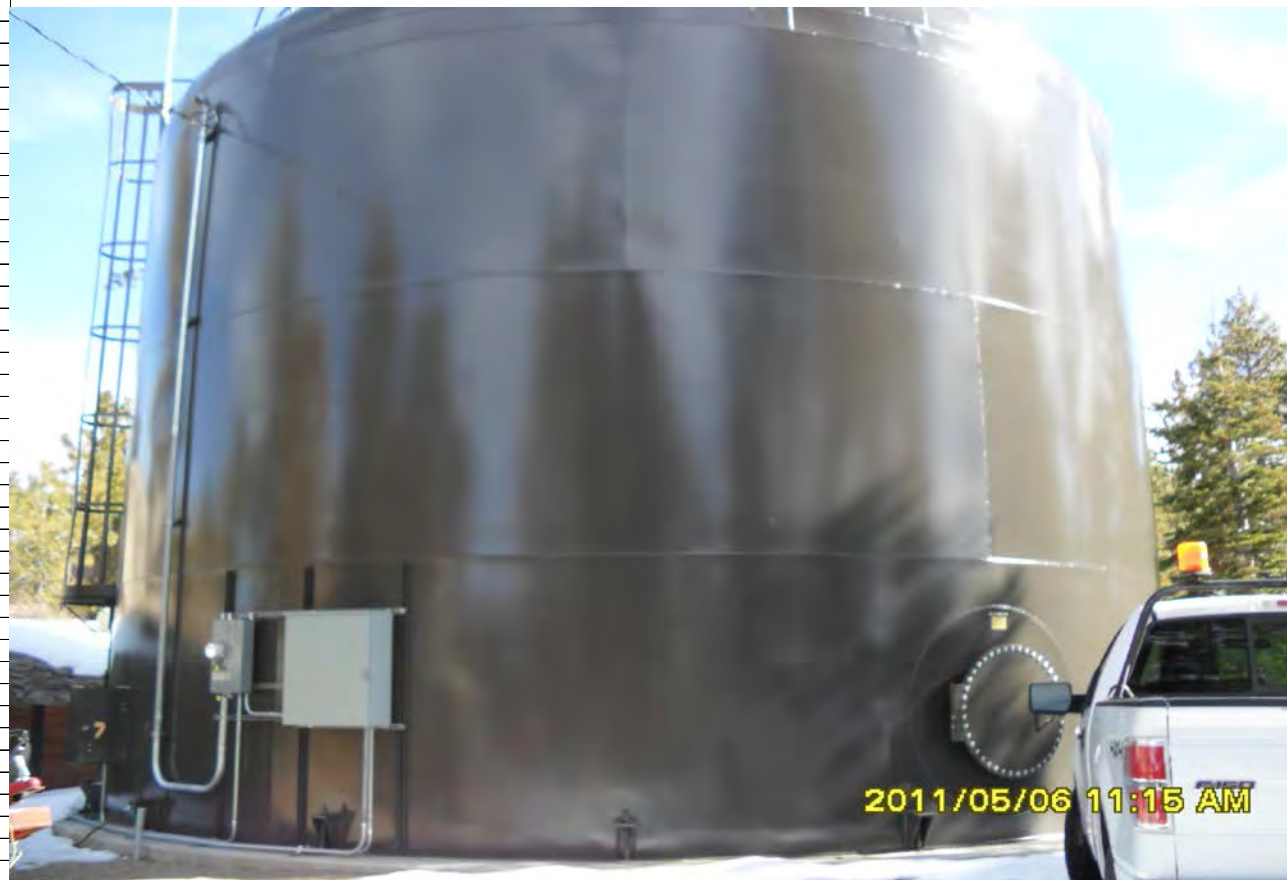
PHOTOS

Photo Evidence for PM, Fn, R, FE [Is the downslope portion of the tank constructed on fill?](#) [Does tank overflow drain adequately to protect tank foundation?](#) [Any bacteriological exceedance at this tank?](#) [Add Photo](#)

Fn	1	4	4.00	tank freeboard dimension from operating high water level to top of tank overflow? adequate?	Tank freeboard is 3 feet which was designed for sloshing due to seismic activity at time of construction and is therefore adequate			
R	1	5	5.00	tank designed to withstand snow load and not create safety issue?	Yes			
PM	1	5	5.00	condition of exterior coatings adequate to protect structure?	Yes coating new in 2010			
Fn	1	4	4.00	adequate openings for ingress/egress?	Yes			
INFORMATION	N/A	N/A	N/A	date of last interior inspection?	Fall 2011			
PM	1	3	3.00	passive or active cathodic protection in place (yes or no) and is it maintained and adequate?	Passive Cathodic installed 2011			
R	1	1	1.00	space available to add solar panels?	Unistruts were installed on the tank for this purpose			
R	1	2	2.00	known fire or haz-mat conditions that could be mitigated?	No known hazmat or fire conditions			
R	1	3	3.00	tank foundation type?	Ring concrete Foundation with anchor bolts

R	1	4	4.00	tank foundation condition?	New			
R	1	5	5.00	has seismic stability been evaluated by a qualified engineer?	Yes when designed in 2009/2010			
R	1	4	4.00	concern with tank compliance with seismic requirements?	No			
Fn	1	4	4.00	other known problems (e.g. adequate freeboard, stagnant water)?	No other known site problems with the tank structure			
PM	1	4	4.00	estimated service life remaining?	48 years based on AWU Useful Life

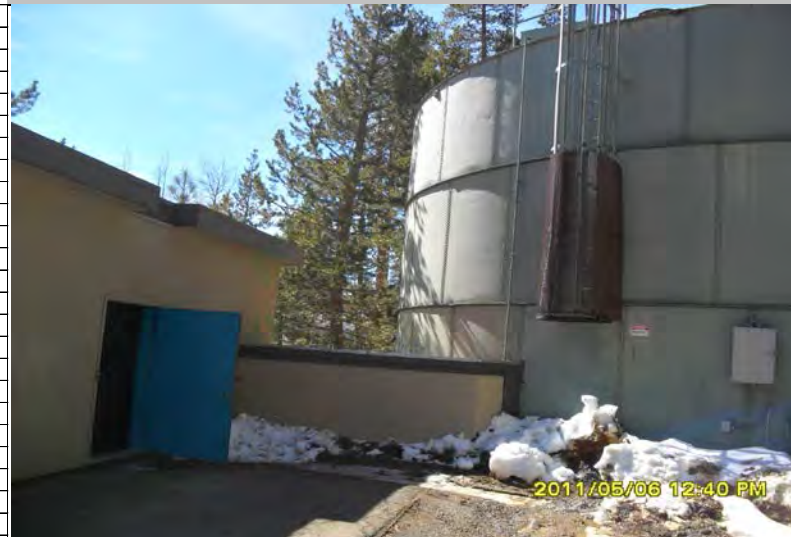
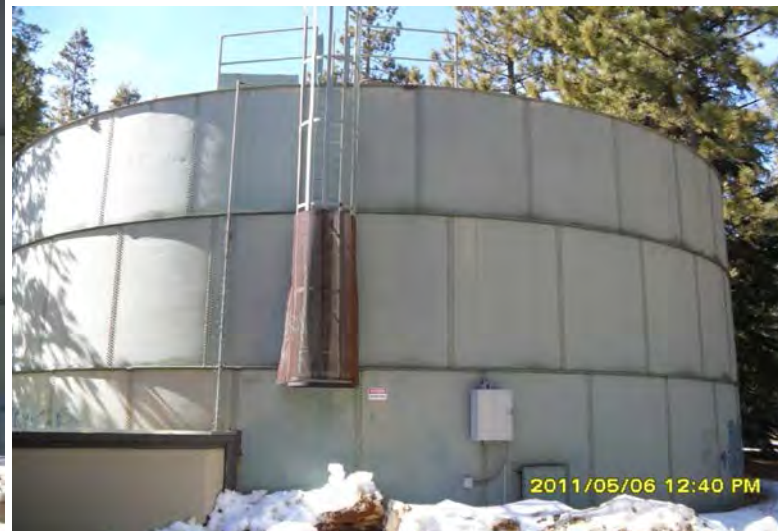
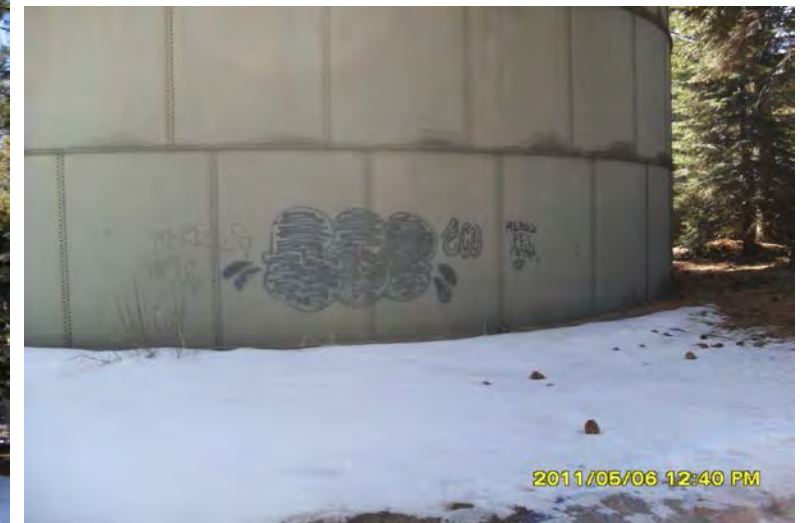
PHOTOS

Photo Evidence for PM, Fn, R, FE [Is the downslope portion of the tank constructed on fill?](#) [Does tank overflow drain adequately to protect tank foundation?](#) [Any bacteriological exceedance at this tank?](#) [Add Photo](#)

Failure Mode Type	Score	Importance Weighting (1-5)	Weighted Score	CONDITION ASSESSMENT CHECKLIST				
				<b>Calif. Waterworks Standards</b>				
				tank openings designed to prevent contamination (e.g., rainwater, runoff, insects, birds, rodents, or other animals)?	Yes, there have been no issues with contamination from outside sources at this tank			
Fn	1	5	5.00	sample tap(s) provided to measure water quality into, out of and inside tank and protected from freezing?	Yes, these taps are provided with easy access on the east side of the tank			
Fn	1	3	3.00	tank designed to minimize dead zones (separate inlet/outlet or mixer)?	No, there is a single pipe into the tank which is also the discharge pipe from the tank			
Fn	5	5	25.00	air-gap provided for tank drain and overflow piping?	This tank has a questionable air gap.			
Fn	4	5	20.00	tank draining removes residual sediments?	The tank drain is not adequate and does not remove residual sediment from the bottom of the tank

Fn	1	5	5.00	adequate isolation valves and bypass to take tank offline and maintain water service?	The tank can be isolated easily and maintain water service.			
INFORMATION	N/A	N/A	N/A	tank used for CT compliance? yes - bypass pipes blind flanged?	This tank is not used for CT compliance			
Fn	1	5	5.00	tank prevent entry of runoff, subsurface flow, or drainage into the tank?	The tank does prevent entry of exterior flows into the tank			
PM	5	5	25.00	condition of interior coatings adequate to protect structure?	Condition of the interior of the tank has been identified to be faulty and in need of recoating			
				<b>Tank Site</b>				
Fn	1	4	4.00	adequate vehicle access for year-round maintenance?	The site is accessible year round with no issues and shares the lot with three wellheads and a booster station			
R	1	3	3.00	is site within 100-yr flood plain?	No. This site is indicated as other areas Zone X on the FEMA flood map.

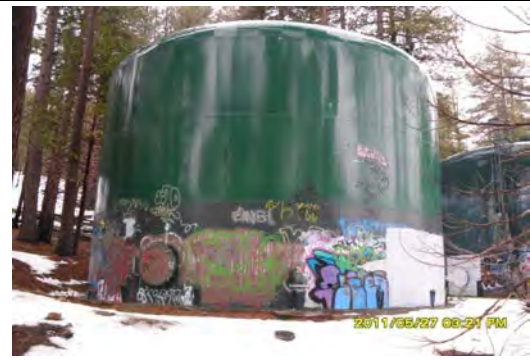
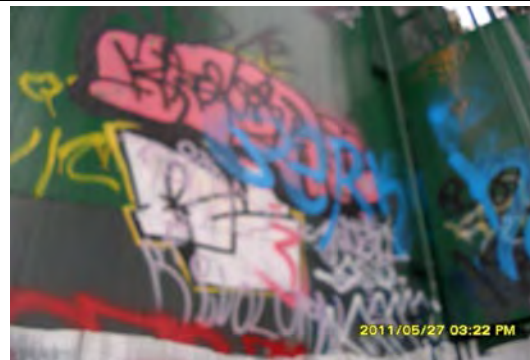
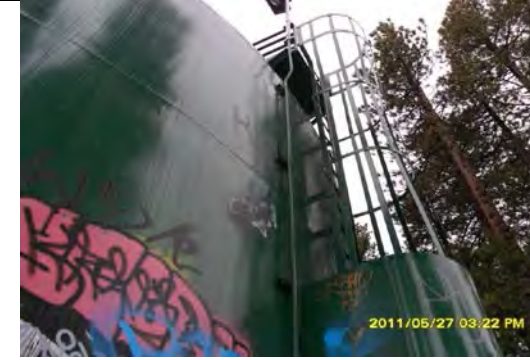
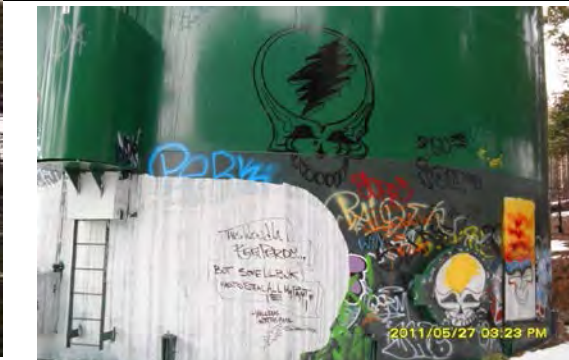
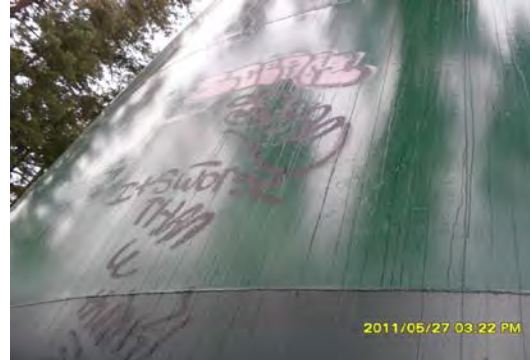
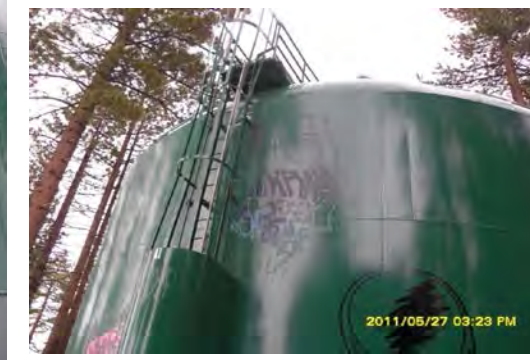
PHOTOS

Photo Evidence for PM, Fn, R, FE [Is the downslope portion of the tank constructed on fill?](#) [Yes](#) [Does tank overflow drain adequately to protect tank foundation?](#) [Yes](#) [Any bacteriological exceedance at this tank?](#) [No](#) [Notes](#)

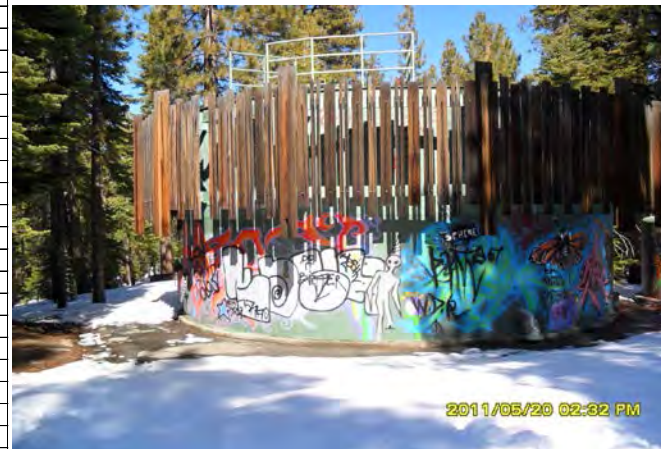
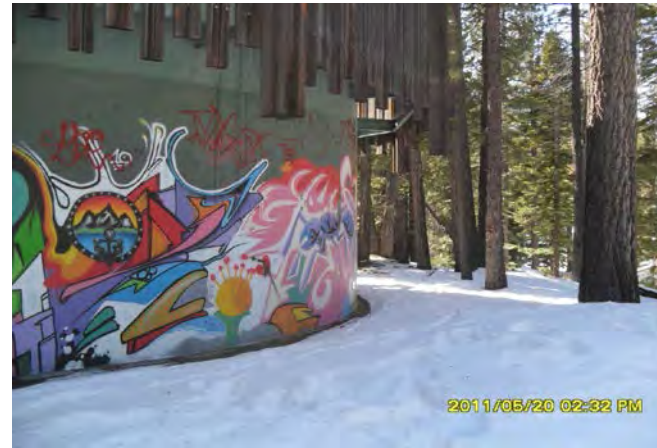
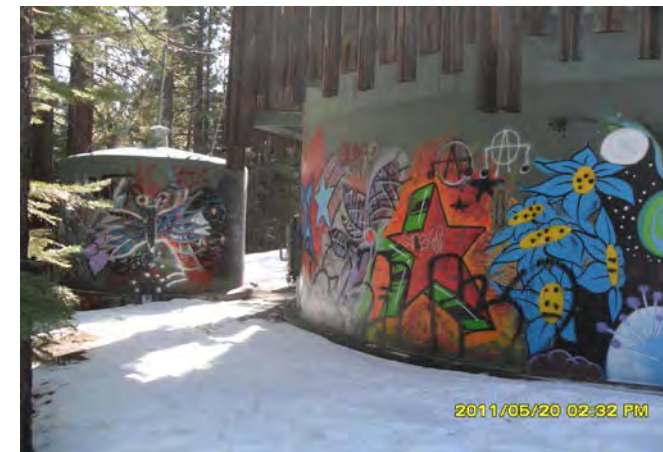
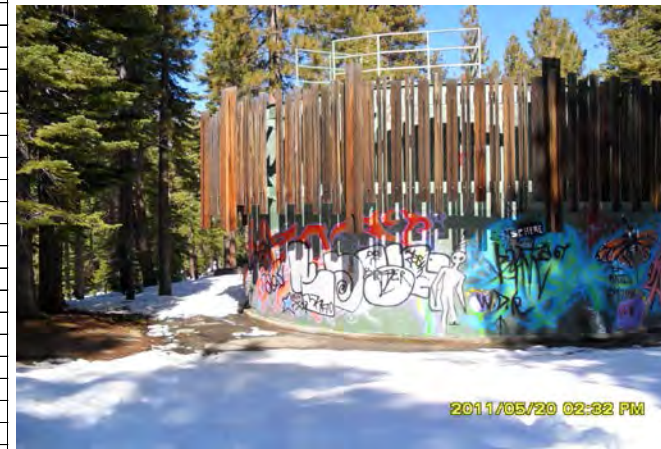
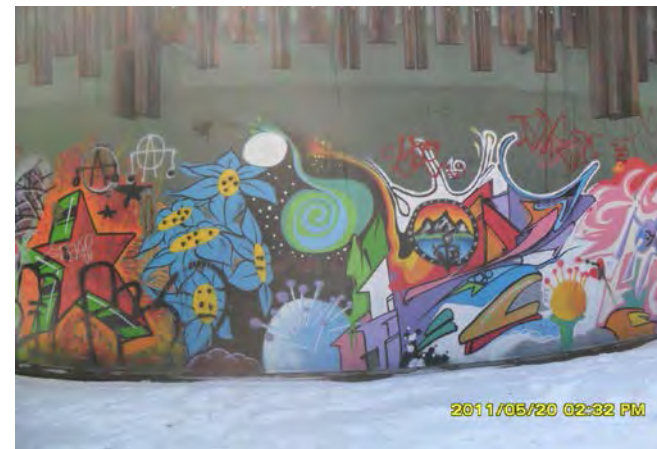
**PHOTOS**

Photo Evidence for PM, Fn, R, FE [Is the downslope portion of the tank constructed on fill?](#) [Does tank overflow drain adequately to protect tank foundation?](#) [Any bacteriological exceedance at this tank?](#) [Add Photo](#)

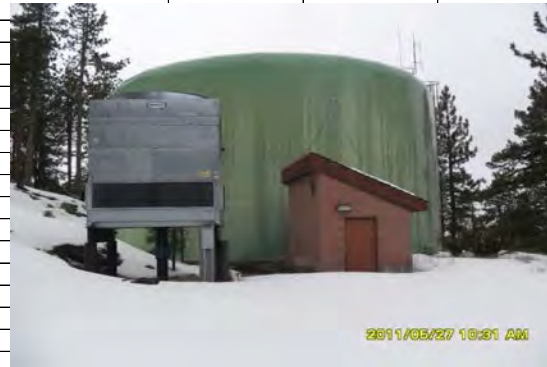
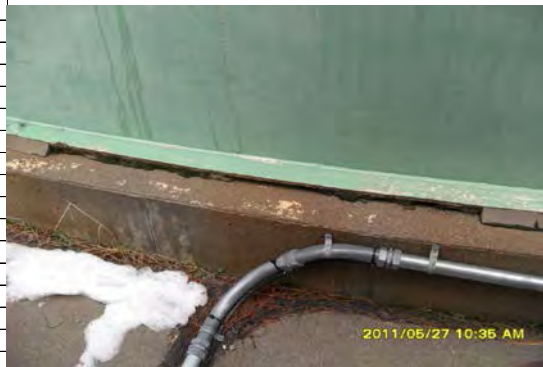
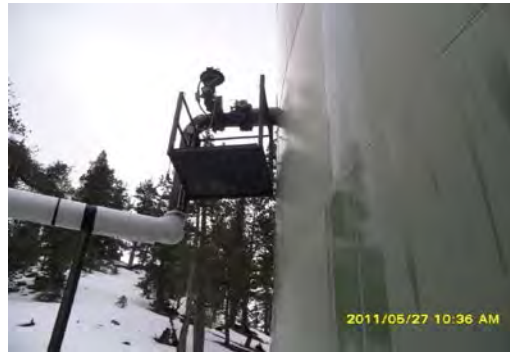
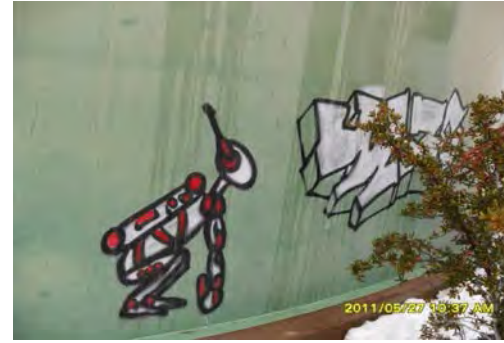
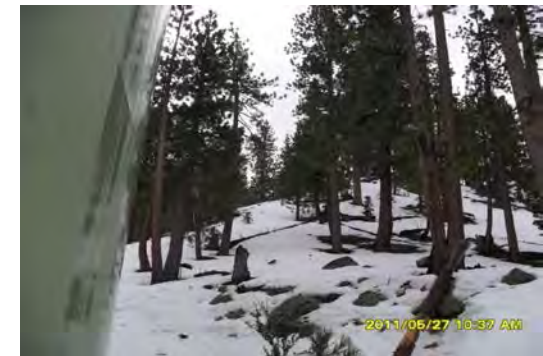
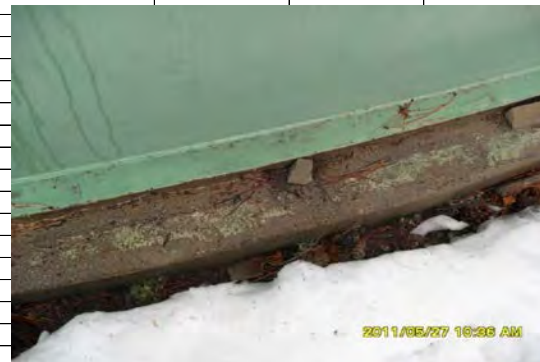
**PHOTOS**

Photo Evidence for PM, Fn, R, FE **Is the downslope portion of the tank constructed on fill? No** **Does tank overflow drain adequately to protect tank foundation? No** **Any bacteriological exceedance at this tank? No** **Any leaks?**

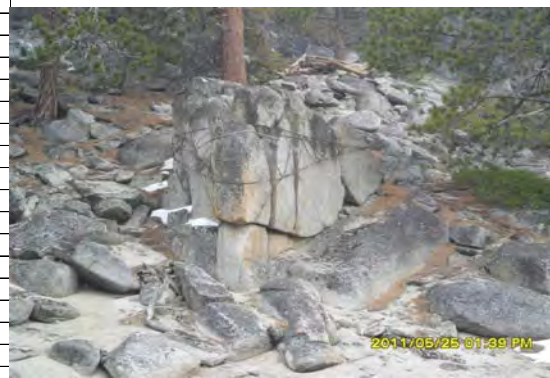
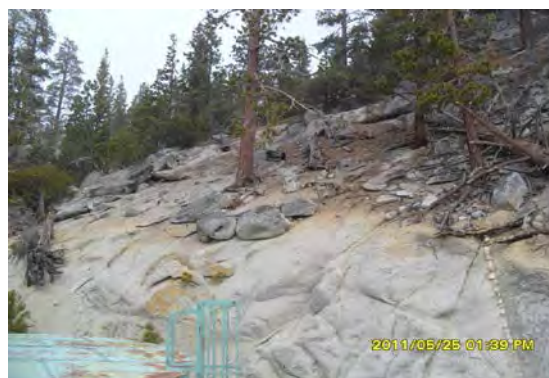
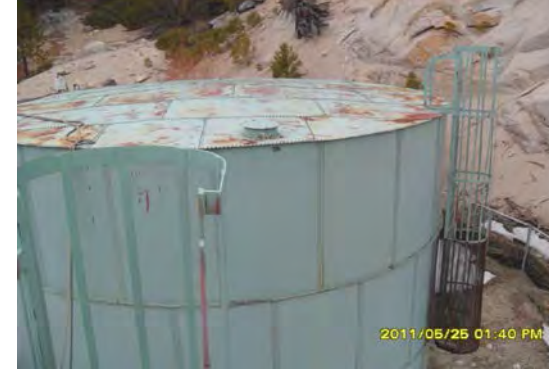
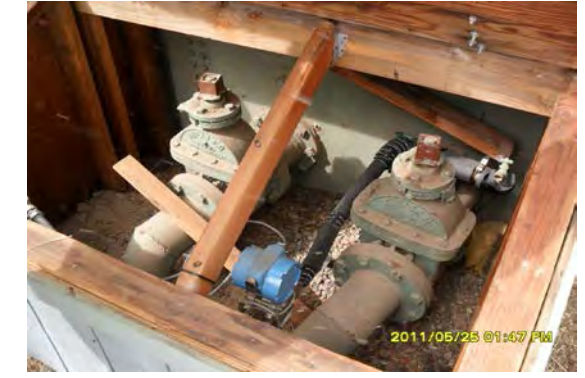
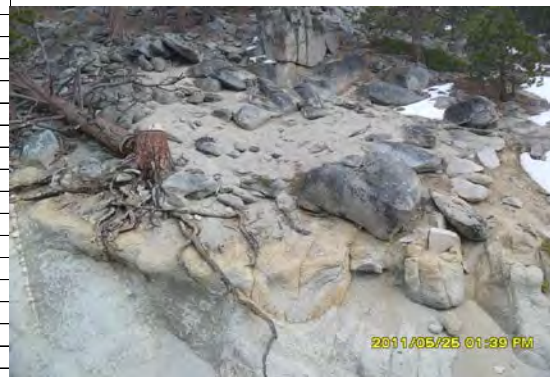
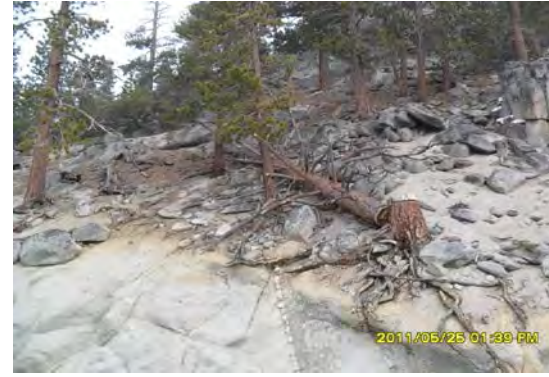
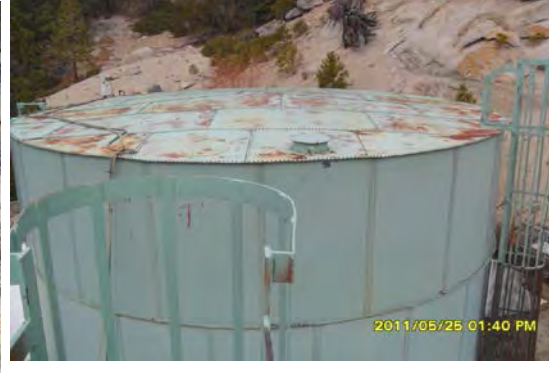
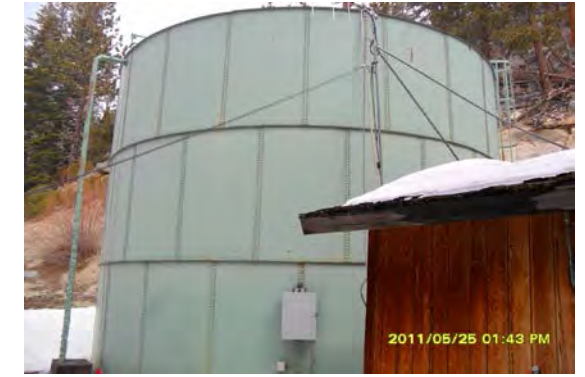
**PHOTOS**

Photo Evidence for PM, Fn, R, FE [Is the downslope portion of the tank constructed on fill?](#) [Does tank overflow drain adequately to protect tank foundation?](#) [Any bacteriological exceedance at this tank?](#) [Add Photo](#)

R	5	5	25.00	any unstable site conditions (if yes, describe)?	There is a large boulder that is perched above the tank that has been strapped back with cables to prevent the boulder from rolling down hill into the tanks. Also the tanks sit above a private residence and if the tanks fail they will flood the home. There are
R	4	3	12.00	is site close to known active seismic faults?	4,595 ft. to the nearest fault
R	1	3	3.00	site drainage adequate to prevent flooding of tank foundation, buildings and critical equipment?	There are no site drainage issues
Fn			0.00	site lighting, fencing, and security monitoring adequate to discourage unauthorized access/vandalism?	There are issues with unauthorized access to these tanks
INFORMATION	N/A	N/A	N/A	other known problems?	None
<b>Tank Structure</b>					
INFORMATION	N/A	N/A	N/A	describe tank structure type (e.g., welded steel, bolted steel, reinforced concrete, prestressed concrete, etc.)	Welded Steel

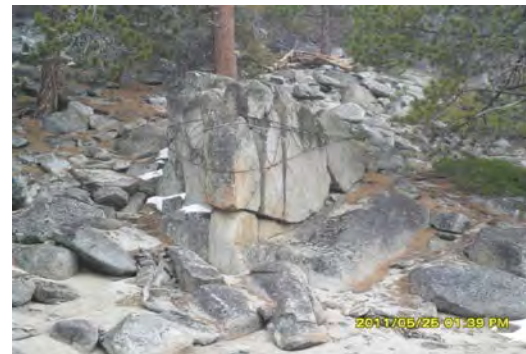
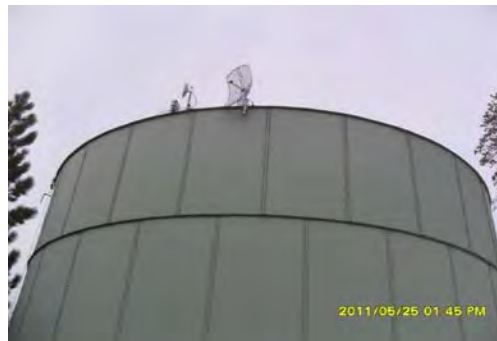
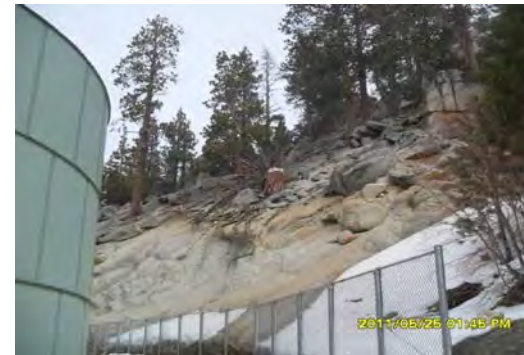
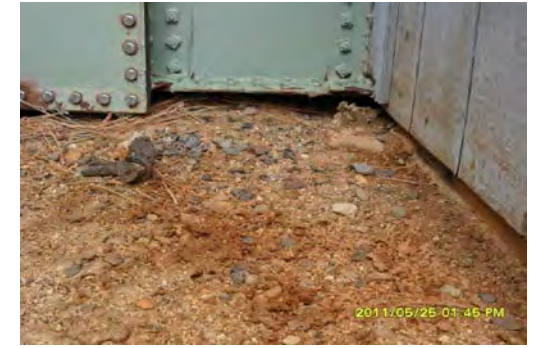
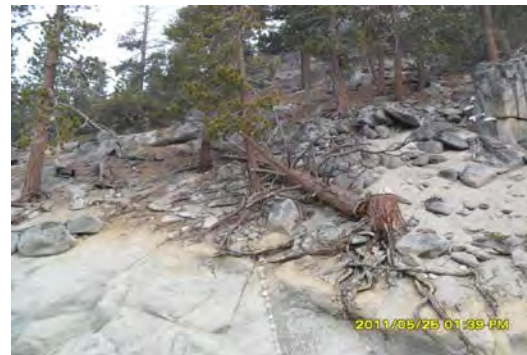
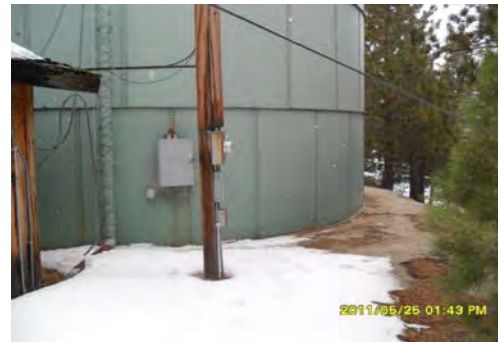
**PHOTOS**

Photo Evidence for PM, Fn, R, FE  Is the downslope portion of the tank constructed on fill?  Does tank overflow drain adequately to protect tank foundation?  Any bacteriological exceedance at this tank?

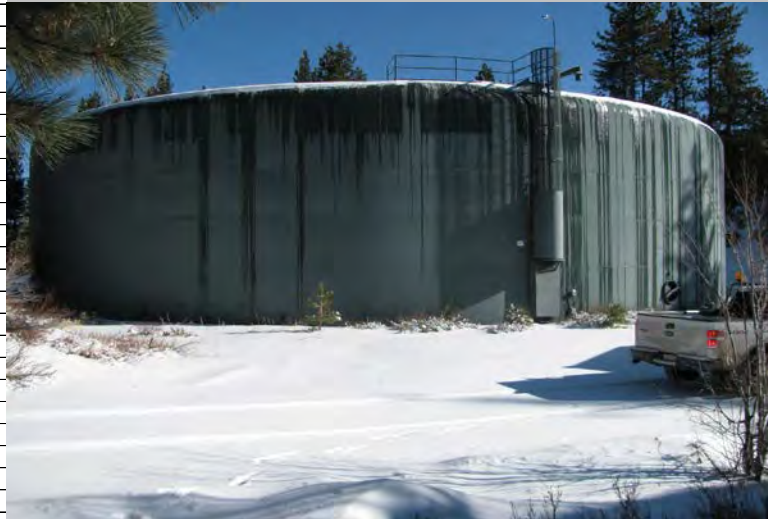
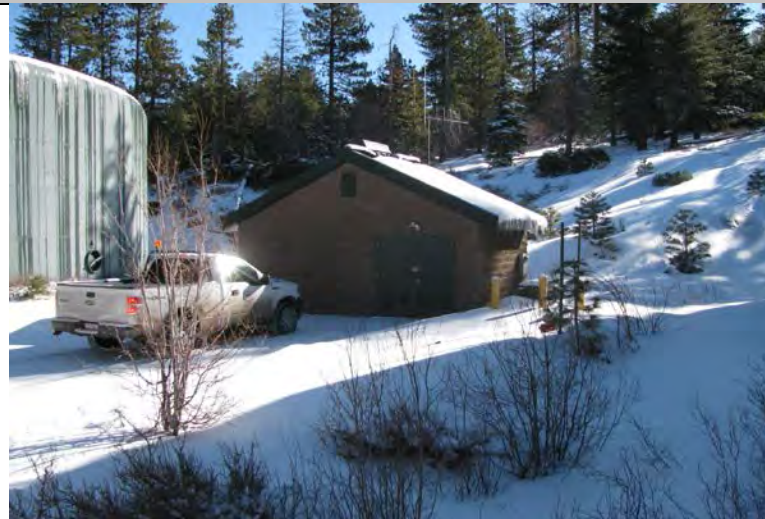
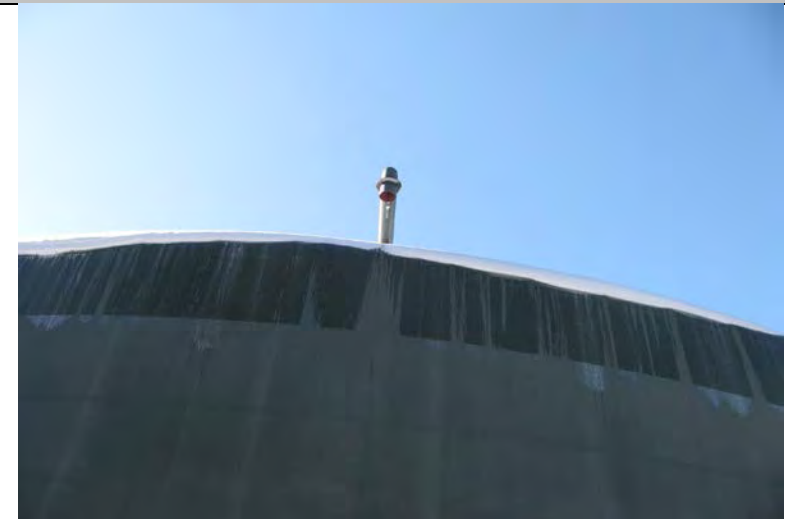
**PHOTOS**

Photo Evidence for PM, Fn, R, FE  Is the downslope portion of the tank constructed on fill?  Does tank overflow drain adequately to protect tank foundation?  Any bacteriological exceedance at this tank?
