South Tahoe Public Utility District

## STPUD Water Facilities CIP

*Final Report - Appendices*

# Water System Optimization Plan

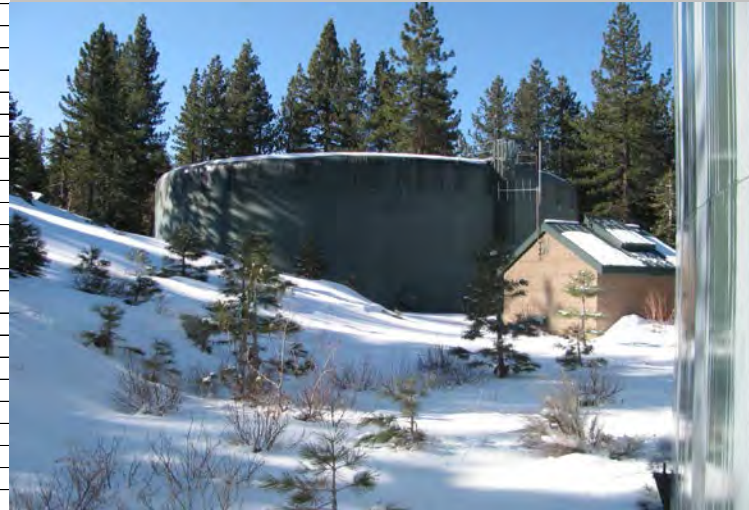
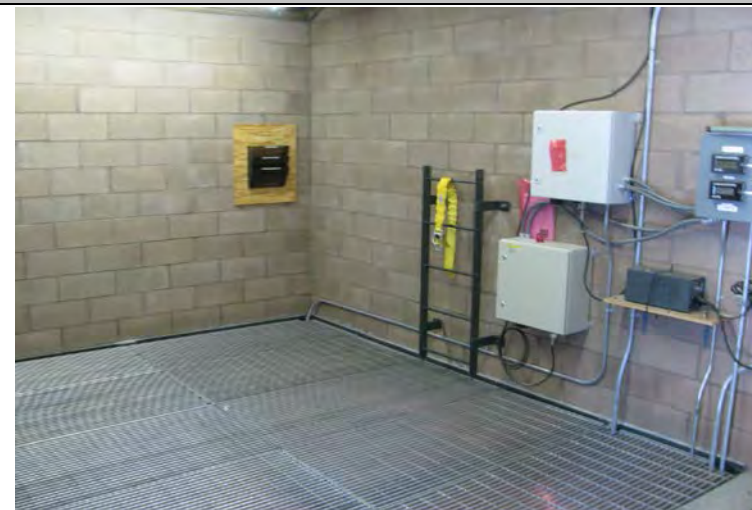
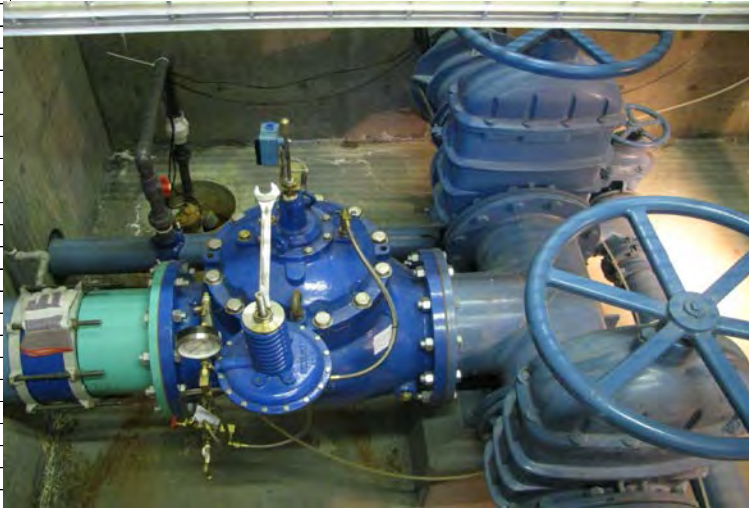
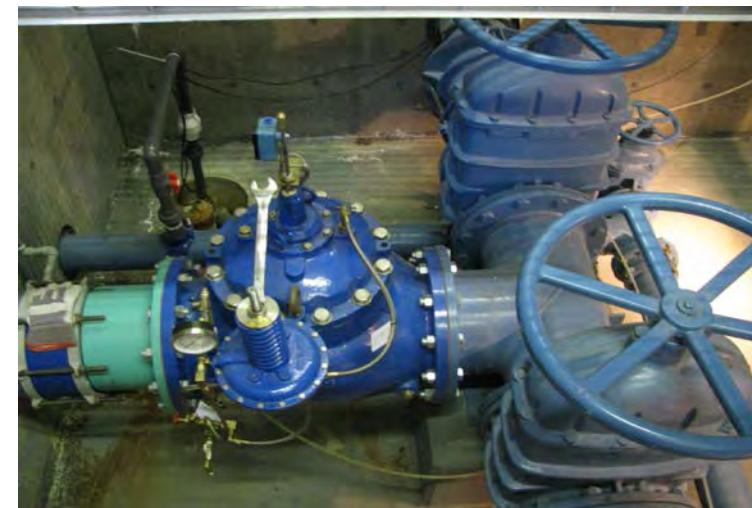
**PHOTOS**

Photo Evidence for PM, Fn, R, FE Is the downslope portion of the tank constructed on fill? **Yes** Does tank overflow drain adequately to protect tank foundation? **Yes** Any bacteriological exceedance at this tank? **Nil** **Verify**

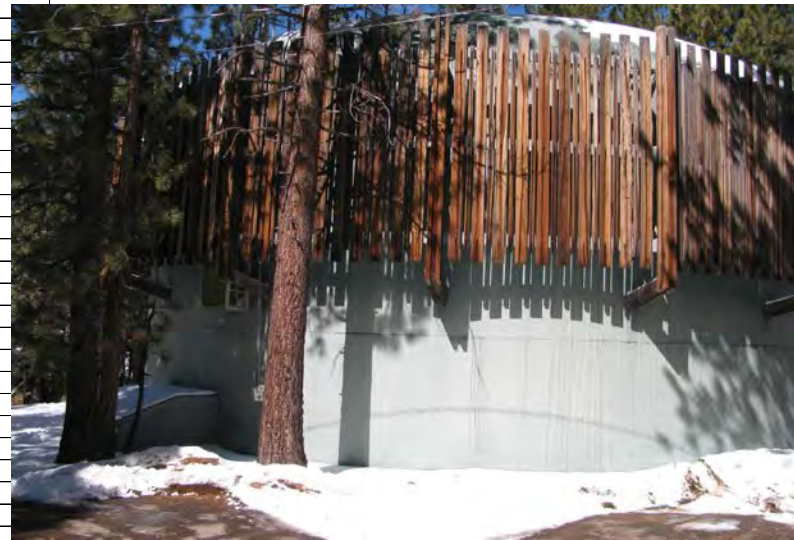
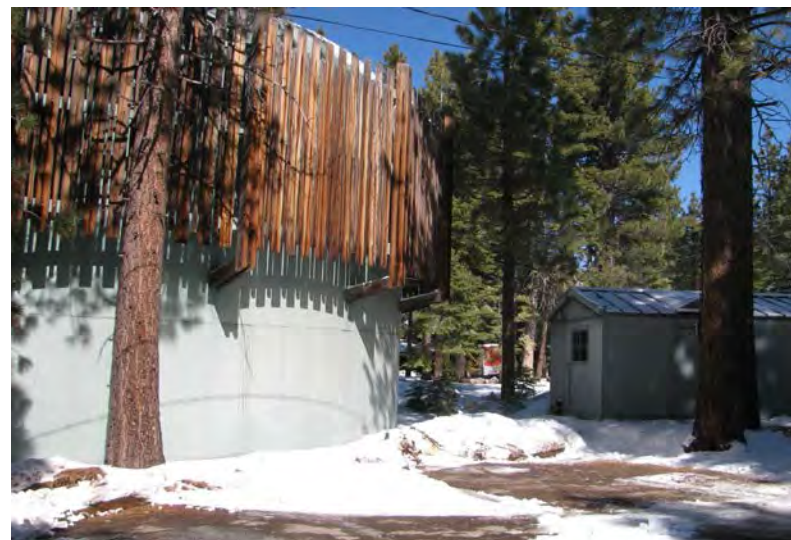
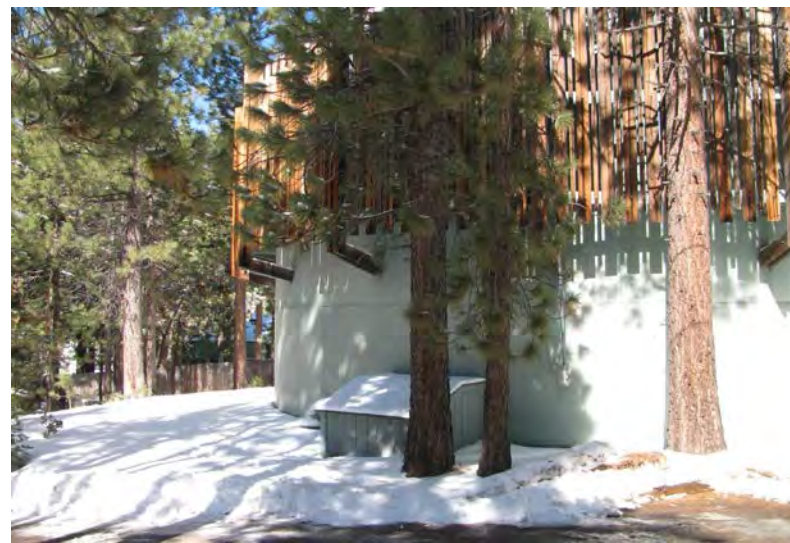
PHOTOS

Photo Evidence for PM, Fn, R, FE  Is the downslope portion of the tank constructed on fill?  Does tank overflow drain adequately to protect tank foundation?  Any bacteriological exceedance at this tank?

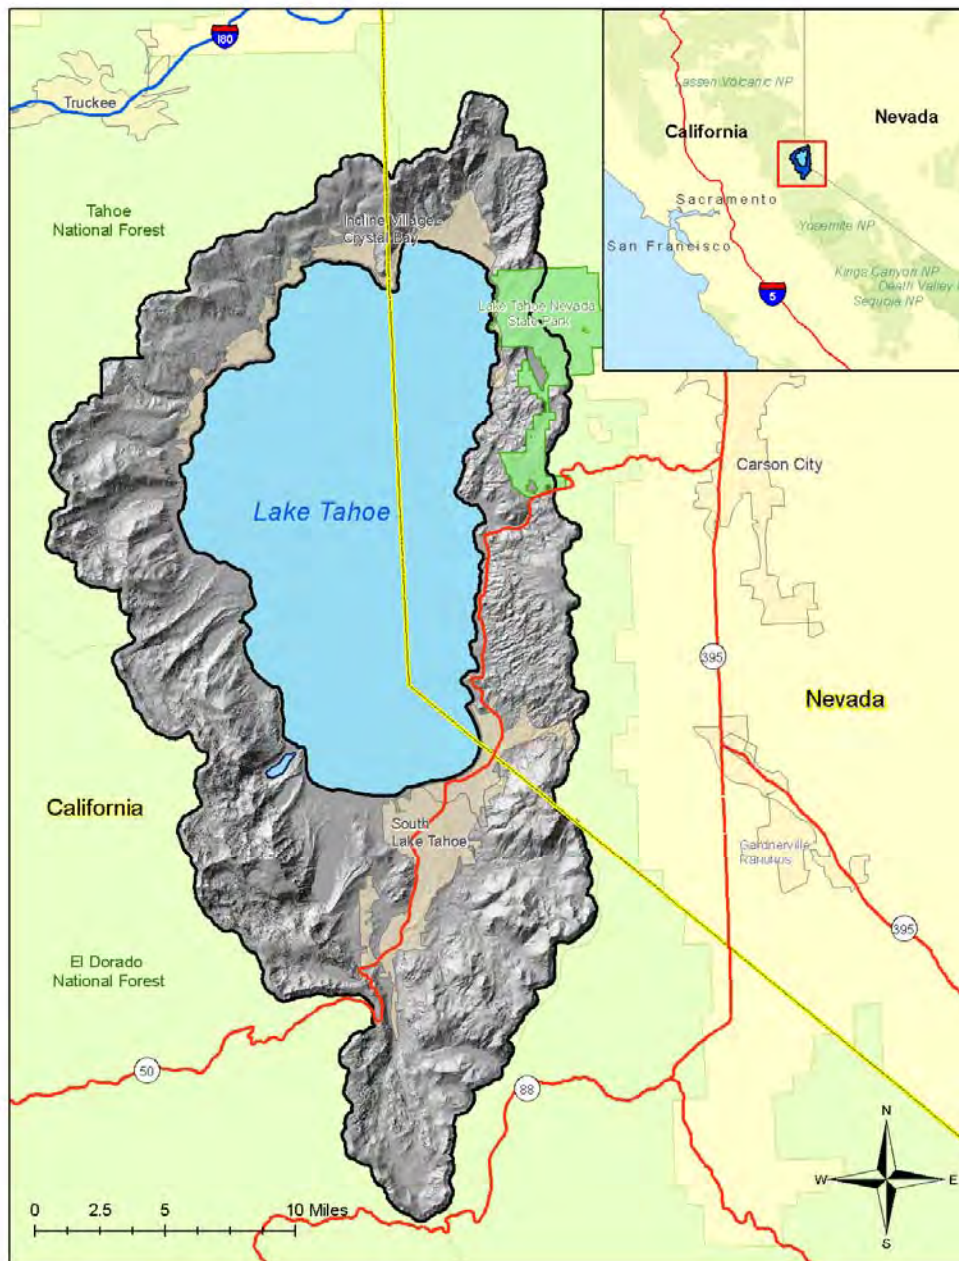
Figure 1. Lake Tahoe Area of Interest (AOI)

Watershed Sciences, Inc. (WSI) collected Light Detection and Ranging (LiDAR) data of land surrounding Lake Tahoe from August 11<sup>th</sup> to August 24<sup>th</sup>, 2010. This report documents the data acquisition, processing methods, accuracy assessment, and deliverables of that data. The requested area of interest (AOI), excluding the actual lake, was 224,725 acres. The area was expanded to include a 100m buffer to ensure complete coverage and adequate point densities around survey area boundaries, resulting in 232,536 acres of delivered LiDAR data. (Figure 1).

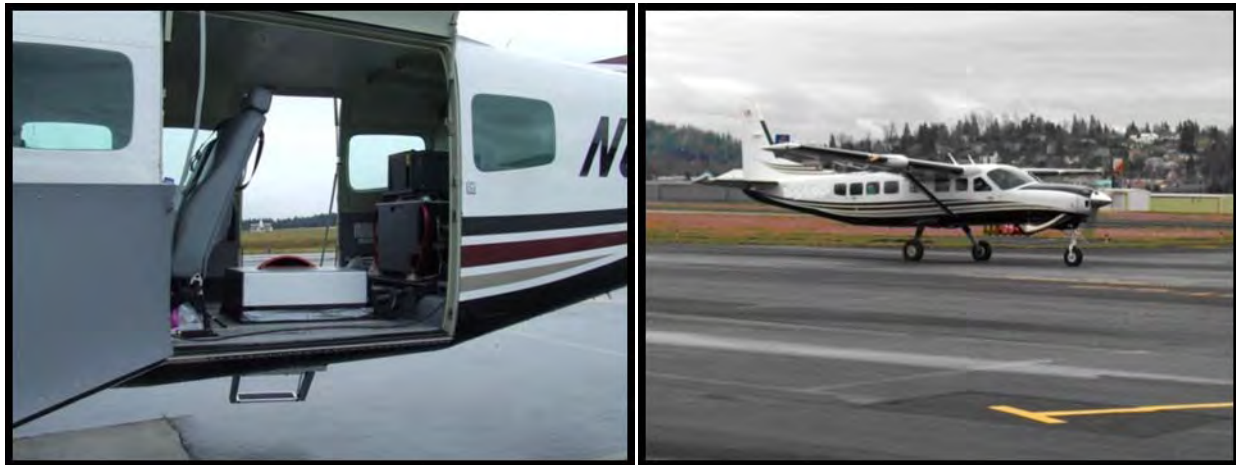
The LiDAR survey used two Leica ALS50 Phase II laser systems mounted in a Cessna Caravan 208B. The Leica systems were set to acquire  $\geq 83,000 - 105,900$  laser pulses per second (i.e., 83 - 105.9 kHz pulse rate) and flown at 900 - 1300 meters above ground level (AGL) depending on weather and terrain, capturing a scan angle of  $\pm 14^\circ$  from nadir. These settings were developed to yield points with an average native pulse density of  $\geq 8$  pulses per square meter over terrestrial surfaces. It is not uncommon for some types of surfaces (e.g. dense vegetation or water) to return fewer pulses than the laser originally emitted. These discrepancies between 'native' and 'delivered' density will vary depending on terrain, land cover, and the prevalence of water bodies.

*The Cessna Caravan is a stable platform, ideal for flying slow and low for high density projects. The Leica ALS50 sensor head installed in the Caravan is shown on the left.*

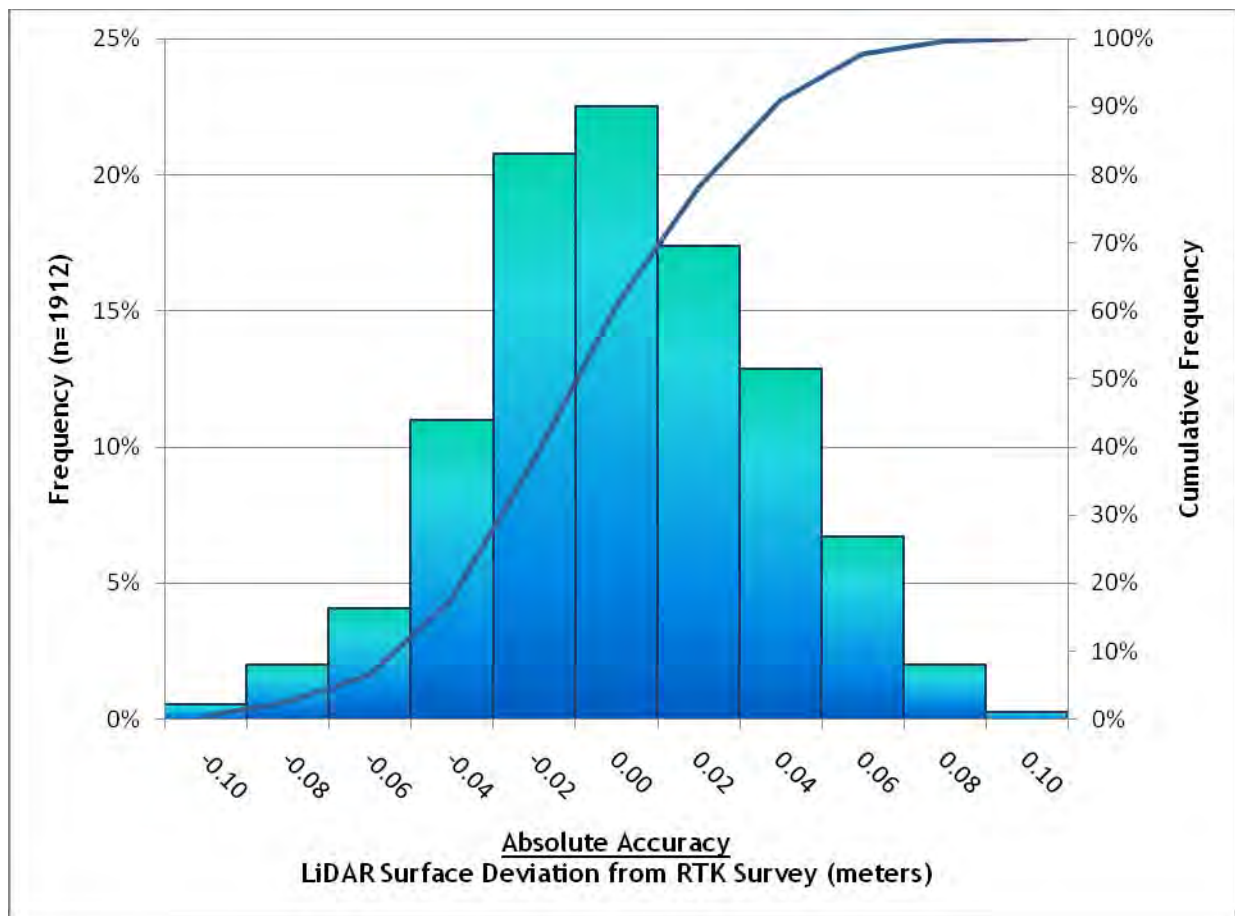
*Figure 8. Absolute Accuracy - Histogram Statistics*

Watershed Sciences, Inc. Absolute Accuracy Assessment		
RTK Survey Sample Size (n): 1912		
Root Mean Square Error (RMSE) = 0.036 m		Minimum $\Delta z$ = -0.113 m
Standard Deviations 1 sigma ( $\sigma$ ): 0.035 m    1.96 sigma ( $\sigma$ ): 0.068 m		Maximum $\Delta z$ = 0.093 m
		Average $\Delta z$ = -0.008 m

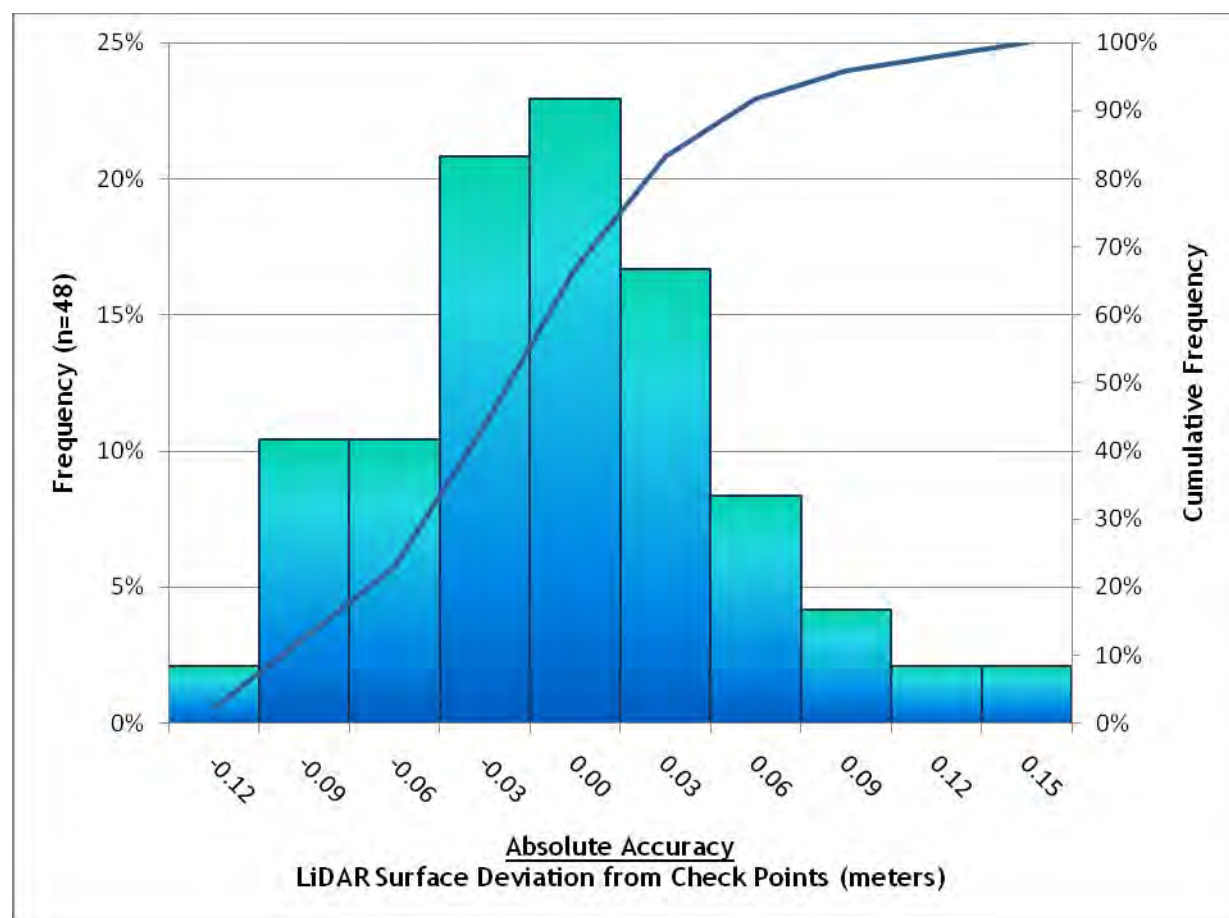
Figure 9. Absolute Accuracy - Histogram Statistics

Andregg Geomatics, Inc. Independent Accuracy Assessment		
Sample Size (n): 48		
Root Mean Square Error (RMSE) = 0.057 m		Minimum $\Delta z$ = -0.120 m
Standard Deviations 1 sigma ( $\sigma$ ): 0.057 m    1.96 sigma ( $\sigma$ ): 0.111 m		Maximum $\Delta z$ = 0.130 m
		Average $\Delta z$ = -0.012 m

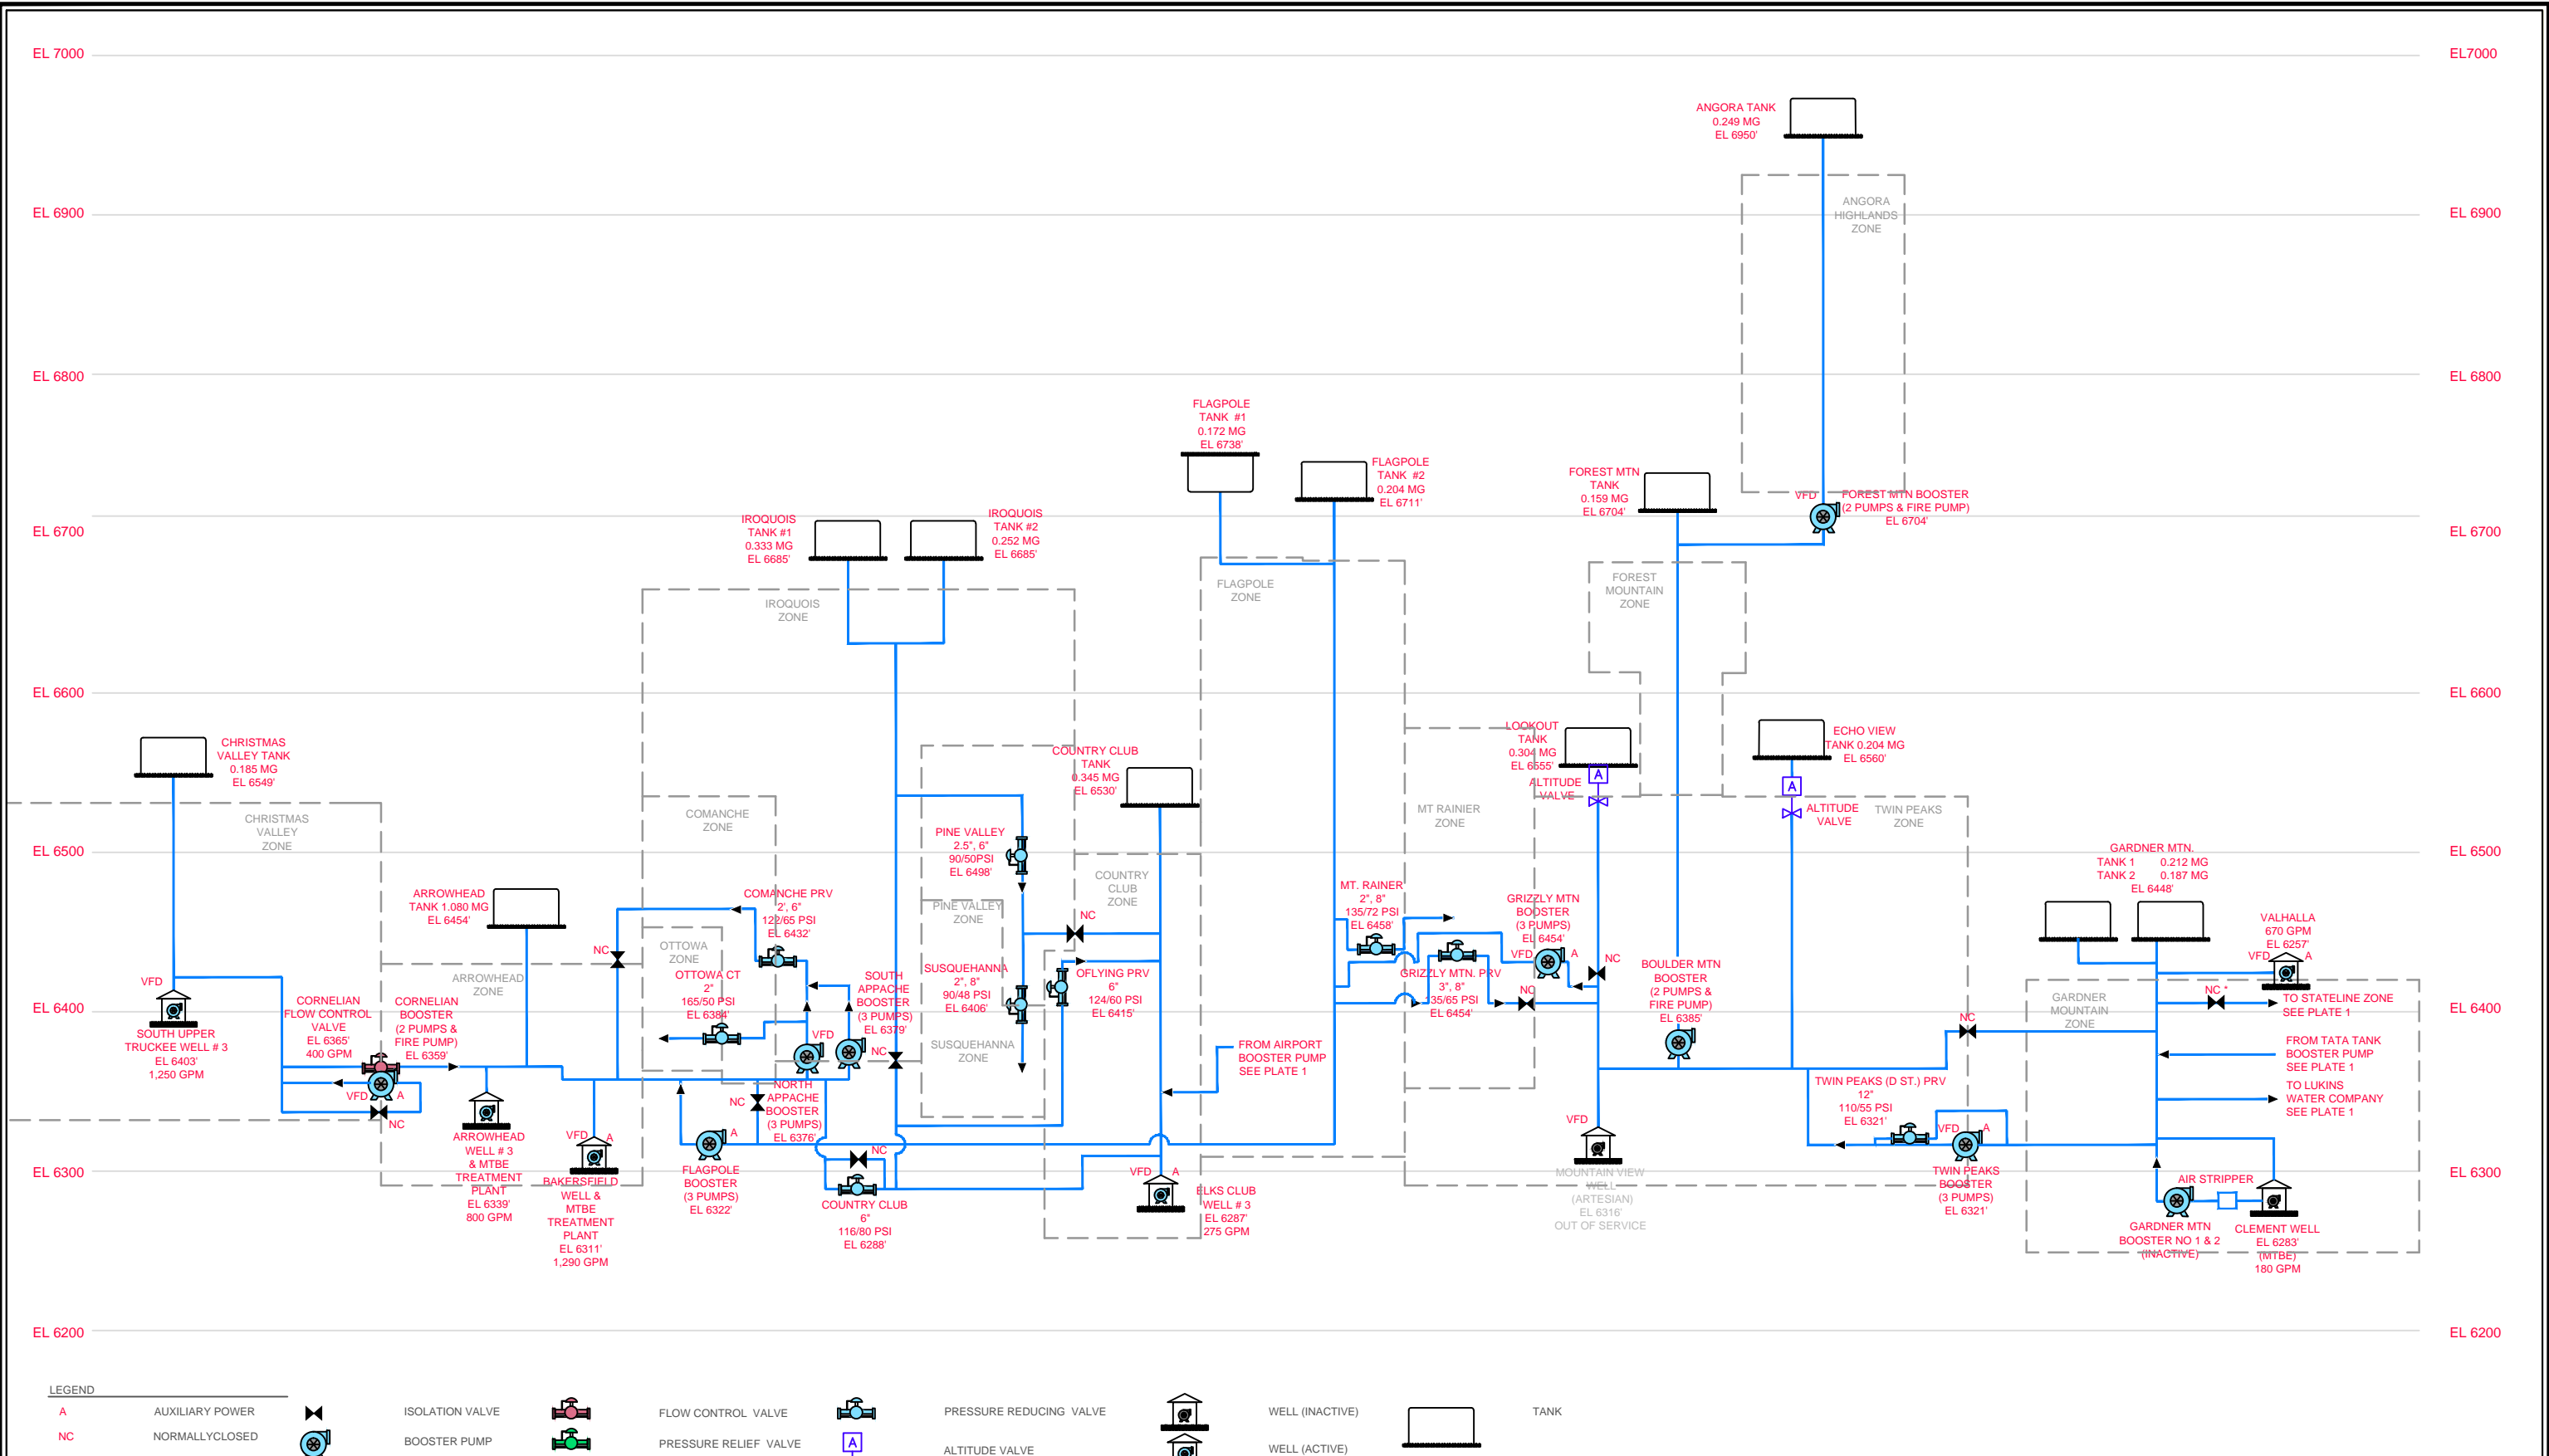
**PLATE 2**

Note: Elevations and dimensions on this figure are from various sources and should be verified with best available information if being used for critical purposes.
